Cottonwood Creek Spring Condition Assessment

Location: Trail Mountain Allotment, Trail Canyon Pasture, Manti-La Sal National Forest

Date: September 28, 2016 **Begin/End Time:** 3:00pm to 4:00pm

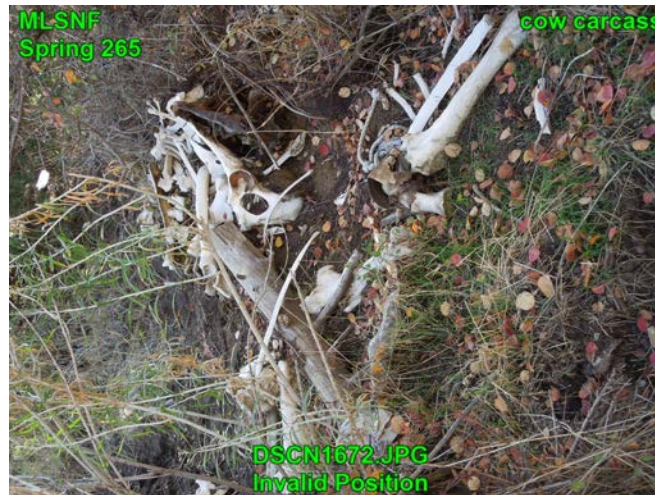
Fig. 1: Cow carcass

The overall condition of the Cottonwood Creek Spring is highly impacted and the spring site is substantially degraded from human and cattle disturbance. Trash was scattered all around the spring site, particularly beer cans and bottles (Fig. 5). The streambed looked washed out and eroded, possibly from a recent flash flood and there was an accumulation of debris on the south side of the streambed (Figs. 3, 8, 9). Herbaceous and woody vegetation was extensively grazed and browsed, most likely by cattle as evidenced by the cow carcass, abundance of cow patties and hoof marks in the dried mud (Figs. 1,4,6,7).

In order to restrict cattle access to the spring area, the current fence should be fixed and there should be a fence built to enclose the spring and keep cattle out.

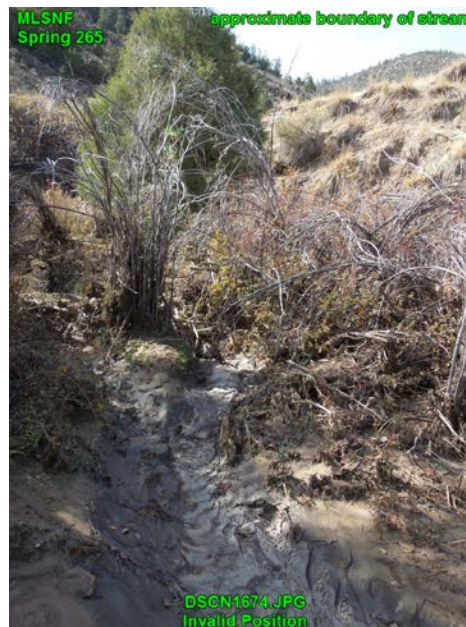
Fig. 2: Boundary of Microhabitat A

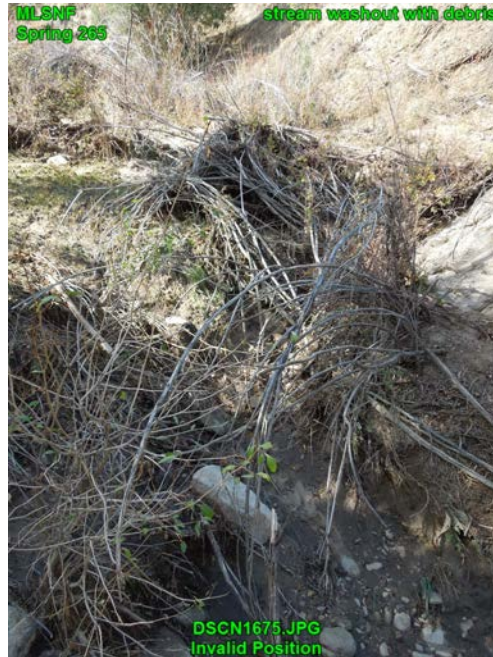
Fig. 3: Debris in the streambed

No water was present in Microhabitat A and no source was identified. As evidenced by dried mud spots, large amounts of debris, and the look of a streambed, there has historically been a stream fed by the spring running through Microhabitat A (Figs. 3, 11). It ranked as erratic intermittent (2) because there was damp soil and water is likely intermittent. No water infrastructure was present.

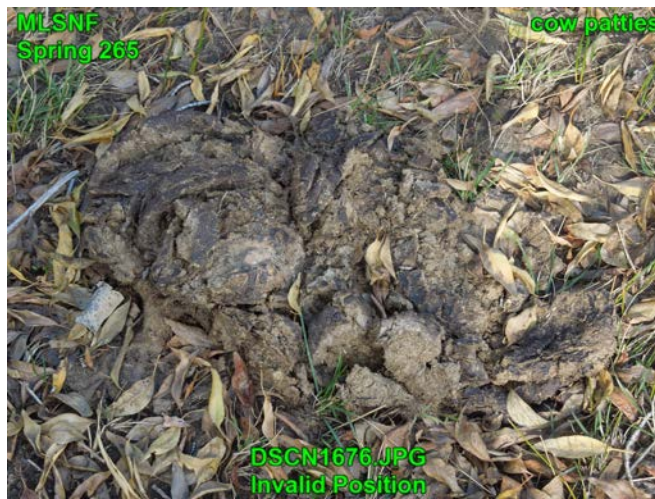
Fig. 4: Cow patty in Microhabitat A

Numerous cow patties were in the muddy area that was probably previously a stream (Fig. 4). A fence does not enclose the spring area but there is a fence on the south side of the spring that is not maintained (Fig. 10). Cattle were grazing on the other side of this fence. There was no other evidence of wildlife.

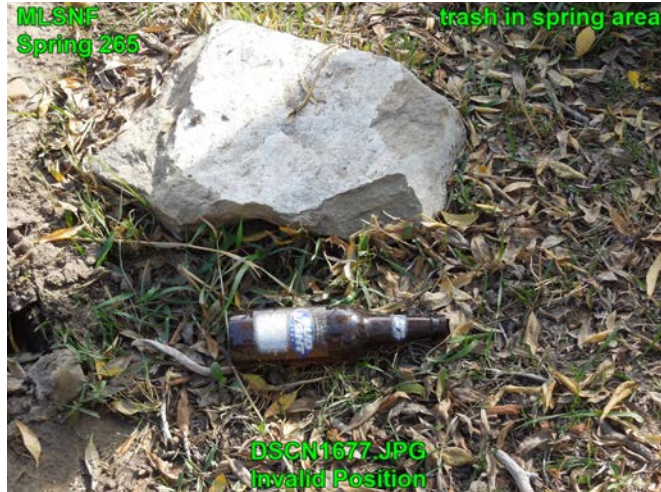
Fig. 5: Beer bottle in the riparian area

In order to help deter people from throwing garbage, particularly beer cans, an informational sign about the value of springs could be put up above the spring near the road.

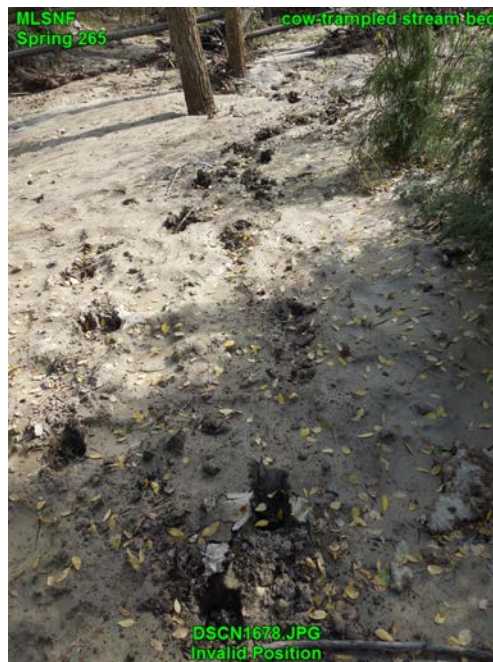
Fig. 6: Ungulate trampling in the streambed.

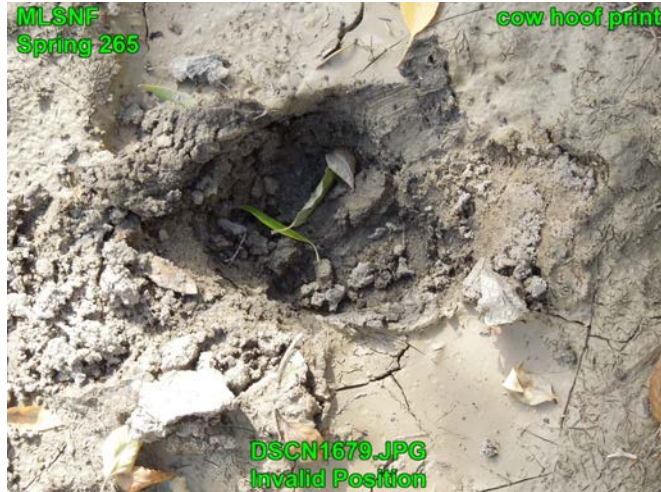
Fig. 7: Ungulate hoof print in the streambed

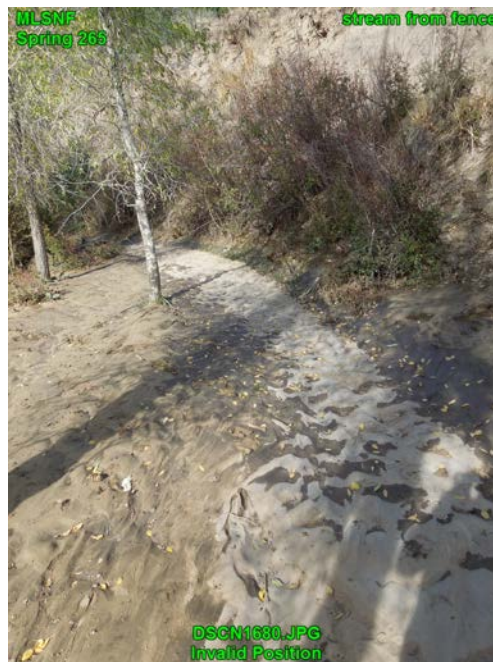
Fig. 8: Washed-out streambed

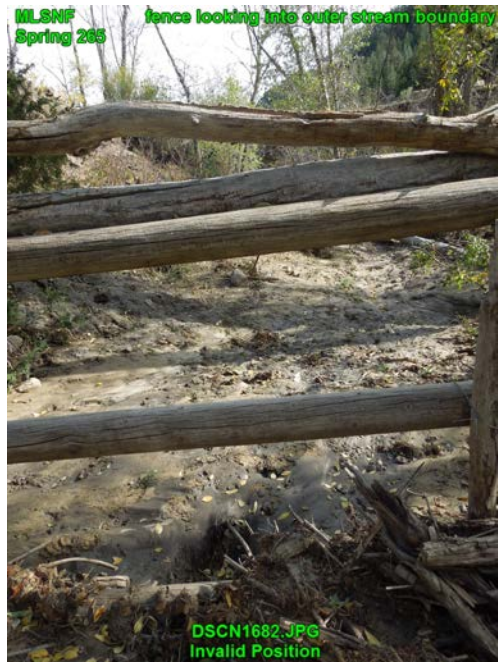
Fig. 10: Broken fence

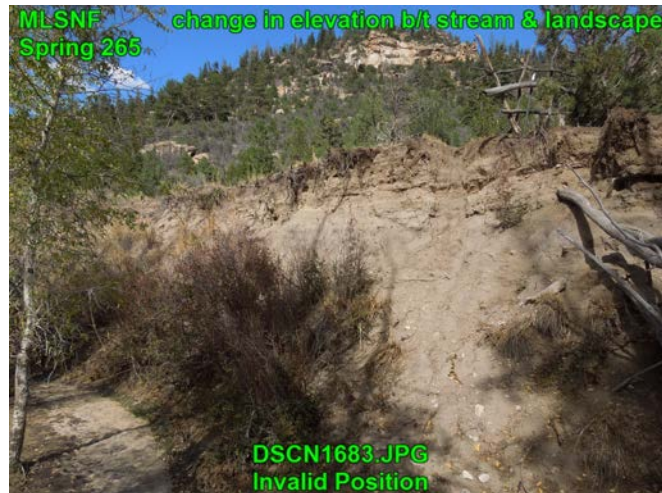
Fig. 11: Streambed wall
