Coyote Spring Condition Assessment

Location: La Sal Allotment, Coyote Pasture, Manti-La Sal National Forest

Date: September 25, 2016 **Begin/End Time:** 4:45pm to 5:25pm

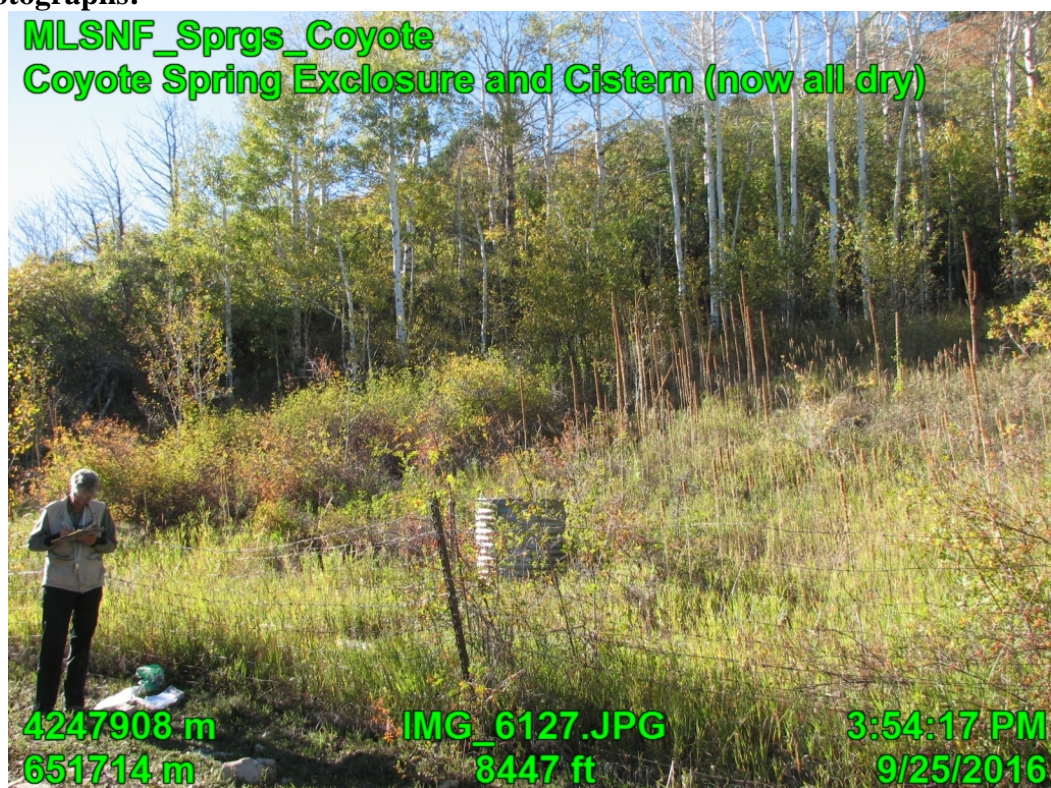
Fig. 1: Coyote Springs exclosure around cistern. Microhabitat A.

The fence around the upper source seemed moderately effective. It went completely around but in some places the wire was stretched and falling down. No grazing was occurring inside the enclosure.

- Any water that is currently diverted from this spring should be returned to the water way when cattle are not present.
- The fence should also be repaired, because at this time it most likely keeps cattle out but is falling down in several places.
- The heavily grazed and trampled meadow below the spring is problematic and at least a portion of it should be protected for its potential.
- It would be worthwhile to study this spring further to examine why it dried out and if it could have water again.

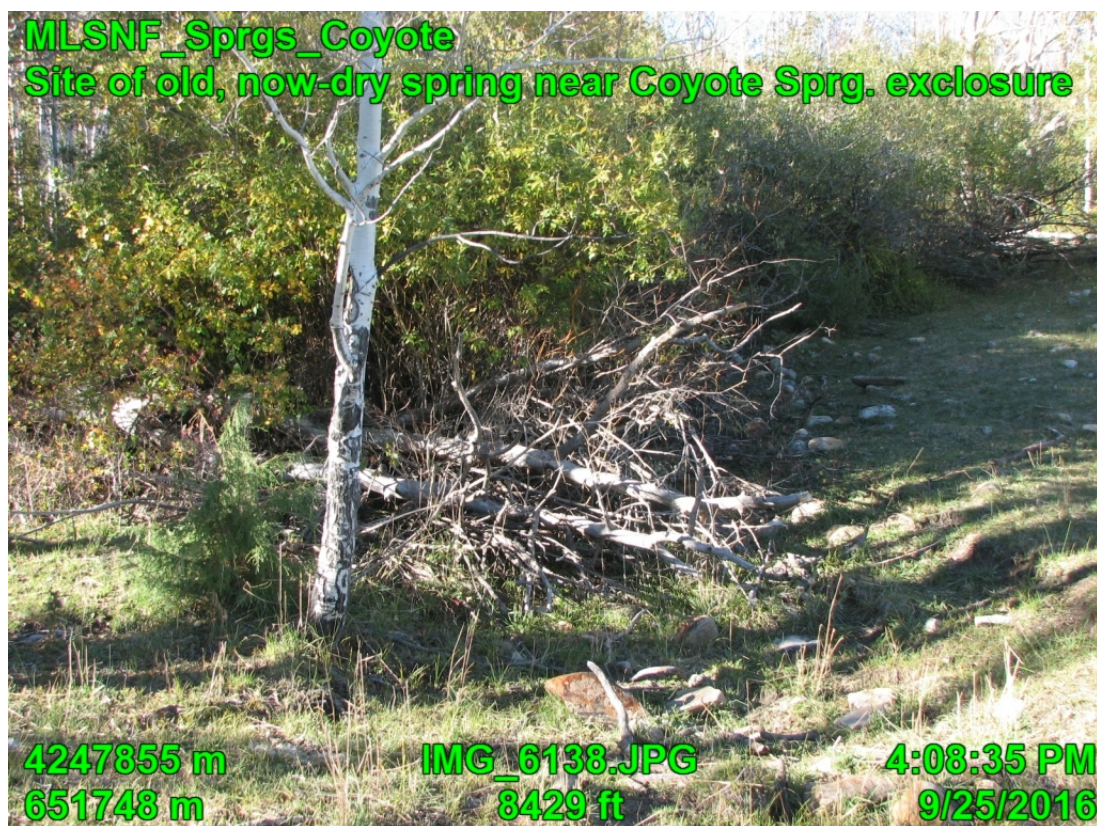
Fig. 3: Dried up spring in Coyote springs complex.

Another small spring was completely dried up and had likely not had any water for at least a year (Fig. 3).

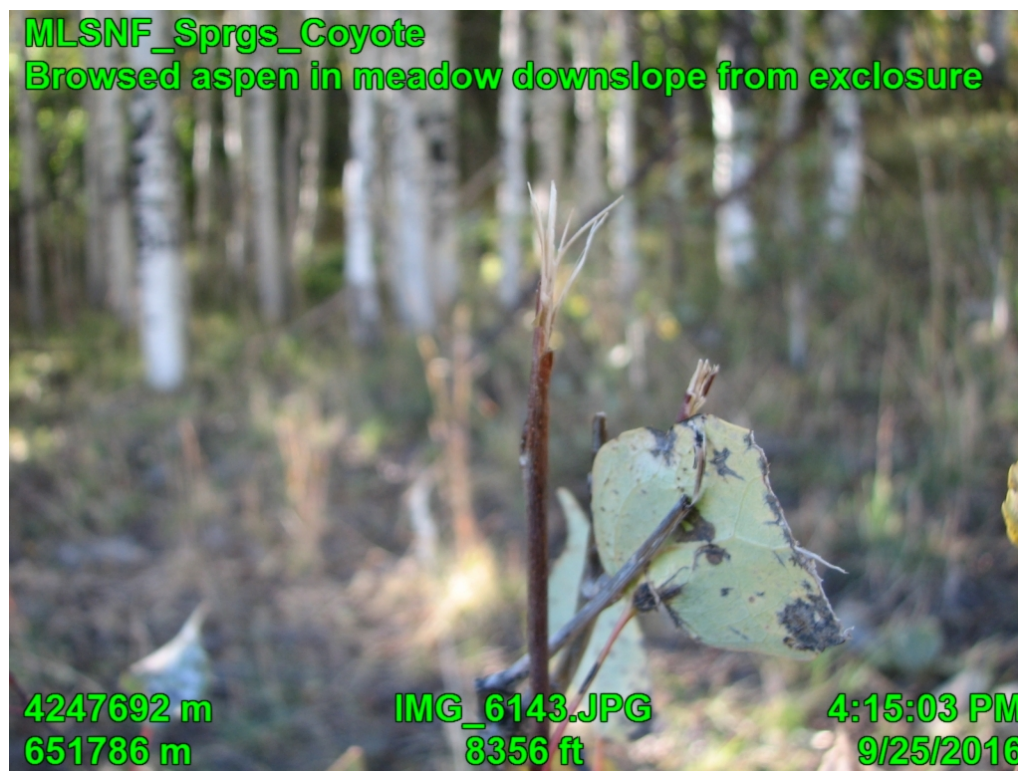
Fig. 4: Browsed aspen near muddy spring.

Around the spring complex there were some signs of browsing especially of aspen sprouts in microhabitat B below the road (Fig. 4).

The meadow, dry stream bed, and muddy spring showed heavy trampling and grazing. Many aspen shoots had been browsed and the grass had also been bitten down (Figs. 4 and 7). There was obvious hummocking around the meadow and the muddy spring (Figs. 5 and 9). The areas of the three spring sources that were partially or completely dried up could be naturally that way or diverting water for the cistern could have dewatered the spring run.

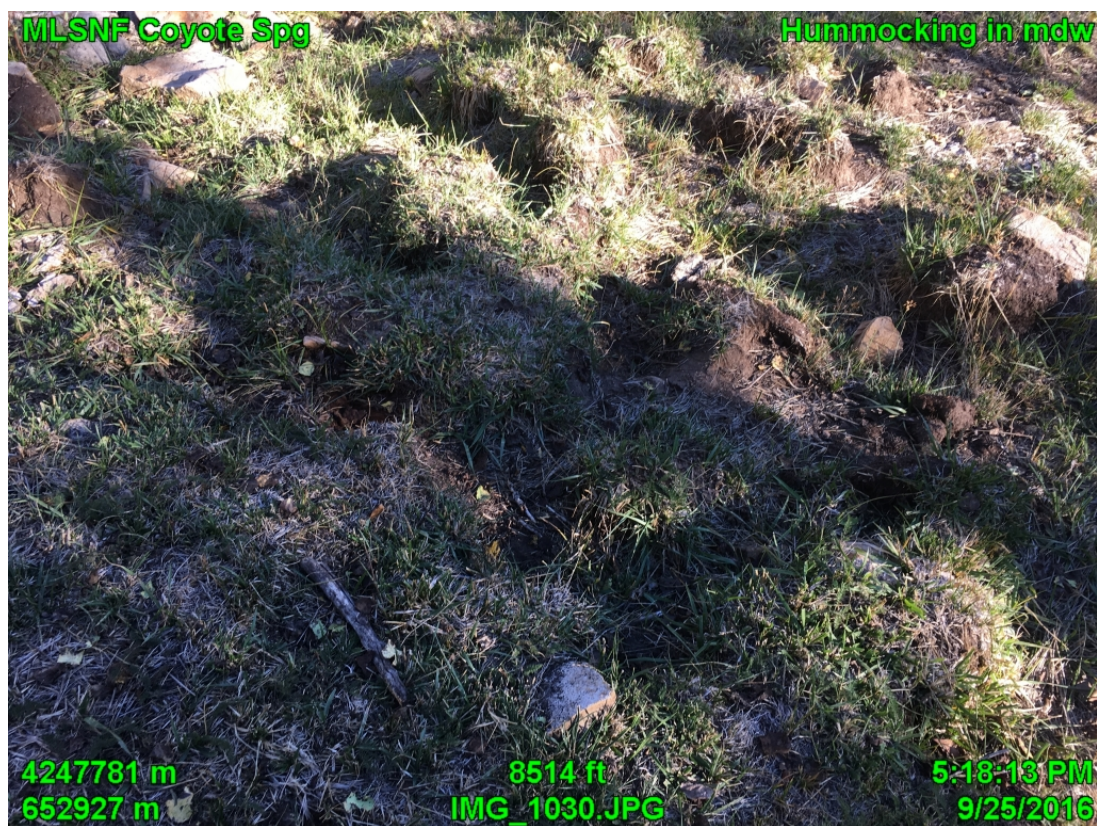
Fig. 5: Hummocking in heavily-grazed meadow by dry streambed

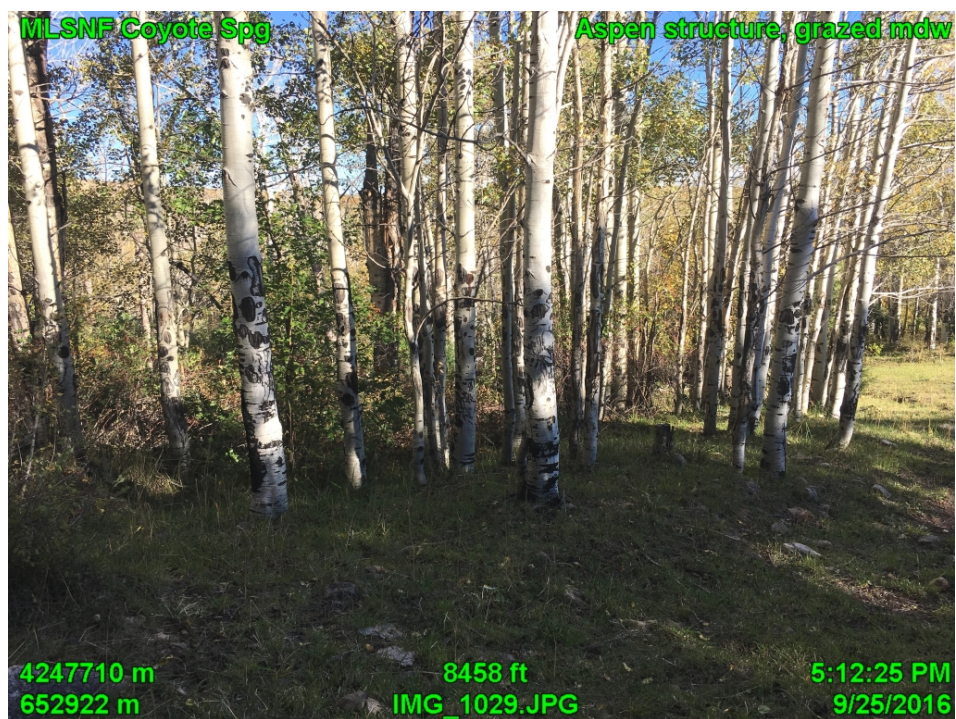
Fig. 6: Aspen structure surrounding the grazed meadow.

mature aspen trees was Gambel oak and some areas the Gambel oak was the overstory, like much of the south side of the mountain (Fig. 6).

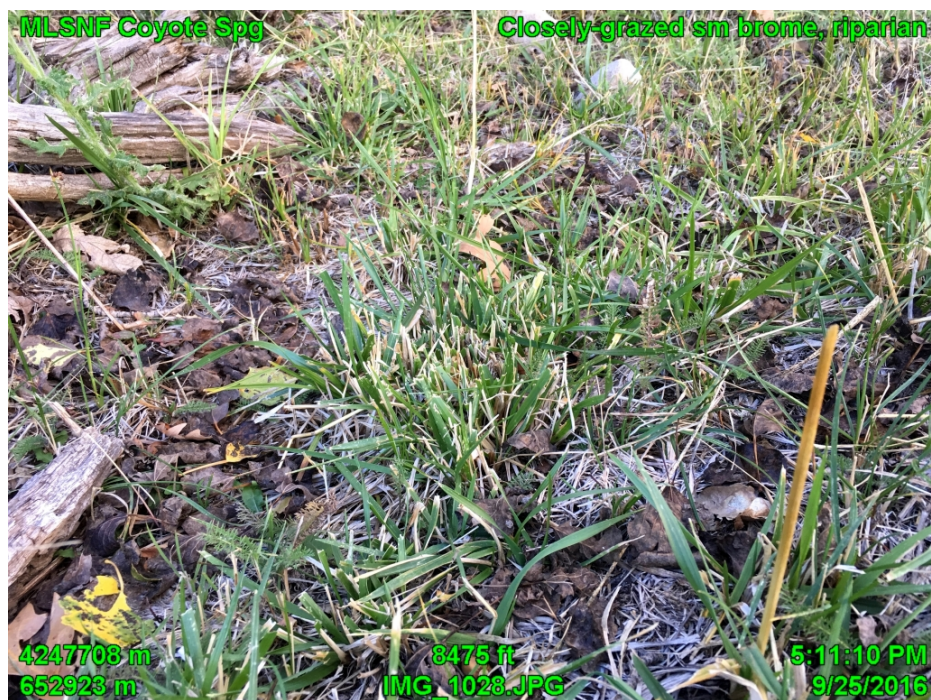
Fig. 7: Closely grazed smooth brome in the riparian area.

Outside the enclosure (Microhabitat B) smooth brome was the primary ground cover and aspen stands surrounded the area (Fig. 7). In some aspen areas the undergrowth beneath the

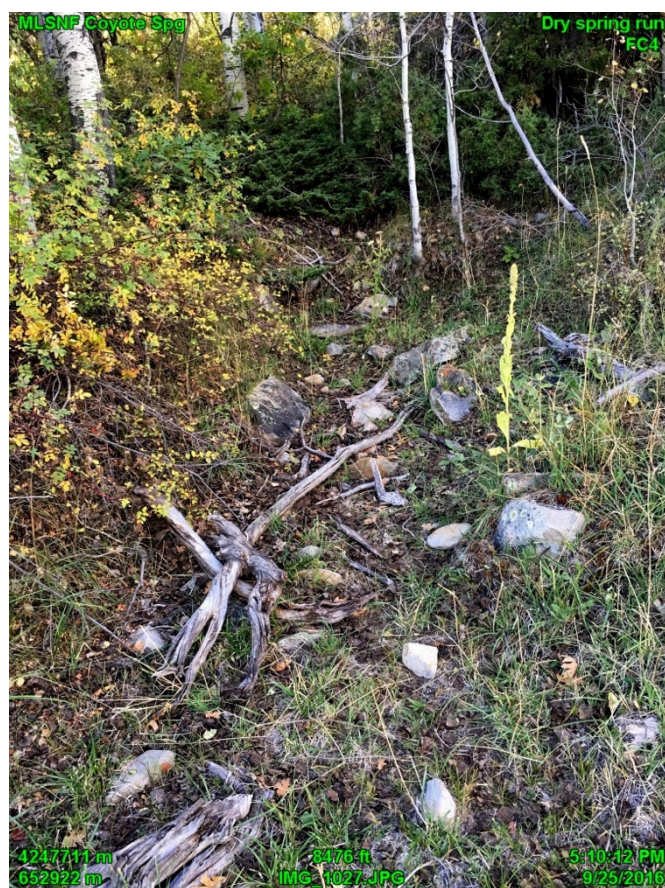
Fig. 8: Dry spring area below muddy spring with water.

A small muddy spring (Fig. 9), labeled FC3 on the diagram had a low flow of water but is likely present year round. Around this spring there were several willow trees and very trampled and grazed grasses (Fig. 9). About ten feet below this pool the spring water dried up again, leaving just the remains of a dry creek bed (Fig. 8).

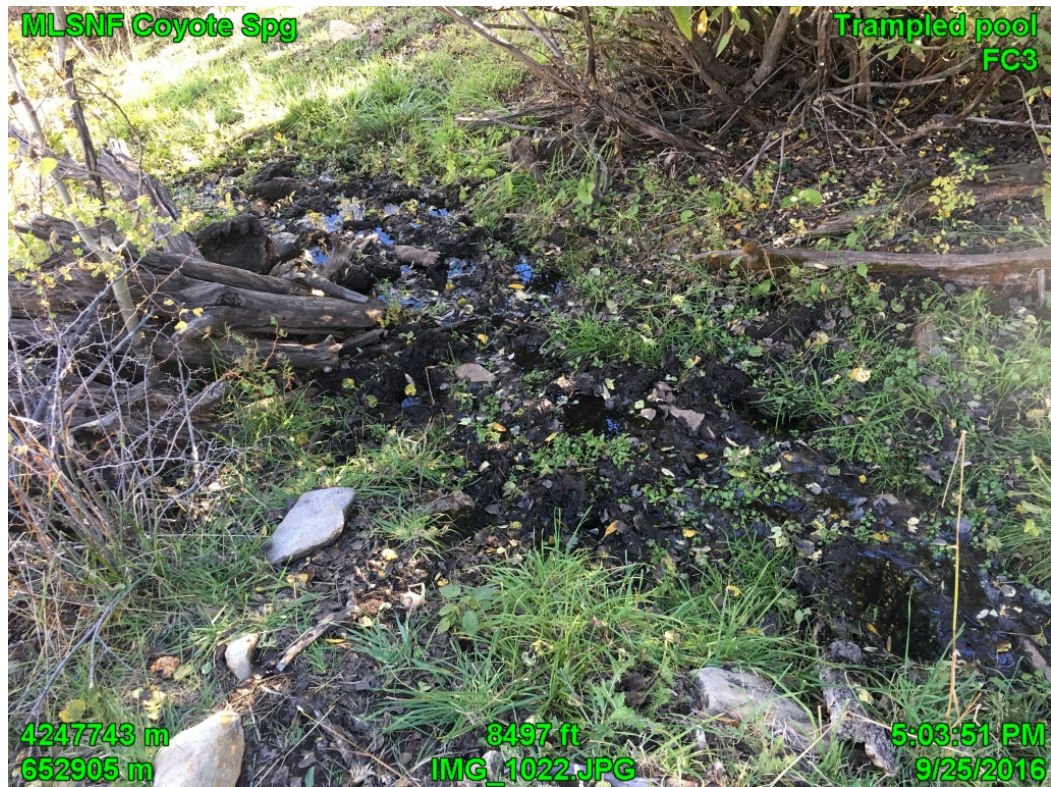
Fig. 9: Heavily trampled pool of muddy spring. Only damp area present at the site at the time of observation.

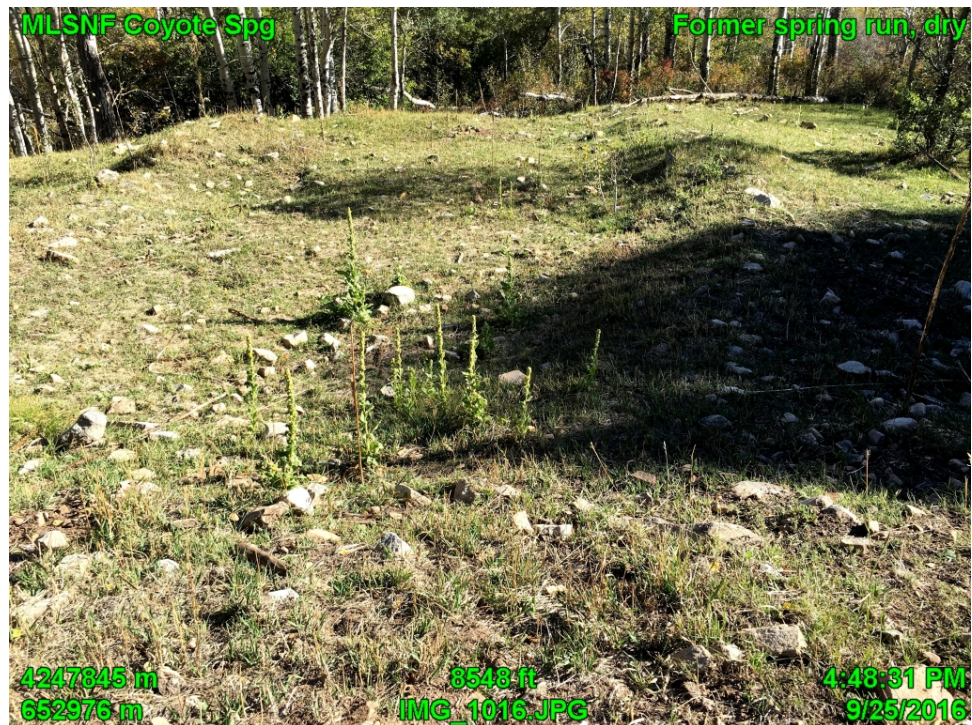
Fig. 10: Former spring run coming down from fenced in exclosure. Note mullein and closely-grazed grass; some bare soil
