Spring 177 Condition Assessment

Location: Gentry Allotment, Wild Cattle Pasture, Manti-La Sal National Forest

Date: September 28, 2016 **Begin/End Time:** 1:00pm to 2:30pm

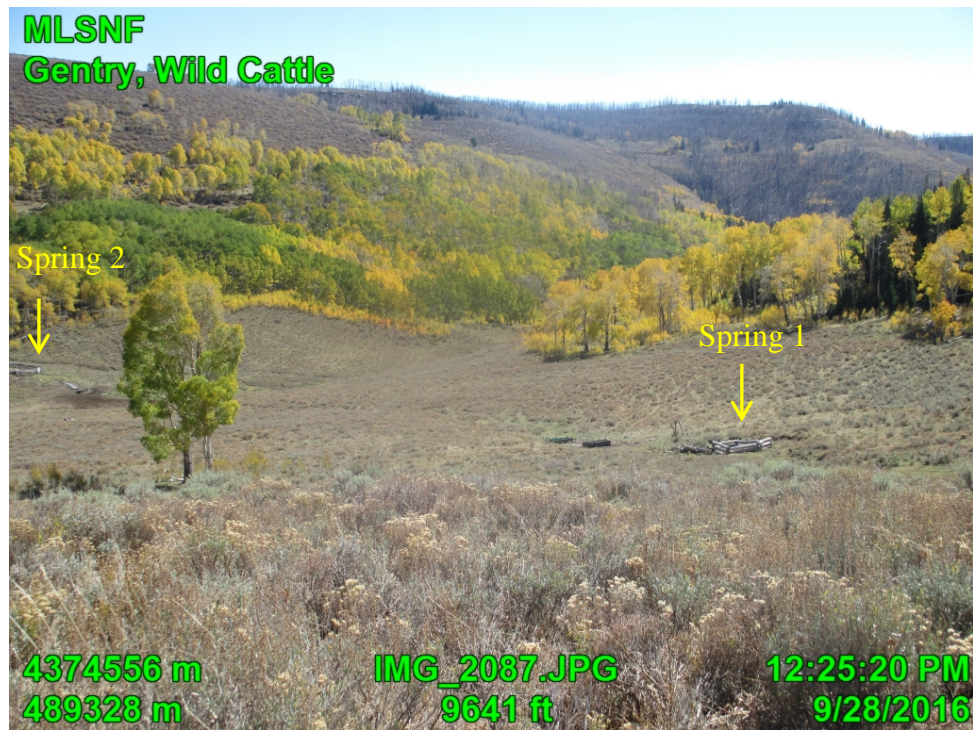
Fig. 3: Overall view of Spring 177

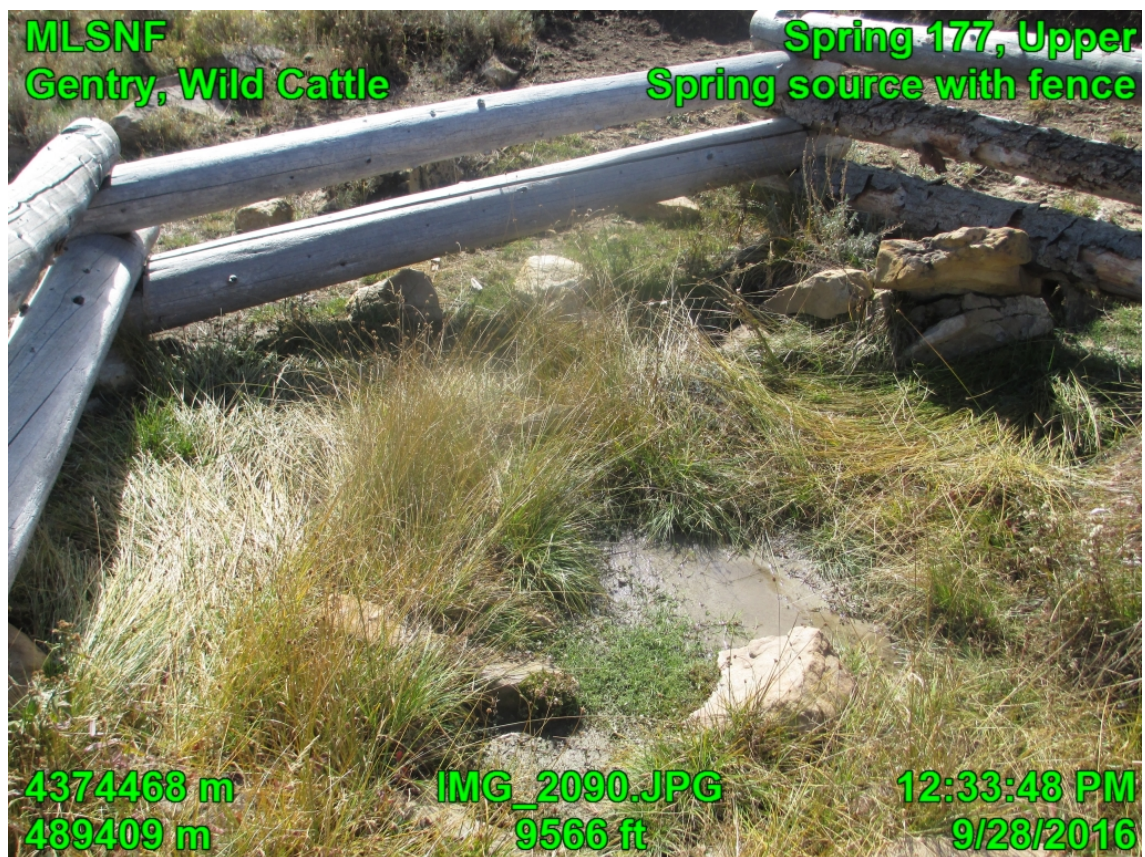
Fig. 4: Surface water of spring source within upper enclosure

Water Presence: Water at the upper source (within the enclosure) took the form of a small, damp puddle measuring approximately 1' X 3'. This surface water was likely present intermittently, but water could be present here underground, indicating a perennial flow consistency (Fig. 4). The upper trough contained approximately six inches of spring water and was being continually filled by rapidly dripping water from the pipe. The soil in the enclosure at the lower source was dry, but the presence of a full grass/sedge community indicated that water was present at least intermittently (Fig. 7). A strong stream of spring water from a pipe was filling the lower trough at a rate of approximately 2 inches per hour.

Water Infrastructure: The upper source enclosure, built from heavy logs, measured approximately 14 feet in diameter, with a wall height ranging from 3-4 feet tall (Fig. 4) An intact cistern with a lid was present on the east side of the enclosure, as well as an extra metal cistern lid. From the spring source to the outside of the enclosure, a pipe ran underground to the upper spring trough. The trough was partially filled by drip-water from the upper spring and did not contain a wildlife escape ramp. There was a second, dry upper trough downslope of the main upper trough.

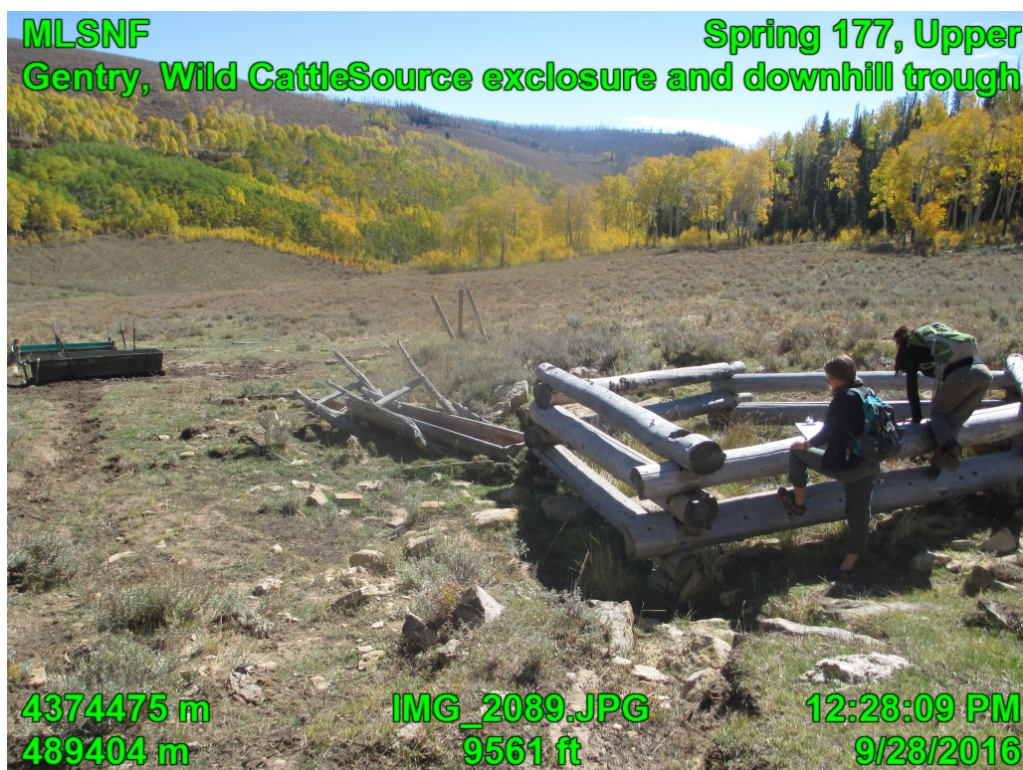
Fig. 5: Full exclosure of upper spring source

Ungulate Disturbance: Due to the sturdiness of the fence surrounding the small upper enclosure, ungulate damage (trampling, grazing/browsing) was virtually absent immediately surrounding the spring source. Downslope of the upper enclosure and the lower enclosure, ungulate heavy trampling, denuding, and browsing/grazing of vegetation dominated (Figs. 5,8,9).

Because the enclosure surrounding the upper spring source was intact and effectively keeping ungulates away from the source, there was no evidence of ungulate

damage inside the spring enclosure. Given the dominant presence of native grasses, rushes, and sedges—which provide wildlife habitat evidenced by the presence of a vole—the area was determined to be healthy, with no or negligible disturbance.

The region outside the enclosure and surrounding the upper trough was heavily degraded in the form of trampled, denuded soil, and grazed/browsed plants at the margin. This area was determined to be severely damaged by ungulate presence.

- Continue to maintain the current enclosures.
- Install a wildlife escape ramp in the upper trough to prevent any accidental drownings.
- Fence the area of potential wetland and moist meadow below both enclosures and place the water troughs in drier, upland vegetation. This would restore a large wetland area.
- Release water from the springs into the restored wetland area when cattle are not in the pasture

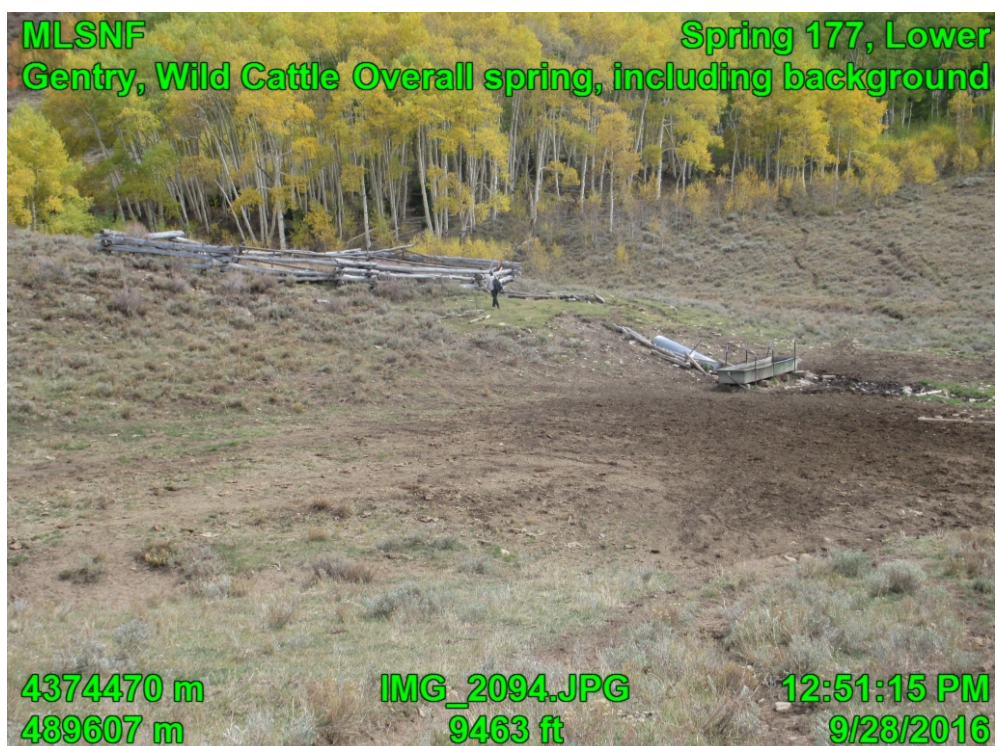
Fig. 6: Overall view of lower spring

The enclosure at the lower spring source was similarly intact, preventing ungulate damage immediately around the source (Figs. 8,9). A 100' X 200' area outside the lower enclosure between the edge of the fence and the lower trough was completely denuded (Figs. 6, 8-10).

The large (100 X 200') denuded area surrounding the lower spring's trough and below the enclosure was due to ungulate disturbance (Figs. 6, 8-10).

Wildlife evidence: Evidence of grazing/browsing, scat, and trampling indicated that cows were the most common form of wildlife in the spring complex area (Fig 6,8,9). Grasshoppers were observed in the grass between the upper and lower springs, and a spider web hung above the empty upper trough. Within the upper enclosure, a single adult vole was sighted underneath an abandoned cistern lid.

The area outside the lower enclosure was severely trampled and denuded. The distinct lack of vegetation or wildlife habitat indicated that the area surrounding the trough had been severely degraded. Furthermore, the outlet pipe leading downslope from the lower trough maintains downhill moisture. This led to the growth of a sedge meadow beneath the outlet that was perhaps indicative of what the area would look like if water not been diverted for livestock use.

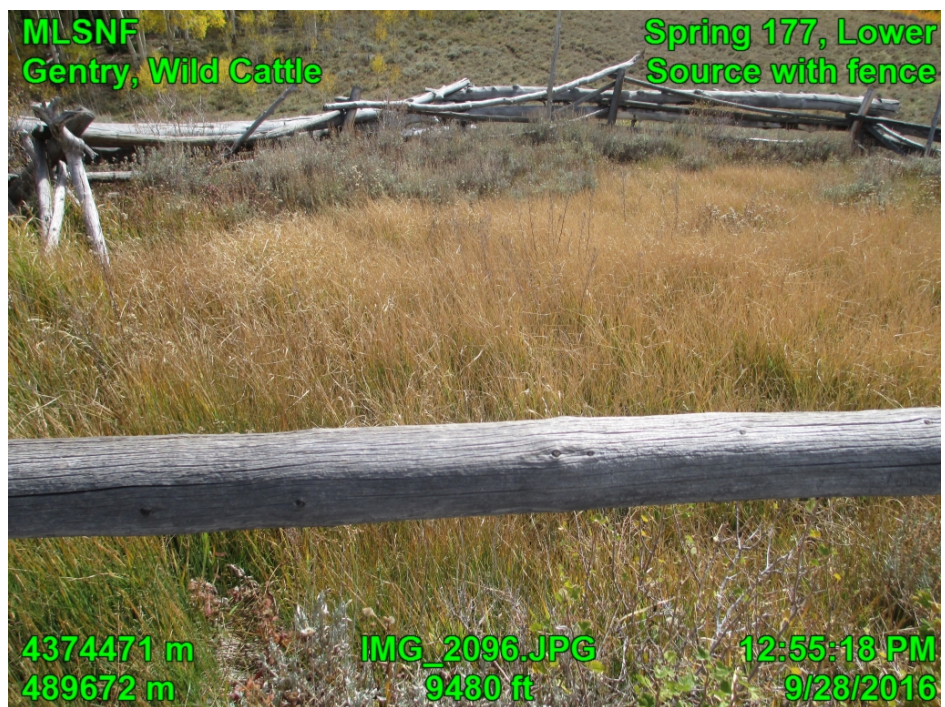
Fig. 7: Lower spring exclosure

The lower spring enclosure was also built from sturdy logs and appeared to be fully intact (Fig. 7). A pipe ran partially above ground from the lower source and emptied directly into the lower trough. An intact wildlife ramp was observed. The lower trough had an outlet pipe head that led to a plastic pipe facing downslope. The plastic pipe emptied into the surface soil, where someone had placed a series of logs to reduce erosion from water action (Figs. 8-9).

The enclosure surrounding the lower spring source was also intact, preventing the enclosed area from suffering ungulate damage. There was a healthy community of grasses, sedges, and rushes as well as smaller shrubs including sagebrush and white stem currant (*Ribes inerme*). This diversity indicated a lack of disturbance or selective browsing/grazing.

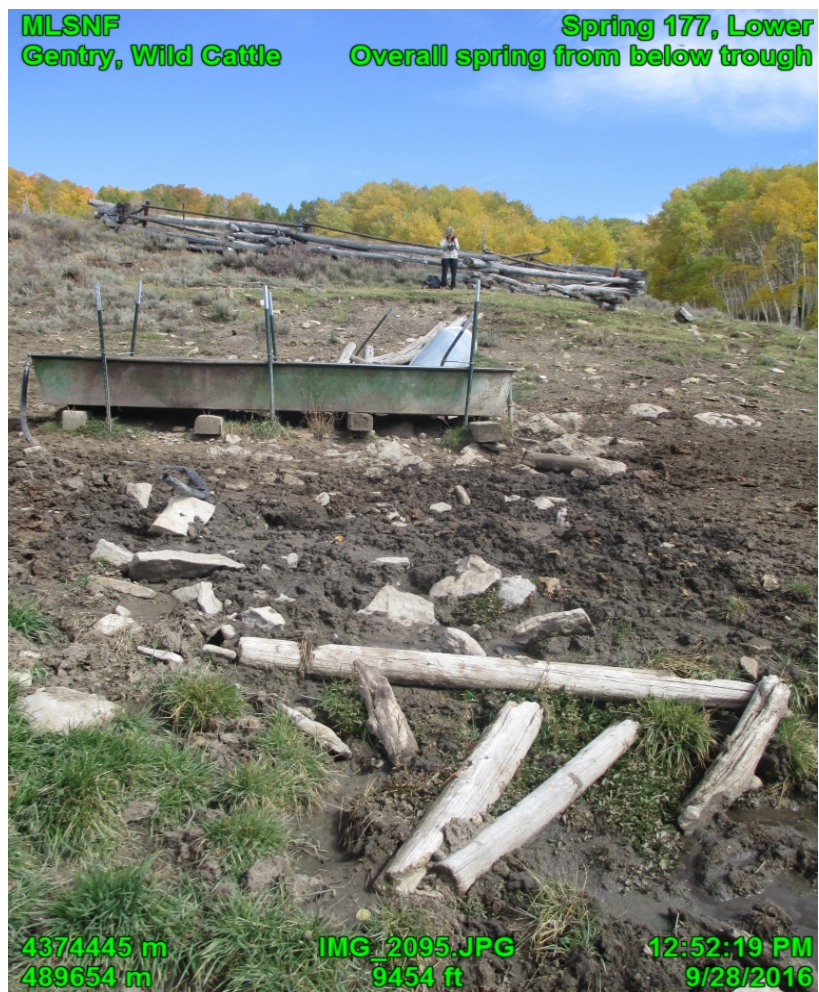
Fig. 8: Lower springs trough drainage and uphill source enclosure

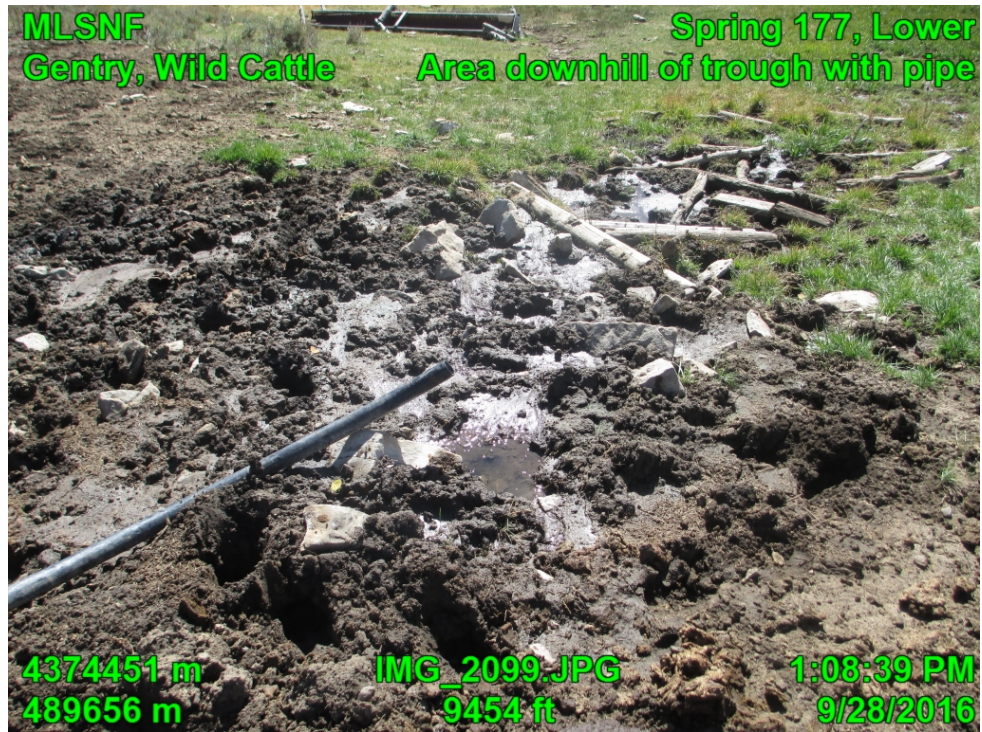
Fig. 9: Lower spring trough pipe draining into soil, rushes and sedges downhill

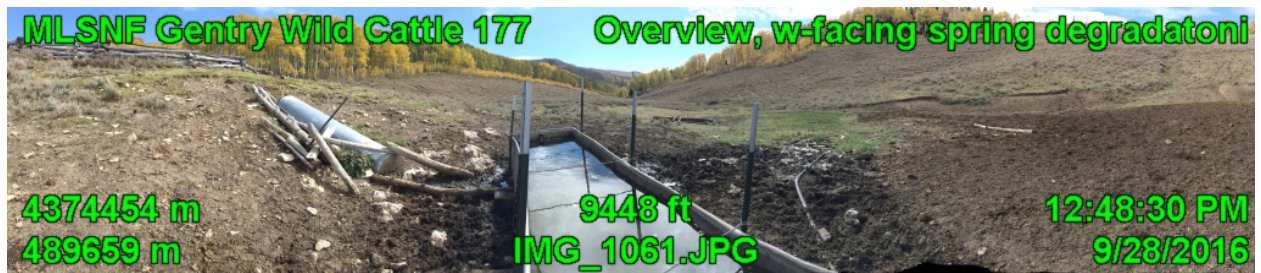
Fig. 10 Panorama, lower spring degradation.

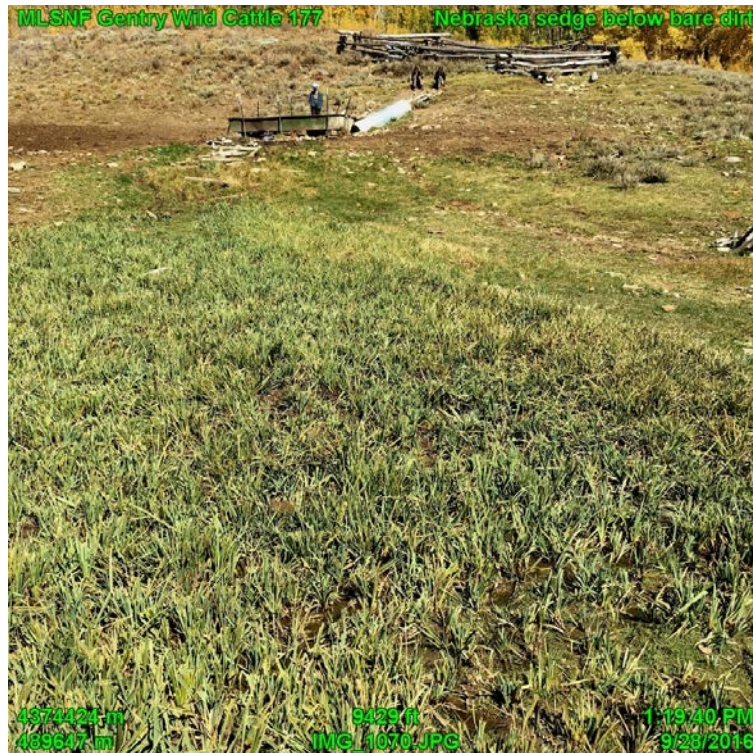
Fig. 11 Nebraska sedge below 200' X 100' bare mud area.

At the downslope outlet of the lower trough, overflow water spilled out into the grassy area below. Due to the increased frequency of water presence in this area, a small Nebraska sedge patch had sprung up at the base of one downhill outlet drainage (Fig. 11) and a Baltic rush patch at another drainage.
