FIELD REPORT

Assessment: Fifteen Elk Ridge Springs, June 27-29, 2016

Grand Canyon Trust

September 2016

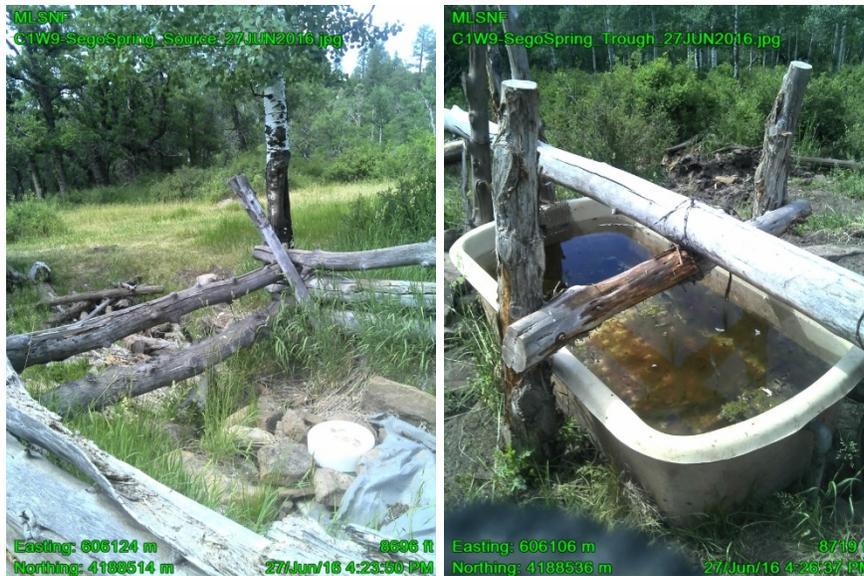
Water presence: Water was present in trough, little surface water was present elsewhere.

Water infrastructure: Spring source was developed with spring box (culvert), valve, and trough. Trough had a wildlife escape ramp.

Photograph Set 1 (June 27, 2016) - Source and trough at C1/W9-Sego Spring. Photographs are georeferenced and indicated in the field map (Figure 1).

- Wildlife water access was limited to water trough. While the full trough could be accessed by larger animals, access for smaller wildlife – including small mammals – was inhibited by the height and design of the trough. Wildlife water access should be improved by increasing the surface water left at the source when cattle are not present in the allotment. For example, water could be left at or shared with the spring source during the off-season (i.e., using a float valve or a variable valve).
- Non-native grasses were present at the site and should be a focus for managers into the future.

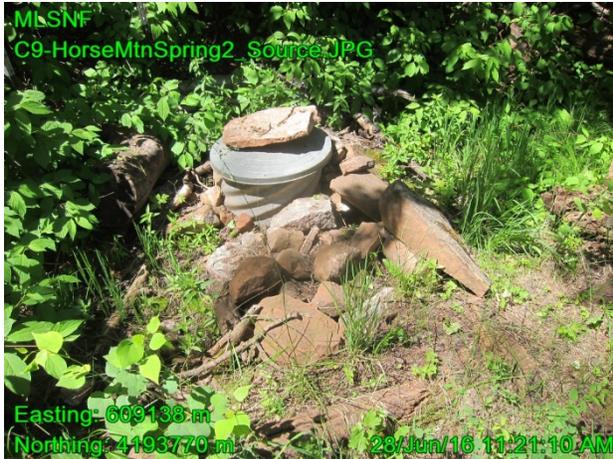
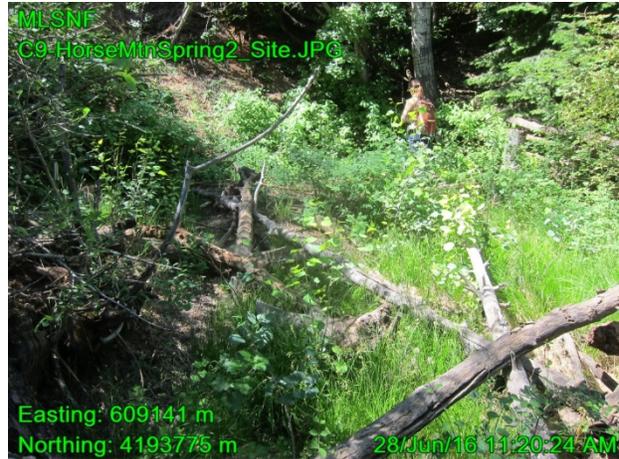
Water presence: Two spring sources were located but surface water was present in only one downstream trough. Overflow from this trough also provided surface water for wildlife, although only as a small wet area where trampling was also present. Lower drainage was damp.

Fence infrastructure: Fence was present around spring source and surrounding area but was in need of repair to be functional.

Photograph Set 2 (June 28, 2016) – Developed spring source (left) and overall site (right) at C9-Horse Mtn. Spring #2. Photographs are georeferenced and indicated in the field map (Figure 1).

- Exclosure fencing around spring source is important, however this could be expanded to include a larger area of riparian vegetation.
- The pipeline and troughs should be managed to control for overflow which encouraged erosion downslope of the trough. For example, the pipeline and trough could be in use only seasonally when cattle are in the pasture and water could be left at or shared with the spring source during the off-season (i.e., using a float valve or a variable valve).

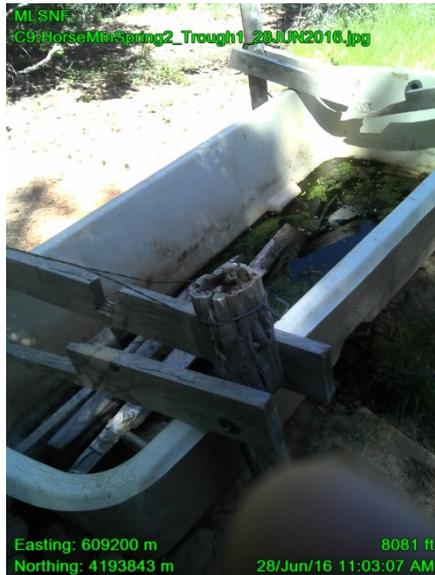
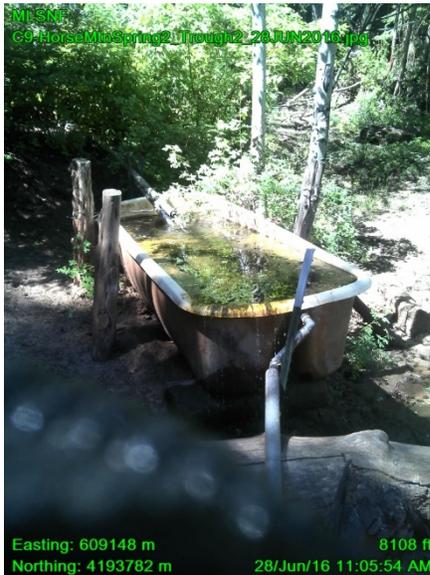
Water infrastructure: Two spring sources were located. Both were developed with spring boxes with sources fenced. Pipelines led to two troughs below. One trough was functional with overflow, the other was damp and with steady leak at the bottom. The troughs did not have wildlife ramps.

Photograph Set 3 (June 28, 2016) - Two troughs at C9-Horse Mtn Spring #2. Photographs are georeferenced and indicated in the field map (Figure 1).

- Both troughs should have adequate wildlife escape ramps which would be partially submerged in the trough, touch the bottom of the tank, and have a portion of the ramp flush with the inside of the trough (as many stranded animals will swim the perimeter of a tank in search of escape and may go under an existing ramp if a portion of it is not flush with the inside wall of the tank). We recommend following the guidelines outlined in *Water for Wildlife Handbook for Ranchers and Range Managers*¹ for wildlife friendly cattle tanks and troughs.

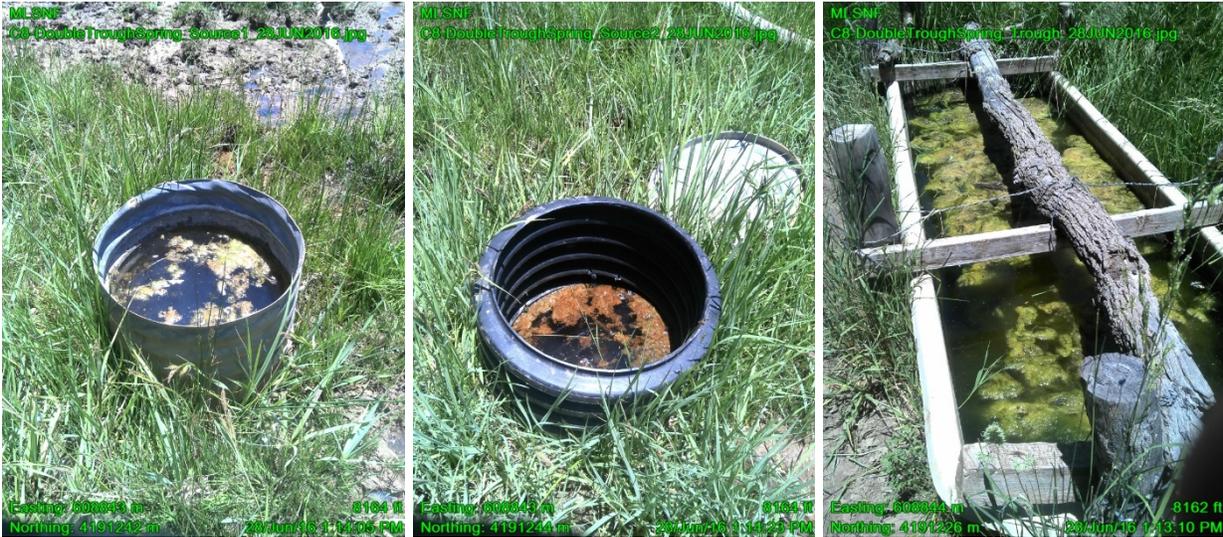
Water presence: Two spring sources were developed and not accessible by all wildlife. Trough provided primary surface water as wet meadow had very little surface water.

Fence infrastructure: Exclosure fence (around spring source) was present but not functional as it was incomplete and in need of repair.

Photograph Set 4 (June 28, 2016) – Spring sources were developed with culverts (left, middle) and trough (right) at C8-Double Trough Spring. Photographs are georeferenced and indicated in the field map (Figure 1).

- The exclosure fence should be repaired to adequately protect the spring sources and wet meadow. Wildlife water access should be increased to be more than just the trough water as smaller animals have limited access. For example, the pipeline and trough could be in use only seasonally when cattle are in the pasture and water could be left at or shared with the spring source and wet meadow during the off-season (i.e., using a float valve or a variable valve).
- Trough should have an adequate wildlife escape ramp which would be partially submerged in the trough, touches the bottom of the tank, and has a portion of the ramp flush with the inside of the trough (as many stranded animals will swim the perimeter of a tank in search of escape and may go under an existing ramp if a portion of it is not flush

with the inside wall of the tank). We recommend following the guidelines outlined in Water for Wildlife Handbook for Ranchers and Range Managers (referenced previously) for wildlife friendly cattle tanks and troughs.

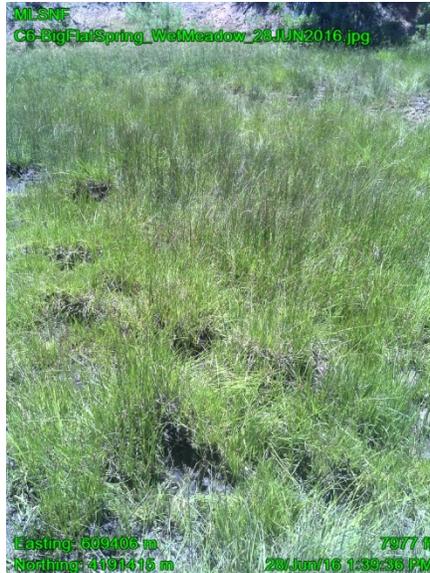
Willow species/age structure/density/condition: Coyote willow (*Salix exigua*) was present and was heavily hedged from browsing.

Photograph 5 (June 28, 2016) - Wet meadow at C6-Big Flat Spring. Photograph is georeferenced and indicated in the field map (Figure 1).

- We recommend additional protections for the wet meadow area at this spring, such as an enclosure fence which could limit trampling. The beginnings of hummocks were noted in the wettest areas due to trampling impacts.

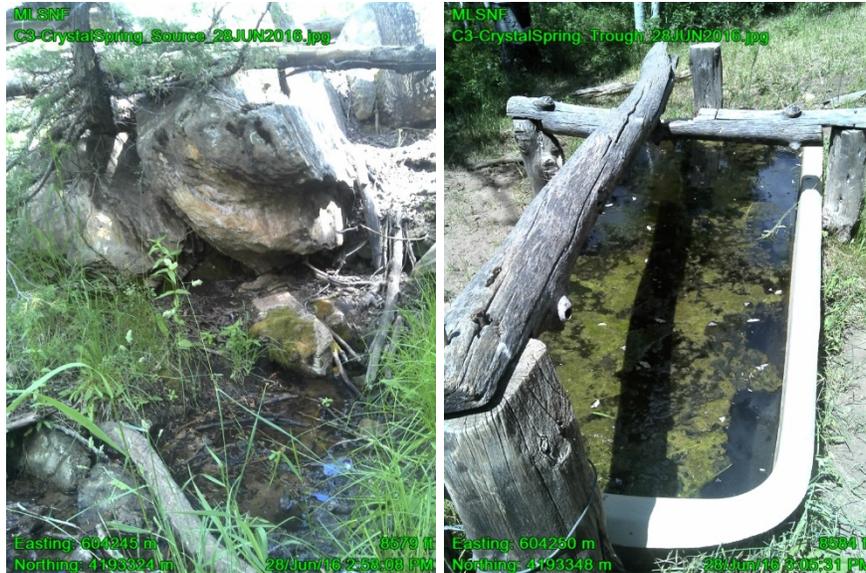
Fence infrastructure: Spring source had a wooden fence enclosure that was broken in one section and was in need of repair. Adjacent to spring site, a barbed wire fence divided two pastures and was also in need of repair.

Photograph Set 6 (June 28, 2016) – Source (left) and trough (right) at C3-Crystal Spring. Photograph is georeferenced and indicated in the field map (Figure 1).

- We recommend that the fences be repaired both around the spring source and along the pasture division.
- The riparian drainage, to which the trough overflow contributed, was not well protected from grazing ungulates and exhibited the potential for erosion. This erosion could potentially be managed. For example, the trough could be in use only seasonally when cattle are in the pasture and water could be left at or shared with the spring source during the off-season (i.e., using a float valve or a variable valve).

- Troughs should also have an adequate wildlife escape ramp which would be partially submerged in the trough, touches the bottom of the tank, and has a portion of the ramp flush with the inside of the trough (as many stranded animals will swim the perimeter of a tank in search of escape and may go under an existing ramp if a portion of it is not flush with the inside wall of the tank). We recommend following the guidelines outlined in Water for Wildlife Handbook for Ranchers and Range Managers (referenced previously) for wildlife friendly cattle tanks and troughs.

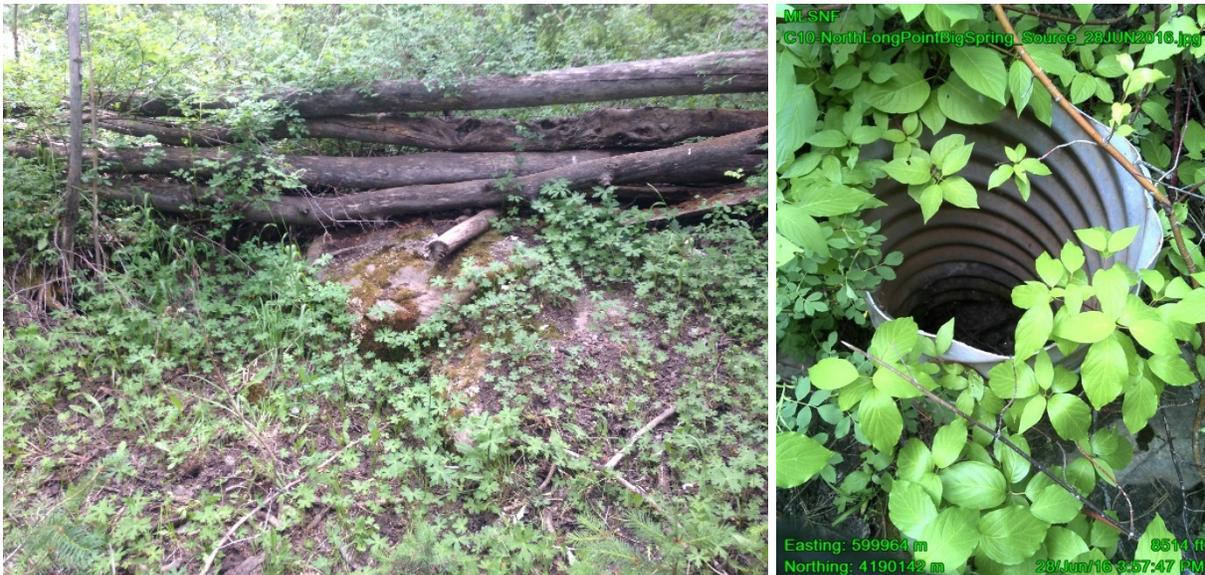
Photograph Set 7 (June 28, 2016) – Source enclosure (left) and developed source (right) at North Long Point/Big Spring (right). Right photograph is georeferenced and indicated in the field map (Figure 1).

- Troughs should have adequate wildlife escape ramps which would be partially submerged in the trough, touches the bottom of the tank, and have a portion of the ramp flush with the inside of the trough (as many stranded animals will swim the perimeter of a tank in search of escape and may go under an existing ramp if a portion of it is not flush with the inside wall of the tank). We recommend following the guidelines outlined in *Water for Wildlife Handbook for Ranchers and Range Managers* (referenced previously) for wildlife friendly cattle tanks and troughs.

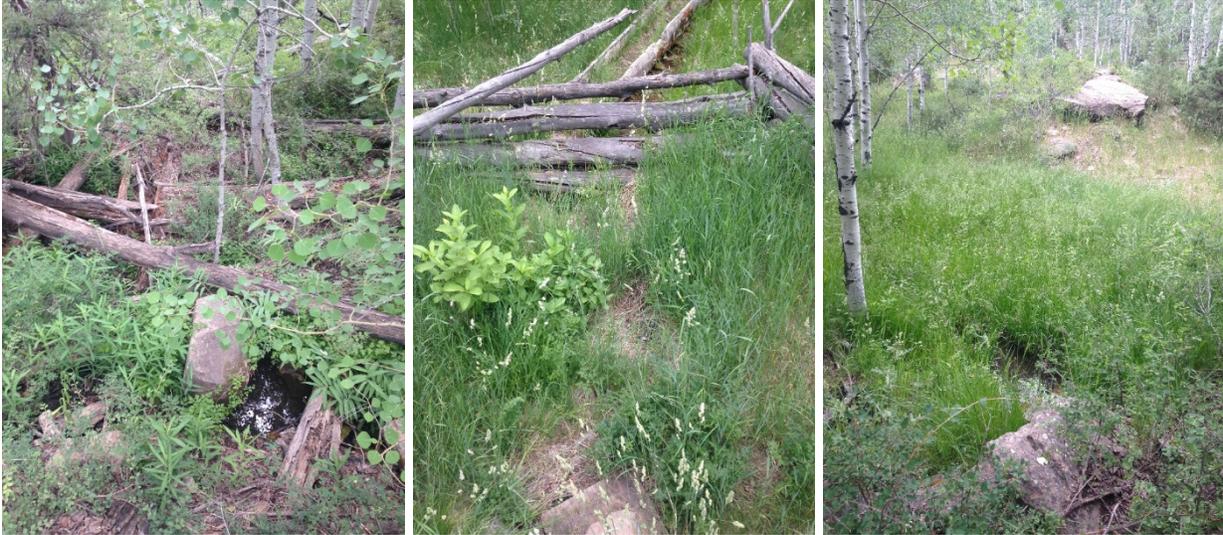
Photograph Set 8 (June 28, 2016) – Source enclosure (left, middle) and outflow (right) at C4-Big Spring.

- Troughs should have an adequate wildlife escape ramp which would be partially submerged in the trough, touches the bottom of the tank, and has a portion of the ramp flush with the inside of the trough (as many stranded animals will swim the perimeter of a tank in search of escape and may go under an existing ramp if a portion of it is not flush with the inside wall of the tank). We recommend following the guidelines outlined in Water for Wildlife Handbook for Ranchers and Range Managers (referenced previously) for wildlife friendly cattle tanks and troughs.

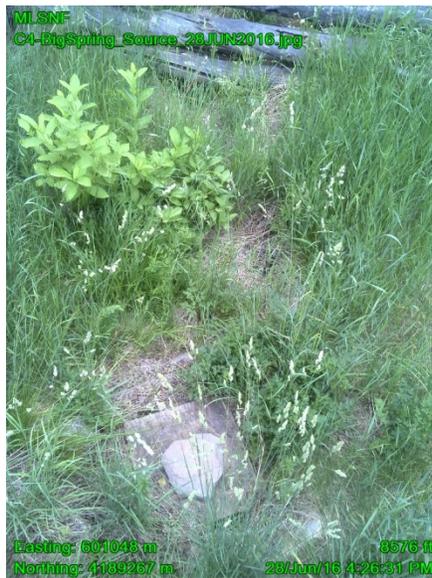
Photograph 9 (June 28, 2016) - Spring source was developed with covered spring box at C4-Big Spring. Photograph is georeferenced and indicated in field map (Figure 1).

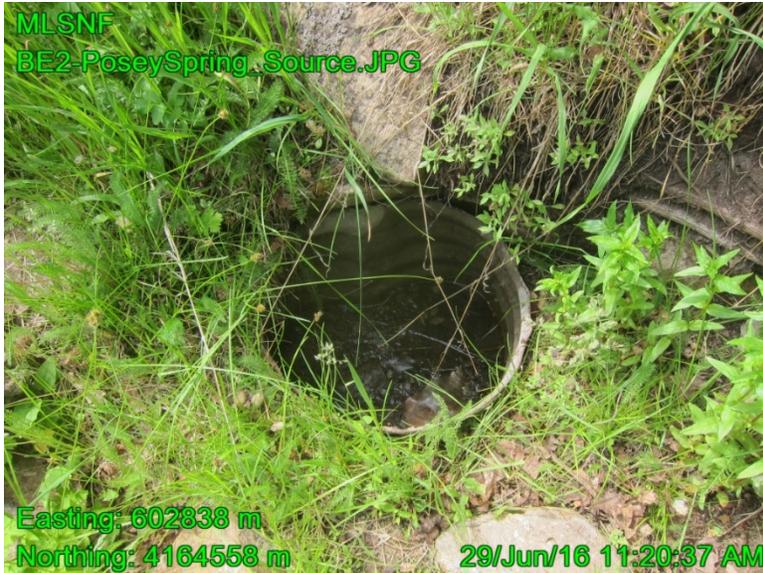
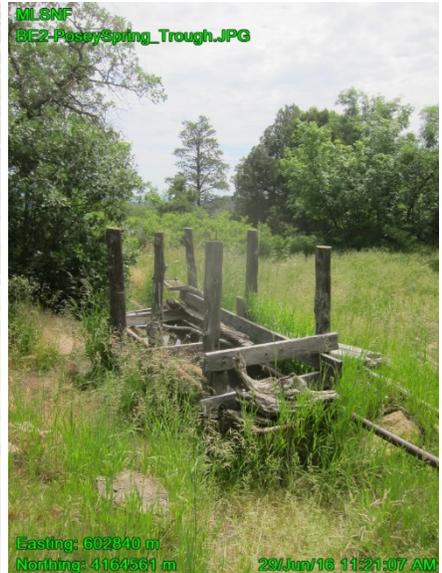
Water presence: Surface water was present inside a developed spring box (culvert) and trough. Willow was noted in drainage below water infrastructure but no surface water was present. Downstream human-made pool area was also dry.

*Photograph Set 10 (June 29, 2016) - Developed spring source (left) and trough (right) at BE2-Posey Spring.
Photograph is georeferenced and indicated in the field map (Figure 1).*

- Trough should have an adequate wildlife escape ramp which would be partially submerged in the trough, touches the bottom of the tank, and has a portion of the ramp flush with the inside of the trough (as many stranded animals will swim the perimeter of a tank in search of escape and may go under an existing ramp if a portion of it is not flush with the inside wall of the tank). We recommend following the guidelines outlined in Water for Wildlife Handbook for Ranchers and Range Managers (referenced previously) for wildlife friendly cattle tanks and troughs.

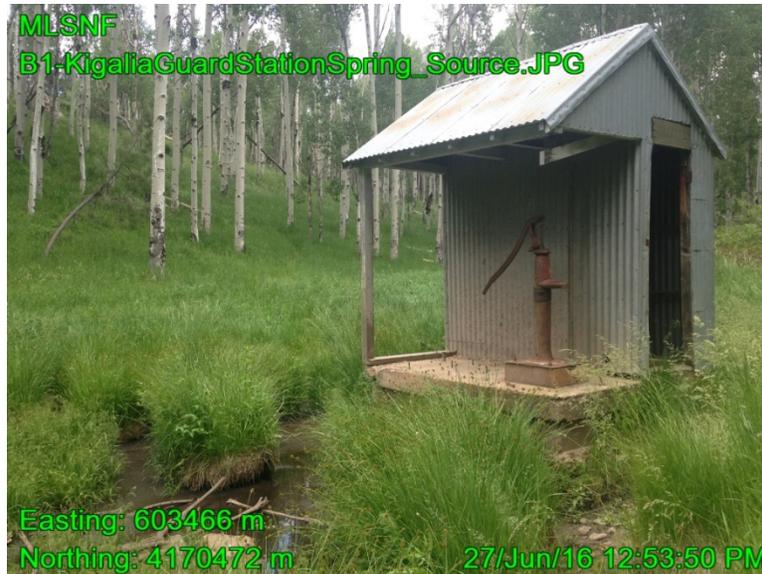
Fence infrastructure: A fence was present around surface water area of spring including some of the surrounding area and may have been a pasture fence rather than an enclosure. The gate of the fence was open and the fence was in need of repair.

Grazing evidence: Elk sign (scat) was noted but no cattle sign was noted. Browsing was evident - willows and other native shrubs were hedged by browsing. Hummocking due to trampling was observed.

Photograph 11 (June 27, 2016) - Spring house and surface water at B1-Kigalia Guard Station Spring. Photograph is georeferenced and indicated in the field map (Figure 1).

- Fence should be repaired so that it would be functional when/if neighboring pasture is grazed. If the area around the spring is intended to be grazed, the surface water area and surrounding riparian vegetation should be fenced to allow willow recruitment and reduce riparian hummocking.

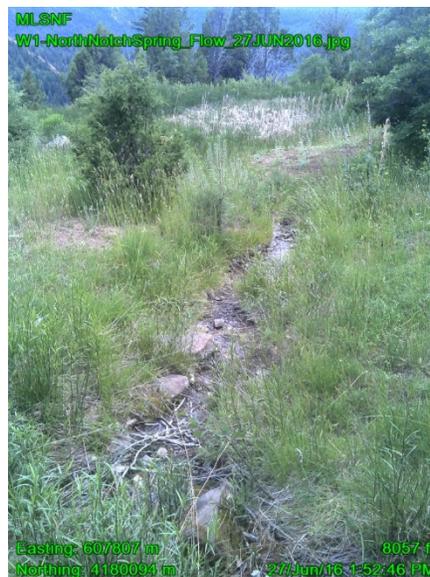
Fence infrastructure: Fence enclosure was present around spring source and surface water, but were in need of repair to be functional.

Grazing evidence: Elk sign (tracks) was noted. Hummocks were also present indicating historical livestock grazing impact.

Photograph 12 - Outflow from source at W1-North Notch Spring. Photograph is georeferenced and indicated in the field map (Figure 1).

- If the White Mesa Cultural and Conservation Area continues not to be grazed, it would be possible to remove most infrastructure (except for the protective source enclosure). If the area were to be grazed in the future, the enclosure fence should be expanded to protect the larger riparian area, not just the spring source.
- Non-native bull thistle can be managed by periodic pulling before seed set.

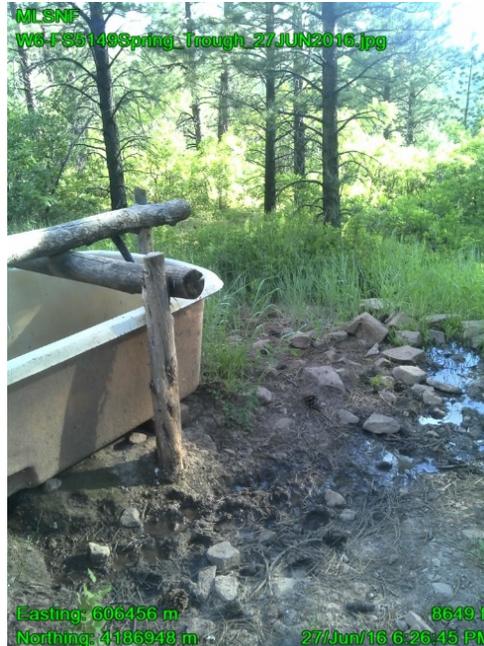
Water presence: Surface water was present as leaked water from trough, into which there was a very low water flow. Trampling was present below trough in this wet area.

Water infrastructure: A pipeline and trough were present. The trough had a leak and did not have a wildlife escape ramp.

Photograph 13 (June 27, 2016) - Trough at FS5149 Spring. Photograph is georeferenced and indicated in the field map (Figure 1).

- If the White Mesa Cultural and Conservation Area continues not to be grazed, it would be possible to remove most infrastructure (except for the protective source enclosure). If the area will be grazed in the future, the trough should be repaired and/or the leaked flow should be managed to avoid erosion downslope of the trough. For example, the pipeline and trough could be in use only seasonally when cattle are in the pasture and water could be left at or shared with the spring source during the off-season (i.e., using a float valve or a variable valve).

- If the trough is to remain, it should have an adequate wildlife escape ramp which would be partially submerged in the trough, touches the bottom of the tank, and has a portion of the ramp flush with the inside of the trough (as many stranded animals will swim the perimeter of a tank in search of escape and may go under an existing ramp if a portion

of it is not flush with the inside wall of the tank). We recommend following the guidelines outlined in *Water for Wildlife Handbook for Ranchers and Range Managers* (referenced previously) for wildlife friendly cattle tanks and troughs.

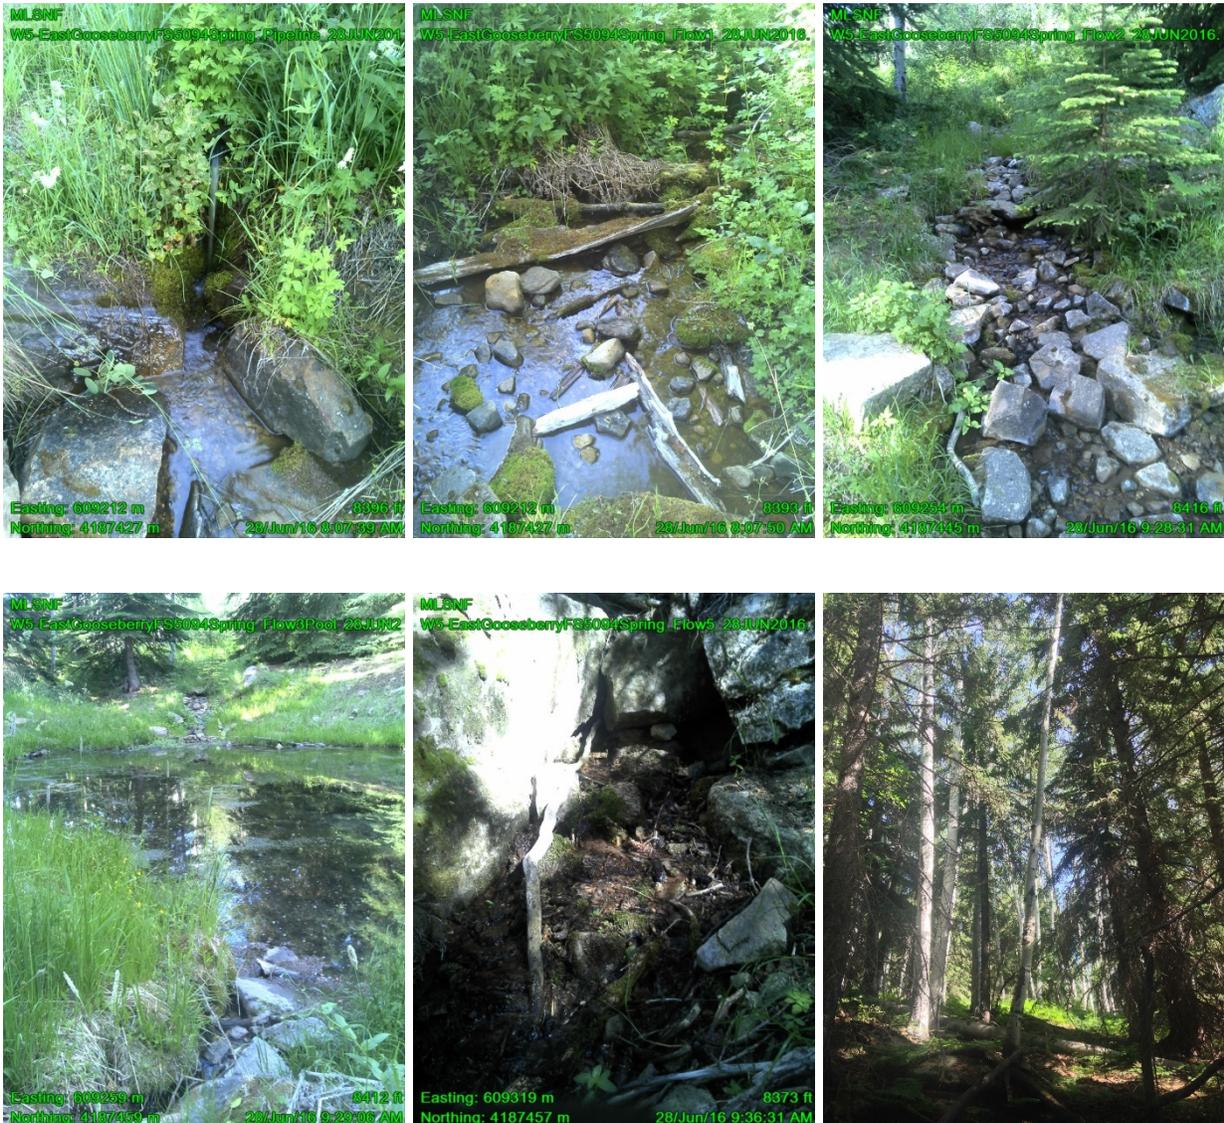
This pool drained down into the forest as a series of small flows, possibly via another pipeline (not found). Other springs/sources likely contribute to flow which was steady but low and continued downhill. The pipeline noted at the first outflow and first channel seemed to be functioning and was likely connected to the source. Pipeline from historical pool to wooded complex also seemed functional, although it was difficult to see connection. Old pipe observed in wooded area of springs complex was rusted, its functionality was unknown.

Grazing evidence: Elk sign (scat, tracks) and elk trampling were noted at historical pool and wooded area of springs complex. No cattle sign or disturbance was noted. Mule deer also were observed. Trampling was noted at human-made pond and in wooded area of springs complex.

Photograph Set 14 (June 28, 2016) - Pipeline (possibly connected to primary spring source; top left) flowed (top middle) into top channel (top right) and then down into pool (created by historical, human-made berm or earthen dam; bottom left). Pool drained down into forest via series of small flows (e.g., bottom middle) likely via a pipeline (not found). Other springs/sources contributed to flow which was steady and continued downhill in and around wooded area (bottom right). All photos but bottom right are georeferenced and indicated in the field map (Figure 1).

- The springs complex provided substantial surface water. The high diversity of native plants and multiple riparian areas suggest that this area should be an important conservation focus.
- If the area is not grazed in the future, the infrastructure could be removed.
- Non-native grasses were present at the site and should be a focus for managers into the future. We encourage managers to research and apply site-appropriate methods where possible.

- The non-native, invasive bull thistle can be managed by periodic pulling before seed set.

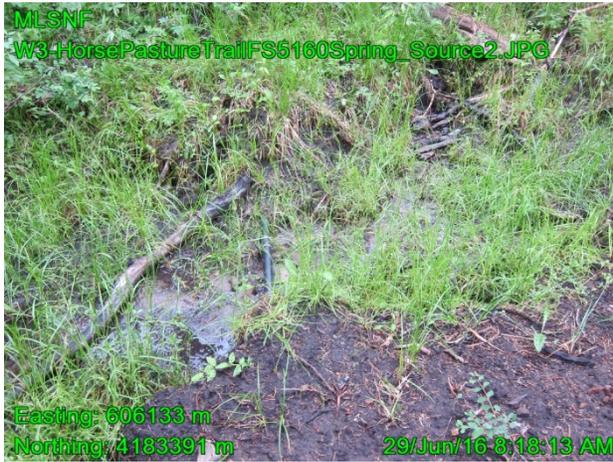
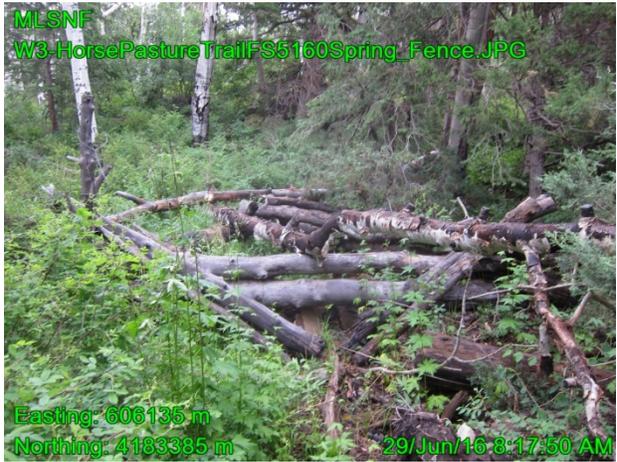
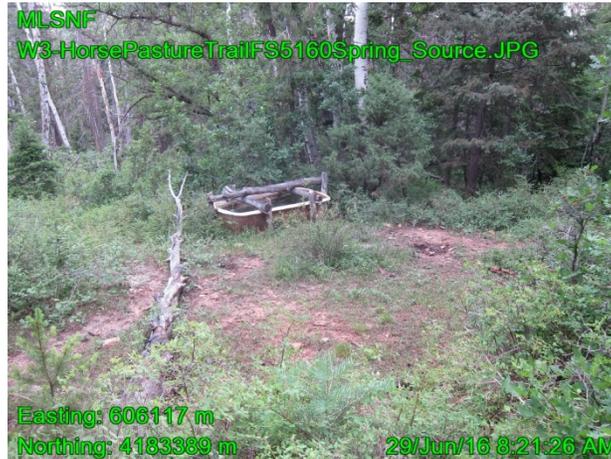
Photograph Set 15 (June 29, 2016) – Presumed emergence zone (top left), enclosure fence (top right), and trough at Horse Pasture Trail/FS5160 Spring.

- If the trough is to remain, it should have an adequate wildlife escape ramp which would be partially submerged in the trough, touches the bottom of the tank, and has a portion of the ramp flush with the inside of the trough (as many stranded animals will swim the perimeter of a tank in search of escape and may go under an existing ramp if a portion of it is not flush with the inside wall of the tank). We recommend following the guidelines

outlined in Water for Wildlife Handbook for Ranchers and Range Managers (referenced previously) for wildlife friendly cattle tanks and troughs.

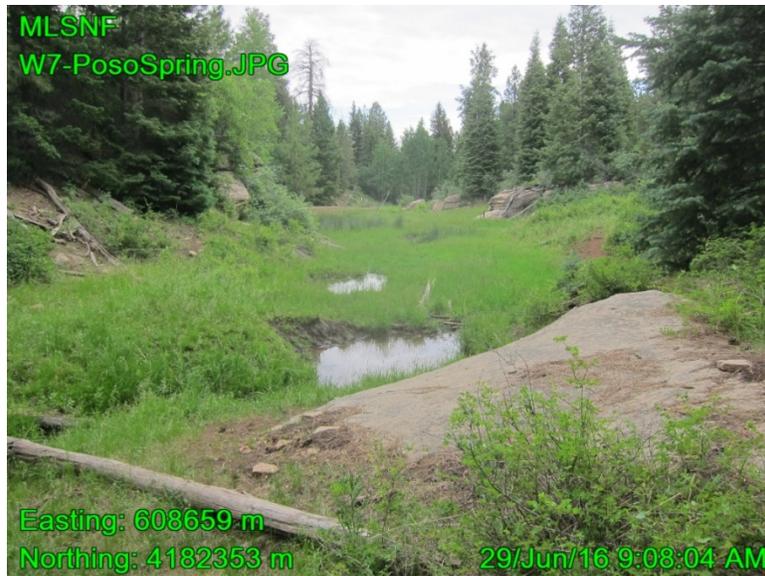
Grazing evidence: Elk sign (scat, tracks) was abundant. Wildlife cameras were noted on tree suggesting hunters were using wildlife cameras to track elk or deer presence.

Photograph 16 (June 29, 2016) - Multiple pools in drainage (foreground) and earthen dam/berm (background) at W7-Poso Spring.

- We recommend removing earthen dam to aid in restoring more natural flow regime to avoid stagnating pools. If earthen dam must remain, some flow must be allowed downstream to encourage greater water flow than exists currently. The situation observed during the field visit created an impact hotspot at the pool and encouraged stagnant water (presumably low water quality) and mosquitoes.
- Non-native vegetation, e.g., woolly mullein (*Verbascum rhapsus*), was present but has the potential to be managed over time through pulling or clipping seed heads prior to seed set.
