169 Spring Condition Assessment

Location: Trail Mountain Allotment, North Trail East Pasture, Manti-La Sal National Forest

Date: September 28, 2016 **Begin/End Time:** 1:15pm to 2:30pm

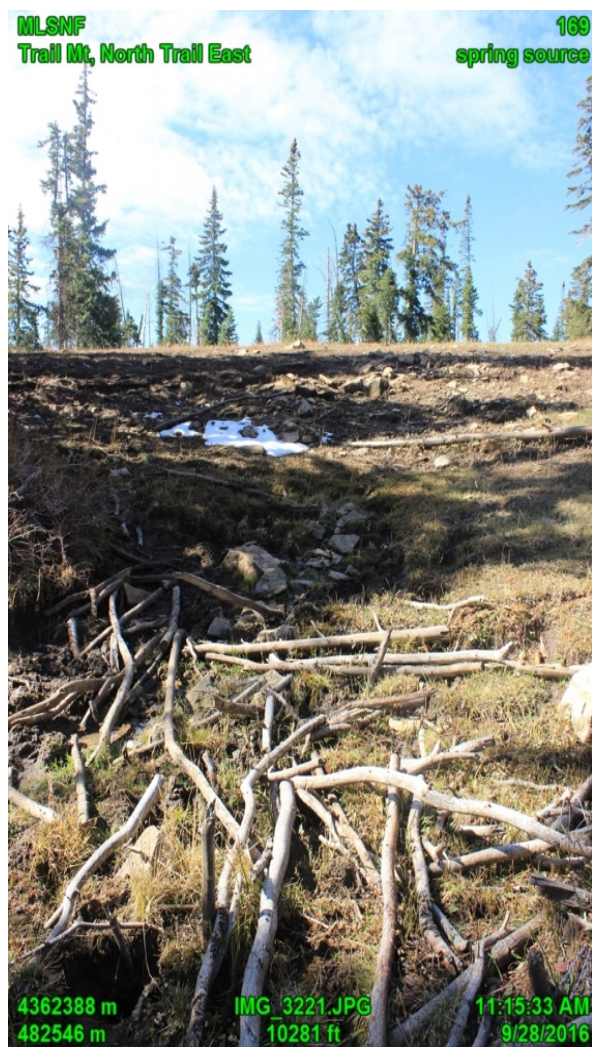
Fig. 1: *Spring Source from afar looking South*

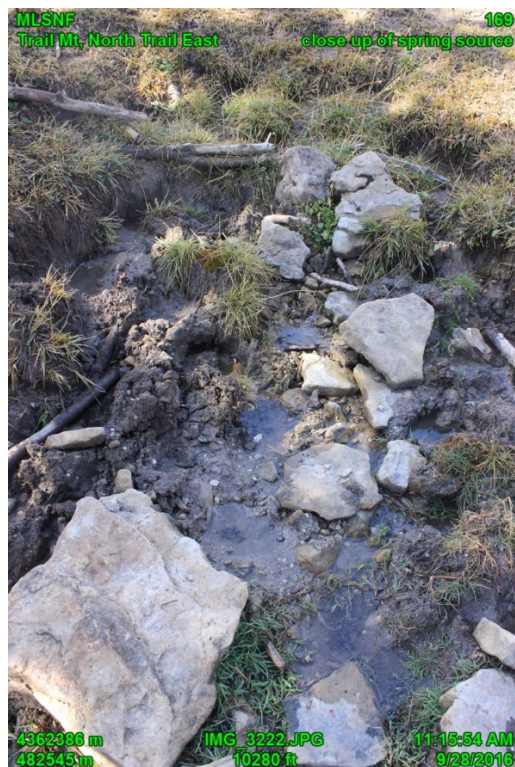
. 2: Spring source

At the source of the spring (Fig. 2) the flow consistency is a 4 meaning that there is surface water and a moderate flow, likely running all year. This flow consistency continues until the beginning of microhabitat B where there is no longer surface water. At this location, in the gully (Fig. 5), there are wet, damp soils but water flow is likely present intermittently. Throughout the spring the water forms small pools in the large hoof prints of cattle because it has been heavily trampled.

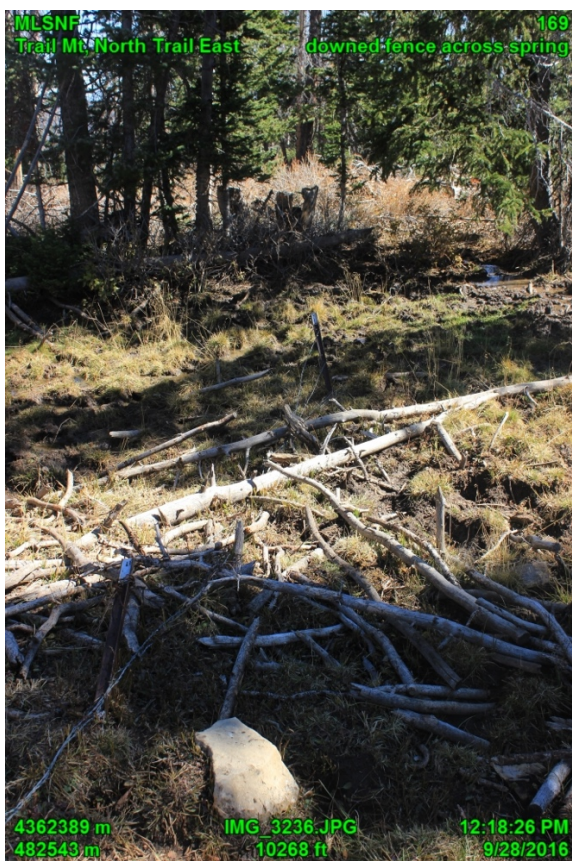
Fig. 3: Fallen barbed wire fence at the source.

There are some human modifications to the spring. There is a downed barbed wire fence next to the spring that crosses through the spring channel about 15 feet from the source (Fig. 3). The wire is completely on the ground and the fence has most likely not been effective for many years. While this fence is near the spring, it did not enclose the spring. Slightly downstream (Fig. 6) sticks have been placed in the spring and logs have been put in the stream itself. This could have been placed to prevent cows from trampling the riparian area, but it is not effective. As shown on the diagram there is a USFS road about 30 feet uphill (south) from the spring. There is no culvert that would create an incised spring run

The current barbed wire fence present should be removed because it is serving no direct purpose and runs through the spring.

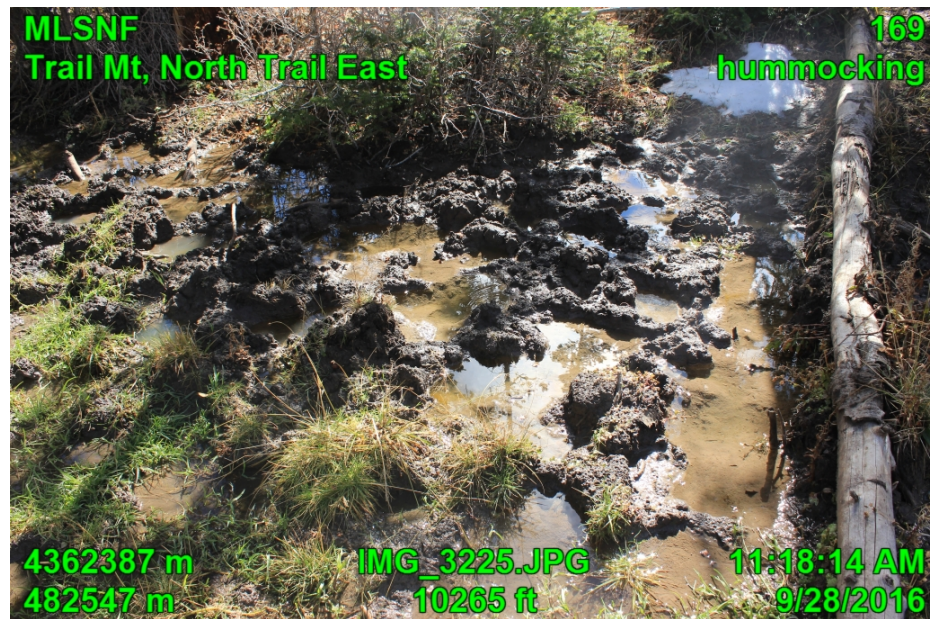
Fig.4: Hummocking in creek bed

Vegetation around the spring is lightly browsed. The spring site (both microhabitats) have been highly impacted due to ungulate trampling (Fig. 4). Another disturbance is the previously mentioned fallen fence and log dam. The spring is easily accessible to ungulates and people, making the likelihood of degradation much higher.

Overall the spring is heavily degraded by ungulate trampling. Cattle appear to have trampled the vegetation in the spring channel as well as defecating in it (Fig. 4). Humans appear to have cut down trees in the area and placed some in the streambed which was unsuccessful in preventing trampling and hummocking (Fig. 6). Most of the species around the spring are native

We recommend fencing off the spring with a well-constructed fence that could stay up for a long time and actually keep cattle out.

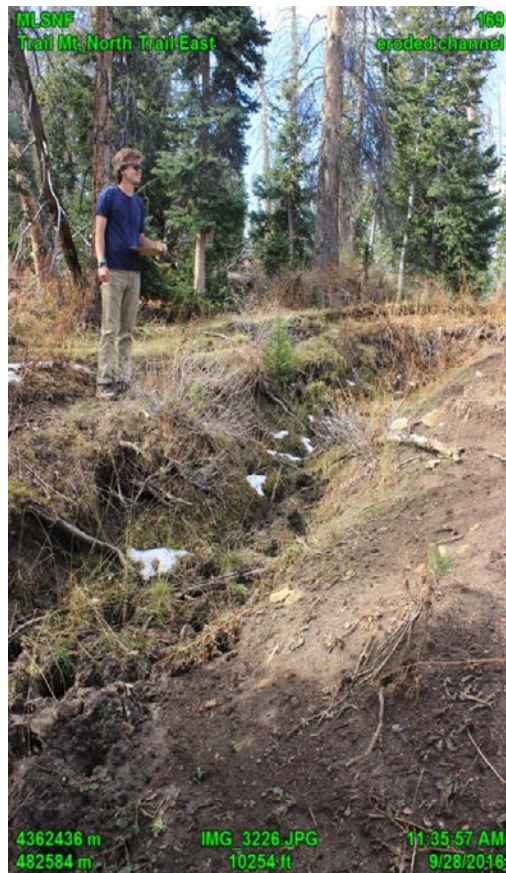
Fig. 5: Partially vegetated gully that begins microhabitat B.

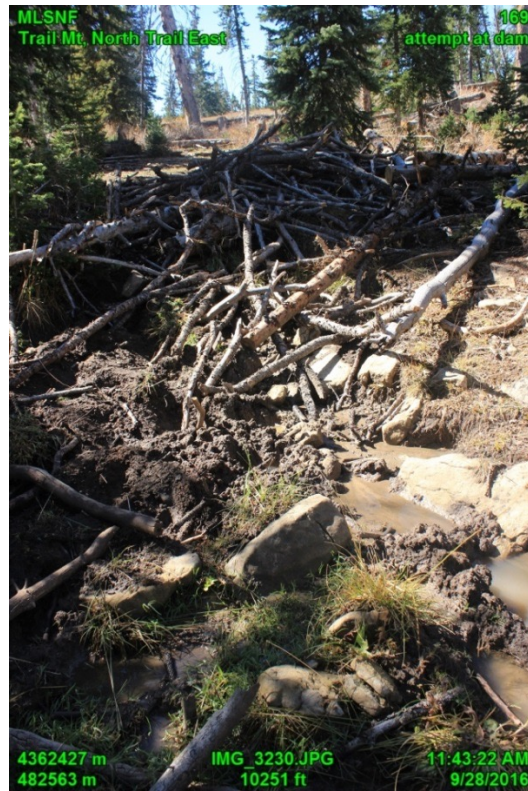
Fig. 6: Sticks placed across the spring

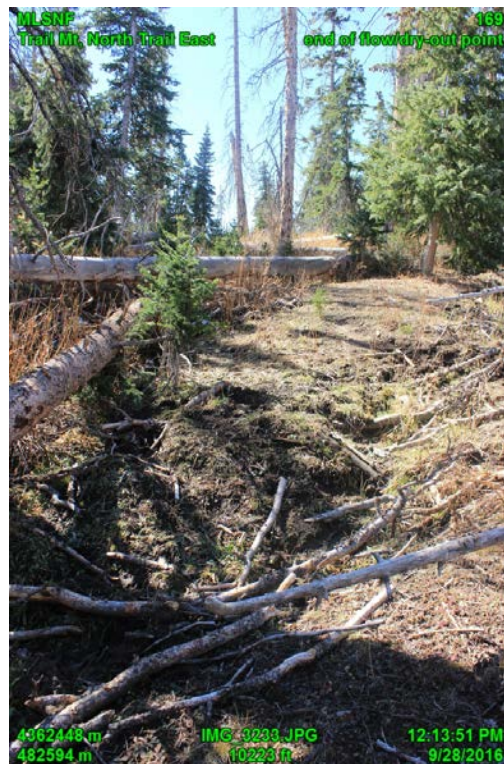
Fig. 7: End of flow, spring channel is dry.
