South Mesa Spring Condition Assessment

Location: Brumley Ridge Allotment, South Mesa Pasture, Manti-La Sal National Forest

Date: September 25, 2016 **Begin/End Time:** 10:30am to 12:00pm

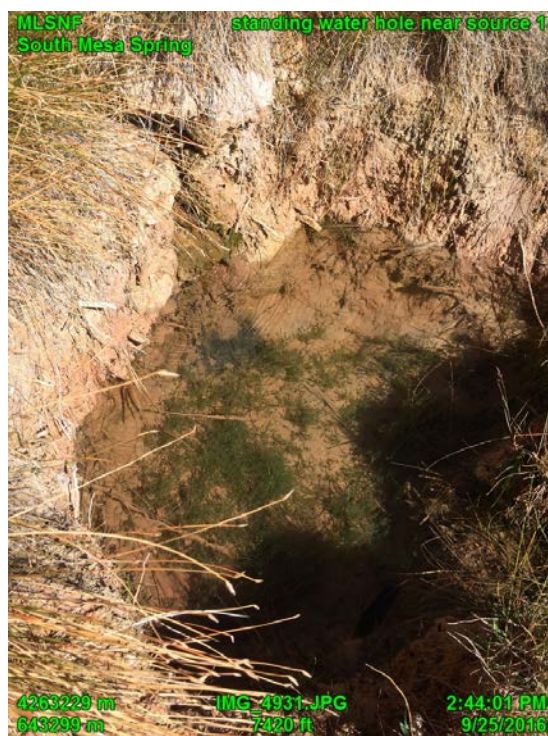
Fig. 4. Watering hole next to trough

Water Infrastructure. There is a watering hole that appears to have been dug for cattle use but there were no recent signs of cattle. An intake pipe extended into the fence line and twisted haphazardly about twenty feet along the spring until it ended suspended several feet in the air. Additionally, there was a watering hole dug into the ground just below a source (Fig. 4).

Additionally, the watering hole should be filled in to allow a natural flow consistency. Ultimately, the obsolete pipe should be removed.

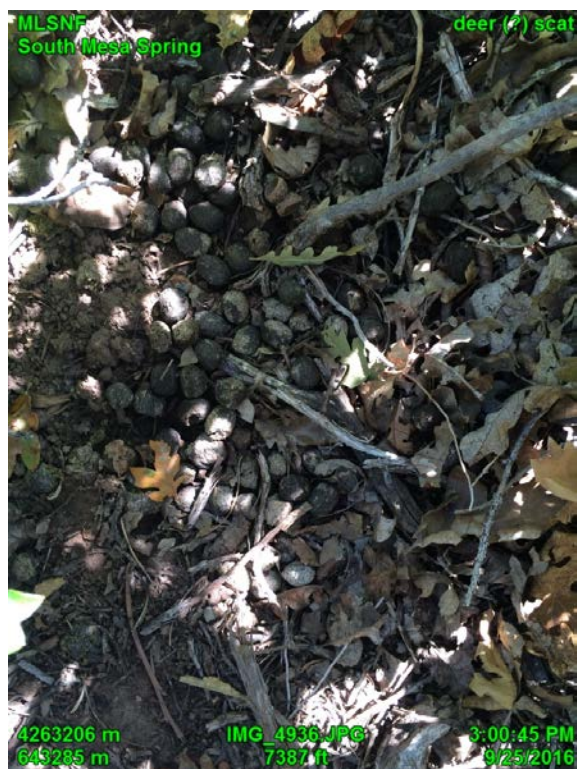
During the summer months, the surrounding area is grazed by cattle. However, signs of grazers have diminished in the past several years as a benefit of a new fence that is in good shape. There was old elk scat present in the area so the fence evidently doesn't ward off all ungulates, but it has excluded cattle.

Fig. 5. Elk Scat

Wildlife evidence. In microhabitat A, bees, flies, and butterflies were observed. Elk scat was found in microhabitat B (Fig. 5).

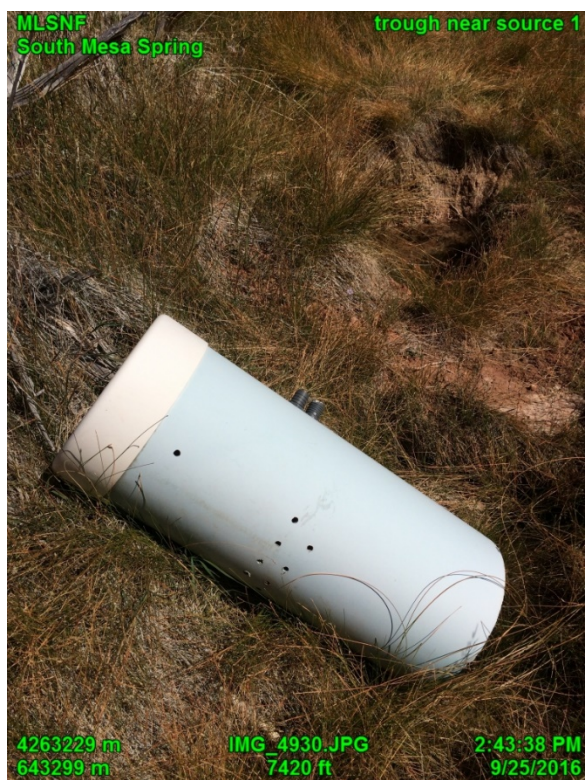
Fig. 6. Water infrastructure by watering hole

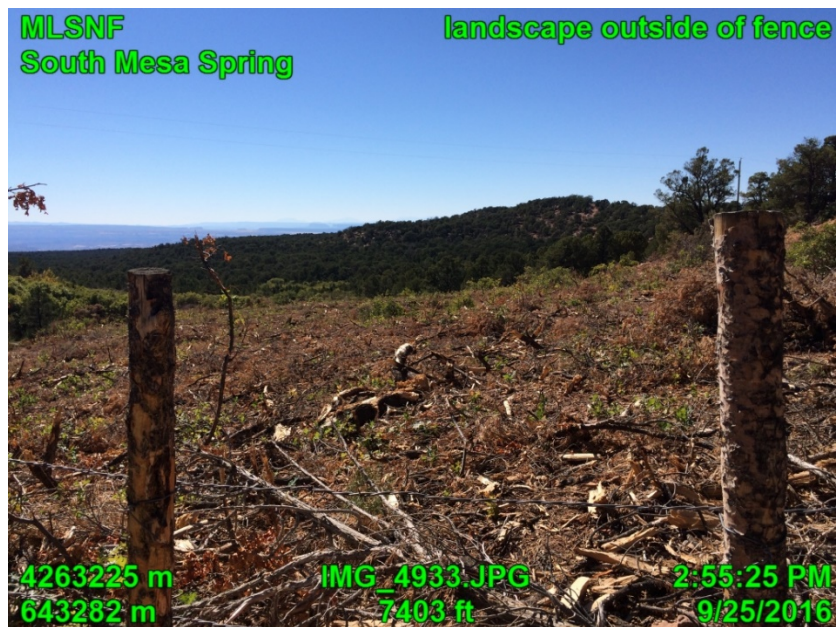
Fig. 7. Landscape outside fenced enclosure

Microhabitat C was free of vegetation. A treatment or wind event may have flattened all vegetation to the ground fairly recently as the trees are torn from their stumps and scattered (Fig. 7). There is no new vegetation recruiting.
