Spring 243 Condition Assessment

Location: North Trail East Pasture, Trail Mountain Allotment, Manti-La Sal National Forest

Date: September 28, 2016 **Begin/End Time:** 1:17pm to 2:30pm

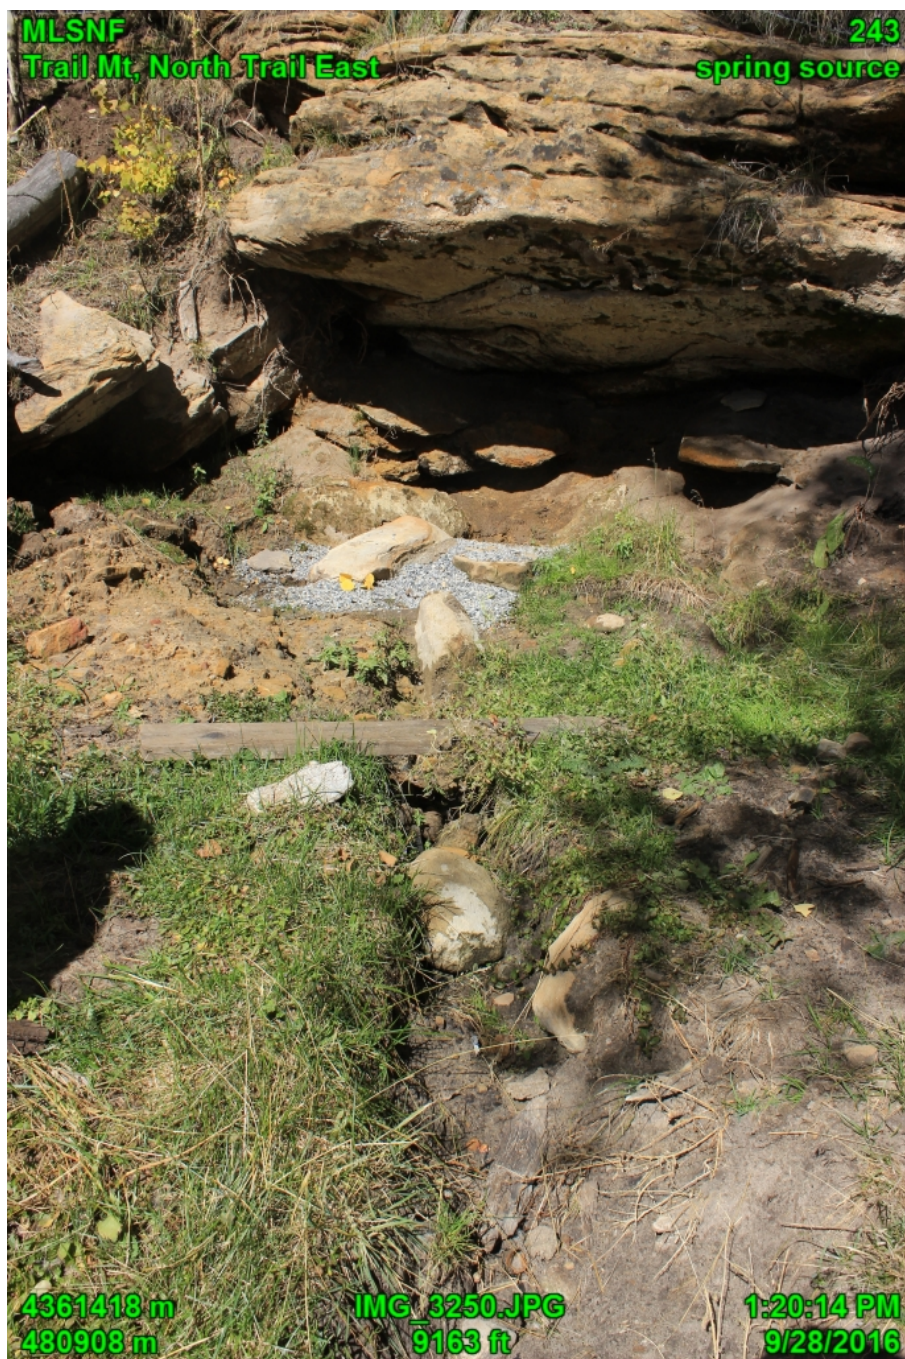
Fig. 2 Microhabitat A; outlet of Spring 243 with trench for water pipe to livestock trough

The pipe that transports water to the trough appears to be capturing so much of the spring flow that it is preventing spring habitat (for wildlife and plants) from existing near the outlet.

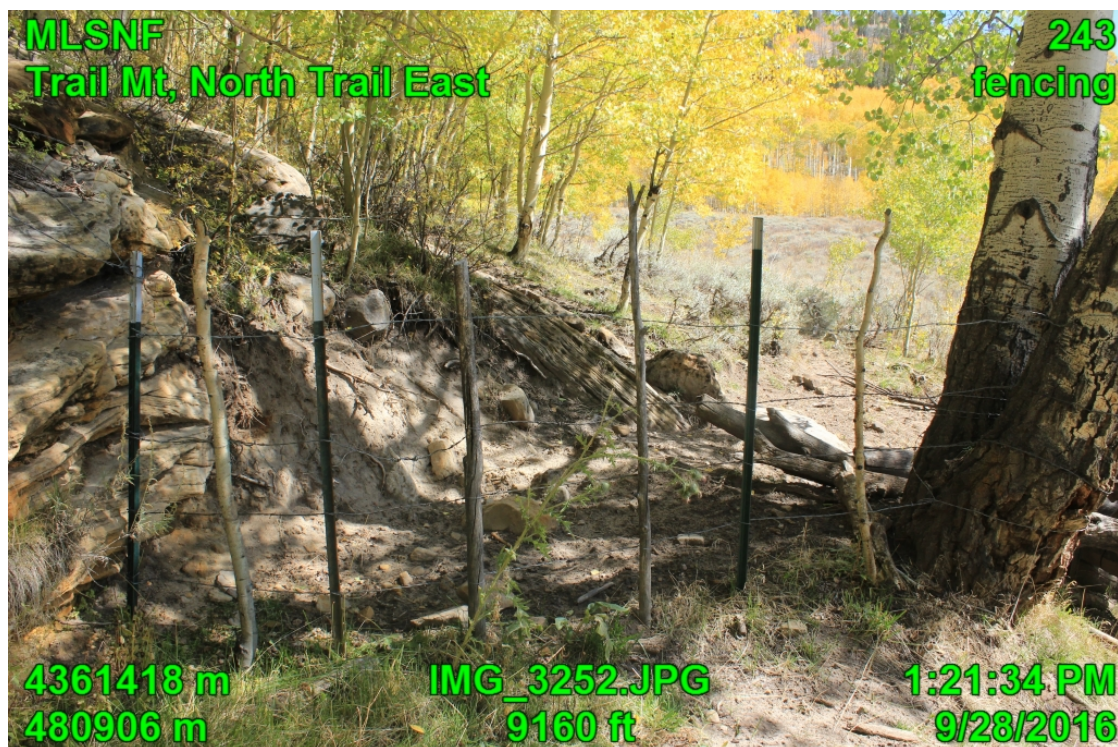
Fig. 3 Exclosure fencing for Microhabitat A spring outlet

The site consists of two areas: the spring outlet (Microhabitat A) and the area surrounding the livestock trough (Microhabitat B). Microhabitat A is enclosed by a barbed-wire and log fence roughly 20' long and 20' wide (Fig. 3). At the base of the sandstone outcrop, where the spring water emerges, there is a pile of gravel on top of the end of a black plastic pipe which leads to the livestock trough (Fig. 2). No water seemed to be flowing from the spring while this assessment took place, however the trough was full of water and the soil near the outlet was wet. The vegetation in this enclosure consists primarily of grasses, with forbs such as exotic bull thistle; mosses also fairly common. Sedges and rushes are also present, but less common than other types of vegetation. Additionally, the spring outlet is surrounded on three sides by mature aspen trees, and several aspen sprouts are growing within the fenced area.

Given that no evidence of browsing or trampling was observed with the fence surrounding Microhabitat A, the enclosure appears to be effective at keeping out cattle that might degrade the spring outlet. However, the combination of the complete diversion of water to a trough and the small size of the area fenced off from cattle means that little to no riparian or spring-influenced habitat is currently provided by the spring.

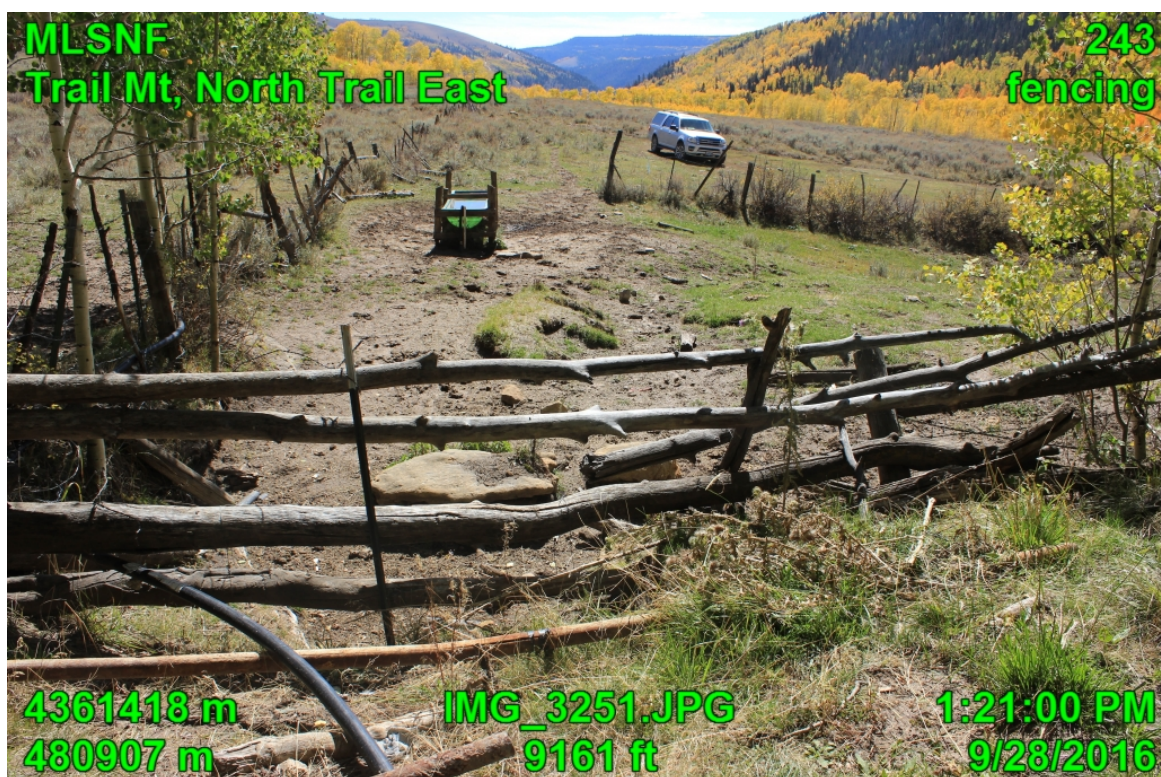
Fig. 4 View of Microhabitat B and livestock trough from spring outlet; black water pipe leading to trough visible in bottom left

Microhabitat B, approximately 110' X 70') is larger than Microhabitat A and is surrounded by a fence on four sides, except for a gap of 15-20 feet which allows cattle to enter the area (Fig. 4). There is a small trench that leads from the general area of the spring outlet downhill to a low-lying area that may become a pool during rain events or higher spring flow (Fig. 6). Bare ground and grasses dominate the ground cover in this area, and a few rushes and sedges are scattered throughout. Cattle manure and hoof-prints were observed throughout this enclosed area, with the ground surrounding the trough being especially bare (Fig. 5). Flora include aspen trees (a few mature, several sprouts), several clumps of sagebrush, and Wood's rose along the southern fence line. Of particular note is a large aspen snag that has fallen on the northern fence, flattening it and allowing cattle to cross into the aspen stand on the other side. Significant browsing of regenerating aspen was observed in this stand.

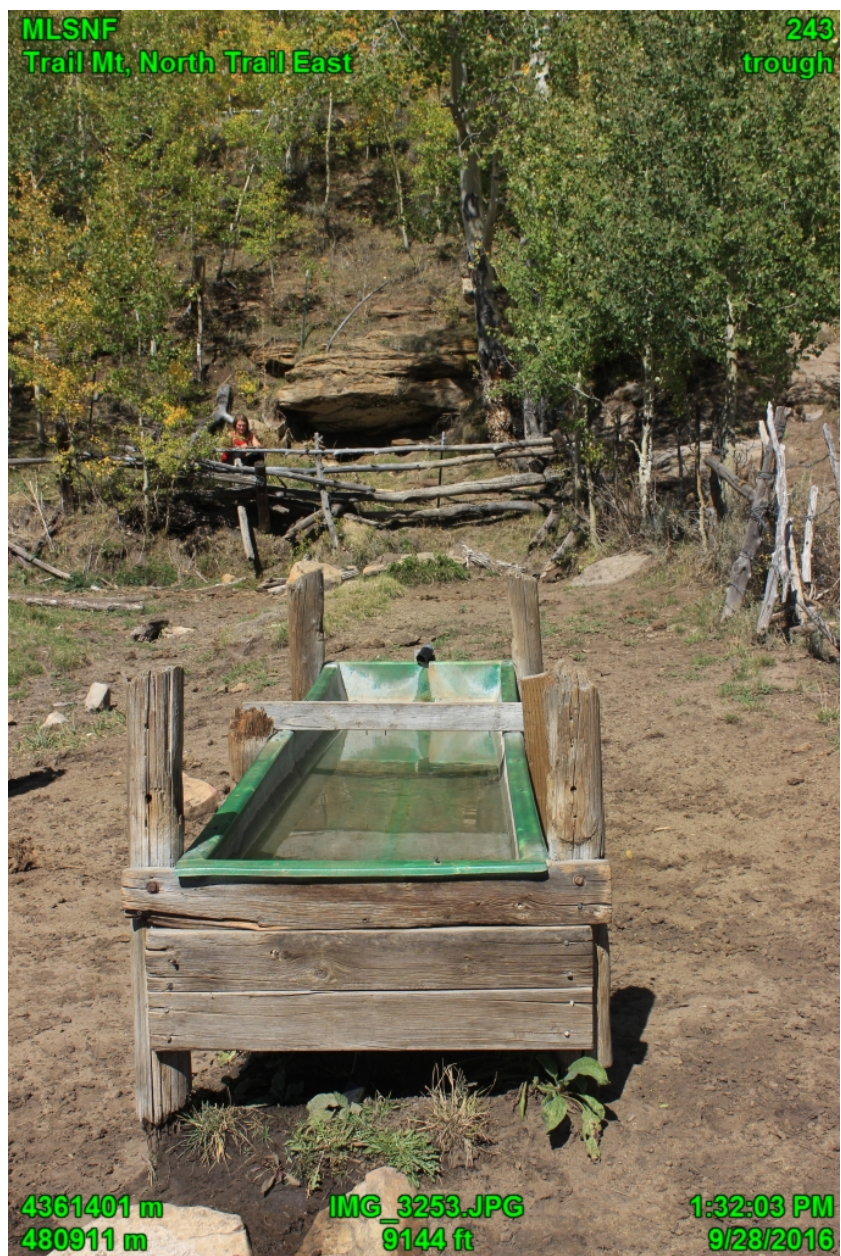
Fig. 5 Livestock trough in Microhabitat B

- Survey and monitor the flow of the spring to ensure that the water is being appropriately divided among spring- and riparian-dependent wildlife and livestock uses.
- Remove the fallen aspen on the northern side of Microhabitat B and the downed fence be repaired in order to prevent cattle from browsing the aspen stand above the spring.
- Install a wildlife escape ramp in the livestock trough, which currently lacks any such wildlife-friendly infrastructure (Fig. 5).

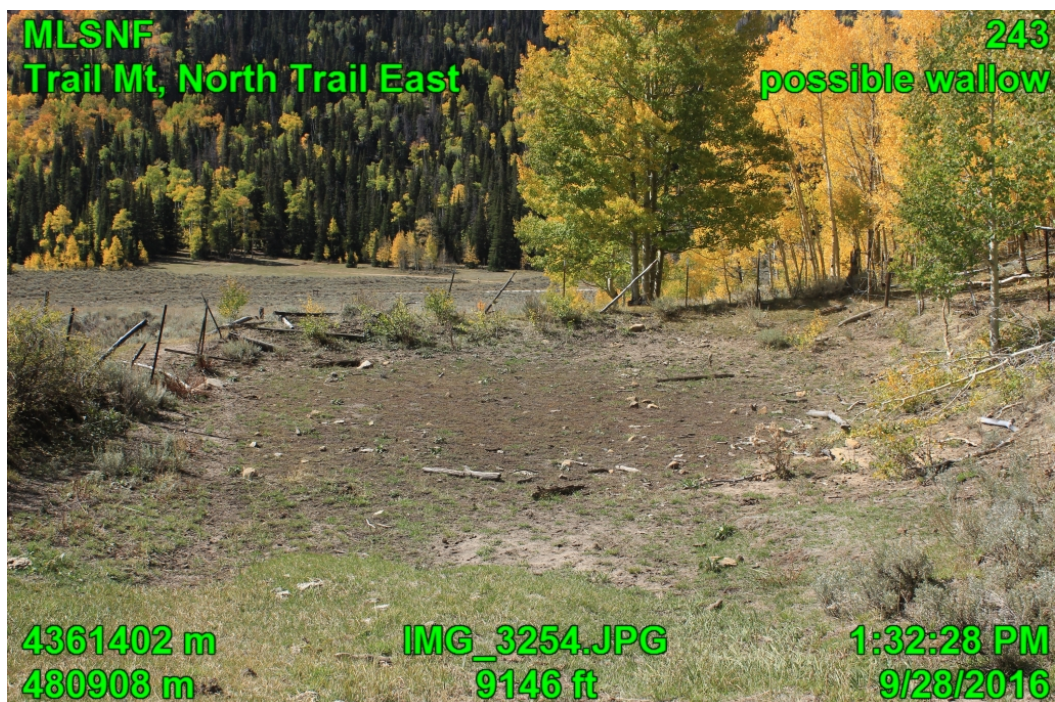
Fig. 6 View towards SW fence in Microhabitat B

Microhabitat B is significantly impacted by cattle and has a large portion of bare or semi-bare ground (i.e., only partial grass cover). In the aspen stand on the other side of the downed fence in Microhabitat B, there is a trampled path along the fence line, cattle manure, and browsing of aspen sprouts.

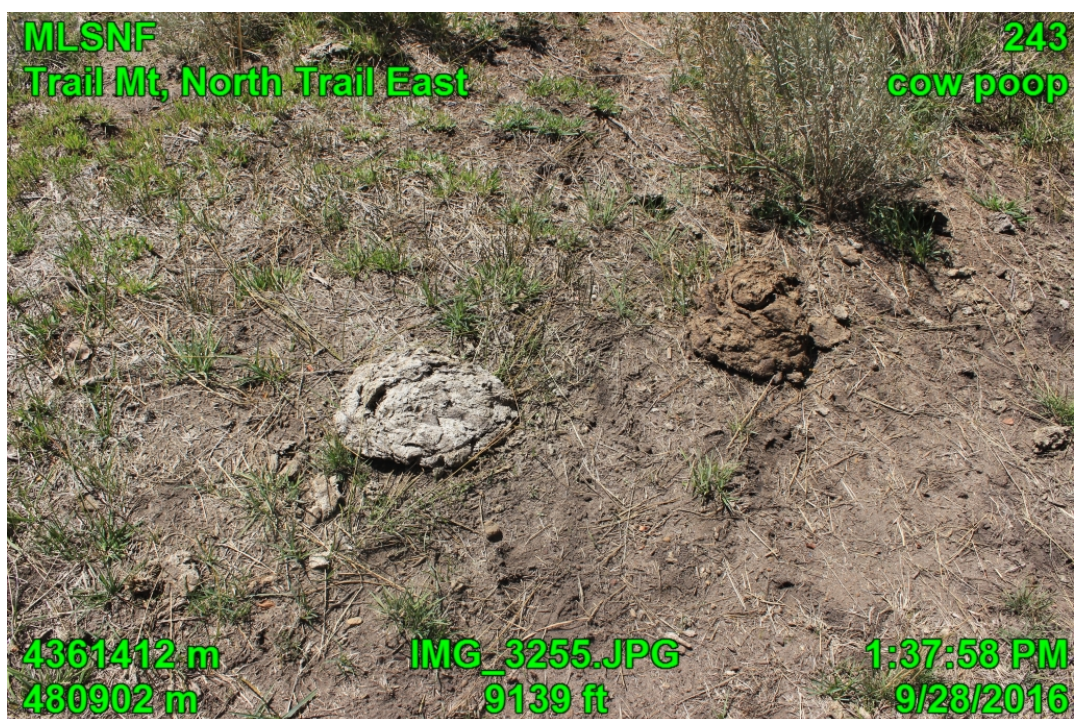
Fig. 7 Cattle manure in Microhabitat B
