# **Deer Springs complex Condition Assessment**

Location: La Sal Creek Pasture, La Sal Allotment, Manti-La Sal National Forest
Date: September 25, 2016
Begin/End Time: 12:51 PM, 3:31 PM
Observers: Fields Ford, Signe Lindquist, Kenzie Spooner, Sarah Dunn

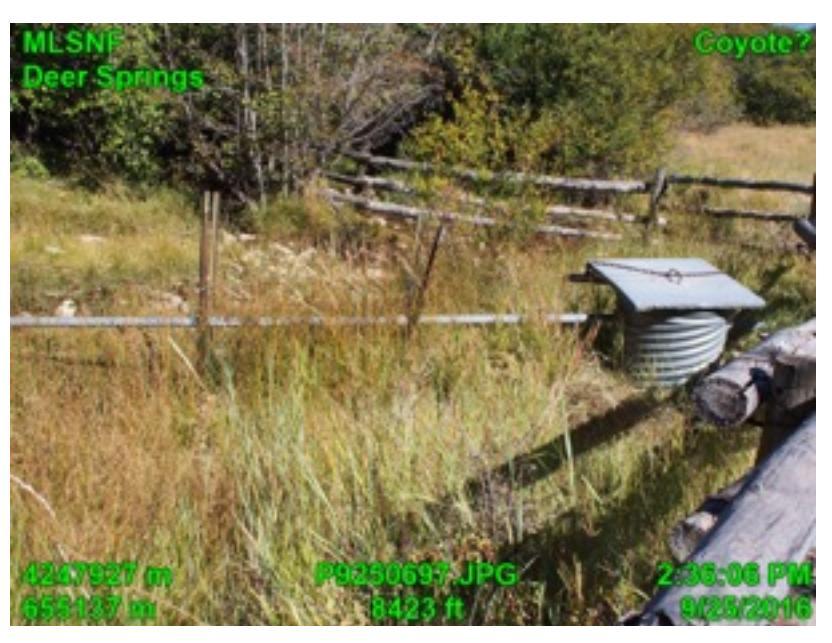
Fig. 1: The main, enclosed source of the Deer Springs complex.

Within the Deer Springs complex, an abundance of water is evident. The most notable is a main source, which is located within an exclosure and flows quickly downhill (Fig.1). This source is at the highest elevation, located just below Forest Service road 128. Northeast of this main source are three smaller sources (Figs.1-3), each with a consistent, trickling flow, located in a marshy meadow above one meadow area. The stream starts below two of the sources and continues southeast and downhill through a wooded riparian area with dense understory vegetation. A significant distance downstream from these sources are two more small sources (Figs. 4,5), both set slightly north of the stream and producing standing water in muddy riparian areas. A second stream also flows southeast from the main, fenced-in source. This waterway moves for a significant distance through another wooded riparian area. South of the beginning of this stream is a seventh source (Fig.6) that originates in a wooded thicket located within a meadow. This source produces standing water within the thicket that permeates out to an open, marshy area. The eighth and final source (Fig. 7) is fairly isolated, but it flows steadily. It is located in between the main enclosed source and the three smaller sources, and only a few feet below the road. The creek beds of the spring flows are fairly armored with rocks, which is preventing significant incision from hoof action by livestock (Fig. 16).

The Deer Springs complex has only one instance of water infrastructure. The main source is located within a small exclosure. The exclosure boundary is a waist-high log fence. The fence has three rungs, each spaced about two or three feet from the next rung above or below. The water infrastructure within the exclosure consists of a metal barrier that backs up the source, allowing water to flow slightly downhill through a pipe into a cistern emerging from the ground.

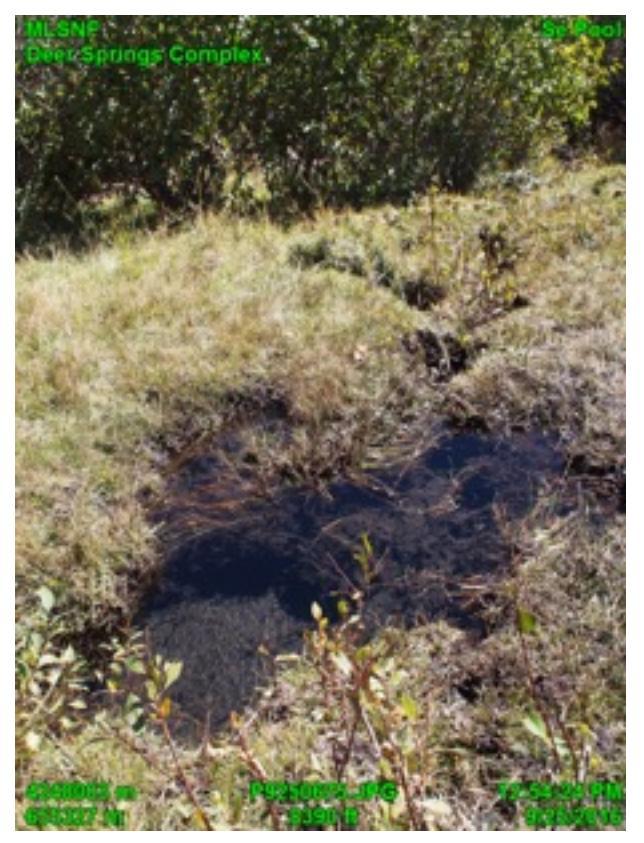
*Fig. 2:* One of three smaller sources located below the main enclosed source.

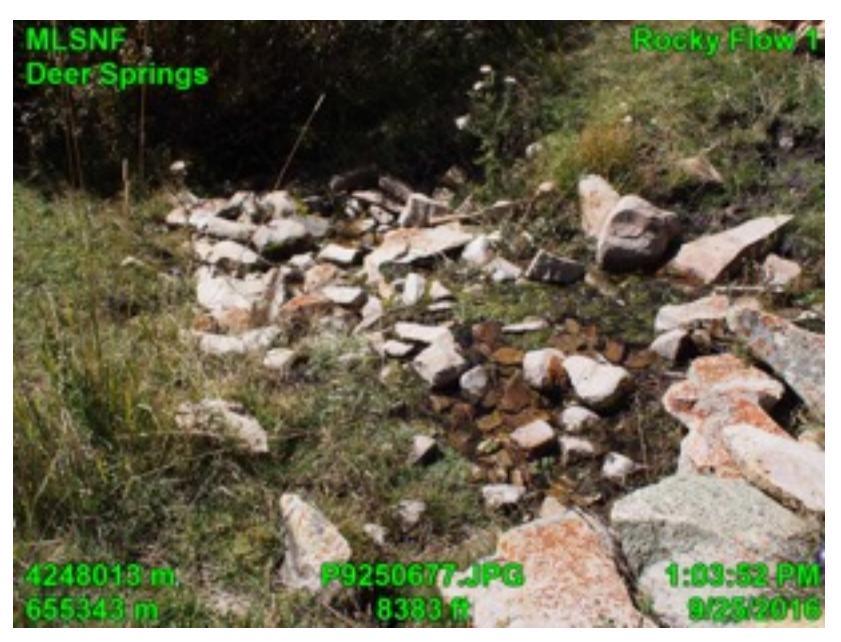
Fig. 3: One of three smaller sources located below the main enclosed source.

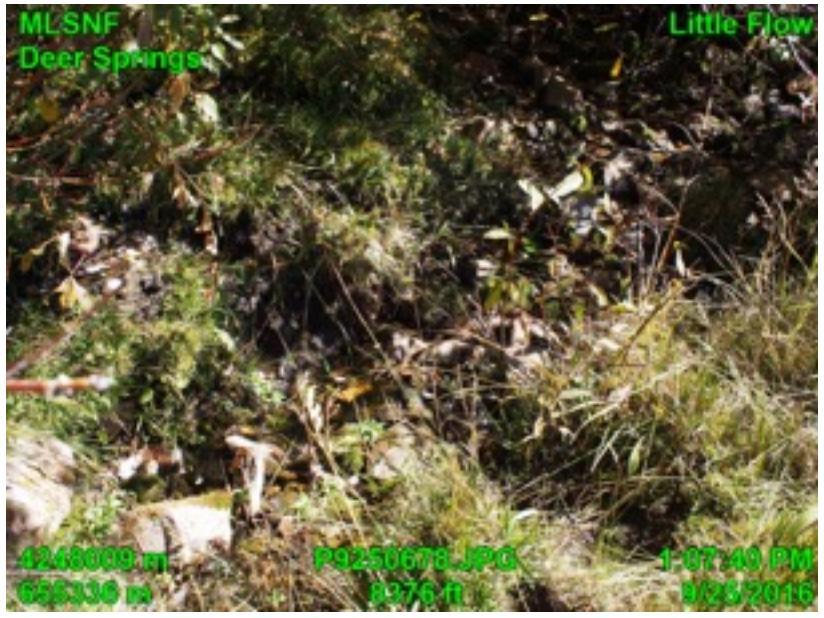
Fig. 4: One of two small downstream sources. Signs of trampling evident.

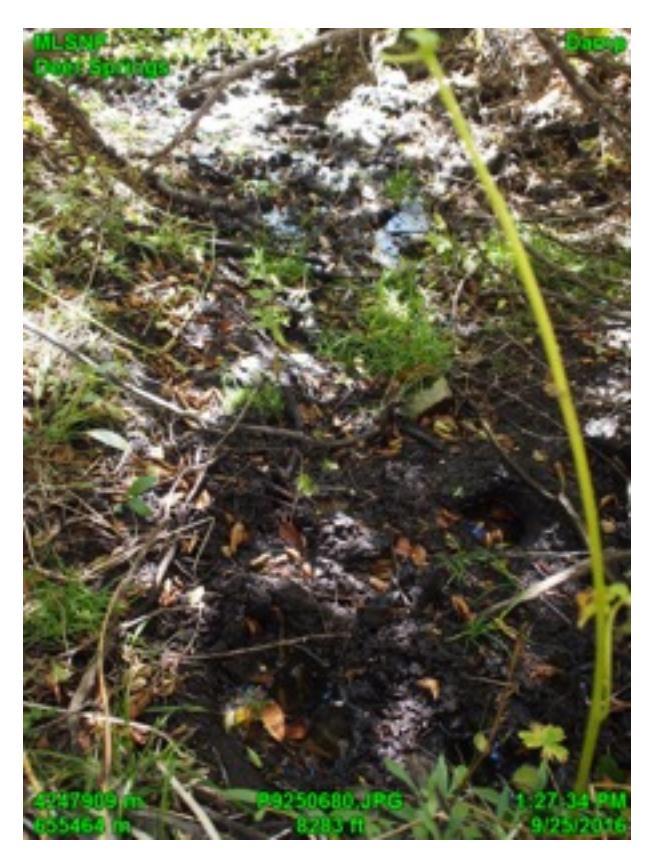
Fig. 5: One of two small downstream sources.

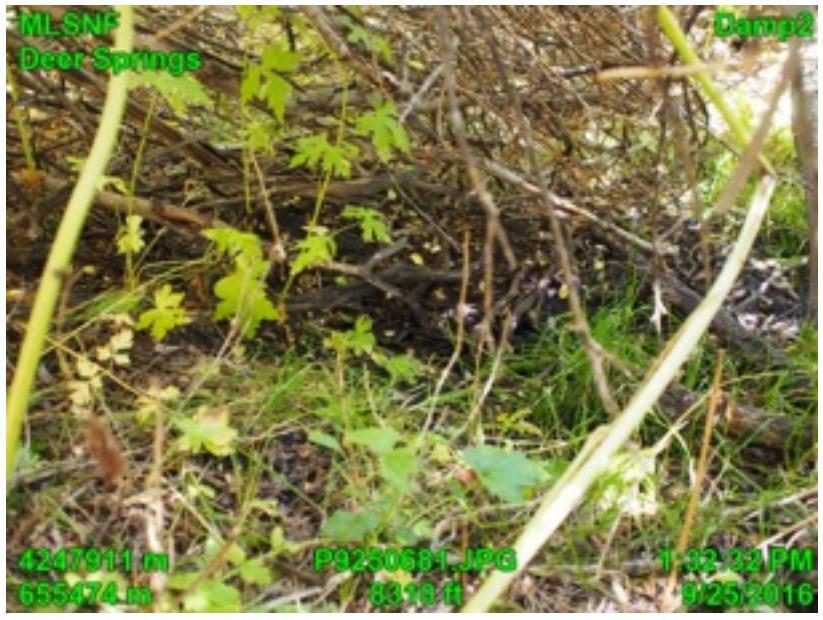
*Fig. 6:* A source located within a wooded thicket in the meadow.

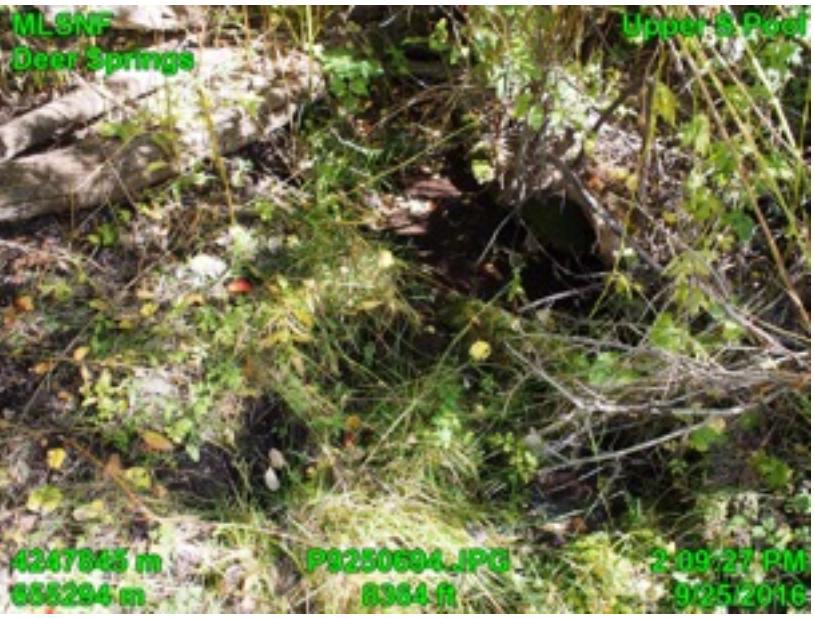
Fig. 7: A source located in between the main enclosed source and the three smaller sources, just below the road.

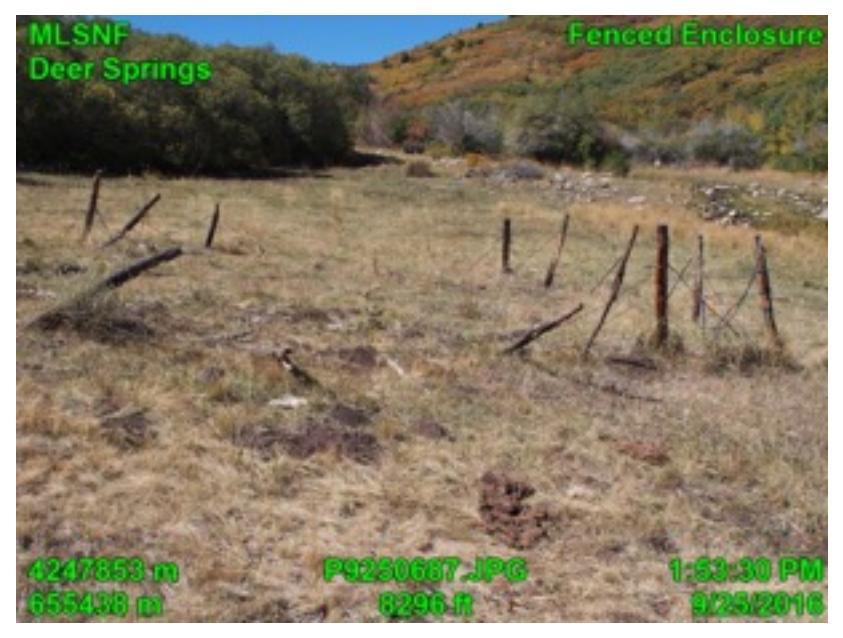
Fig. 8: An unmaintained exclosure in the meadow

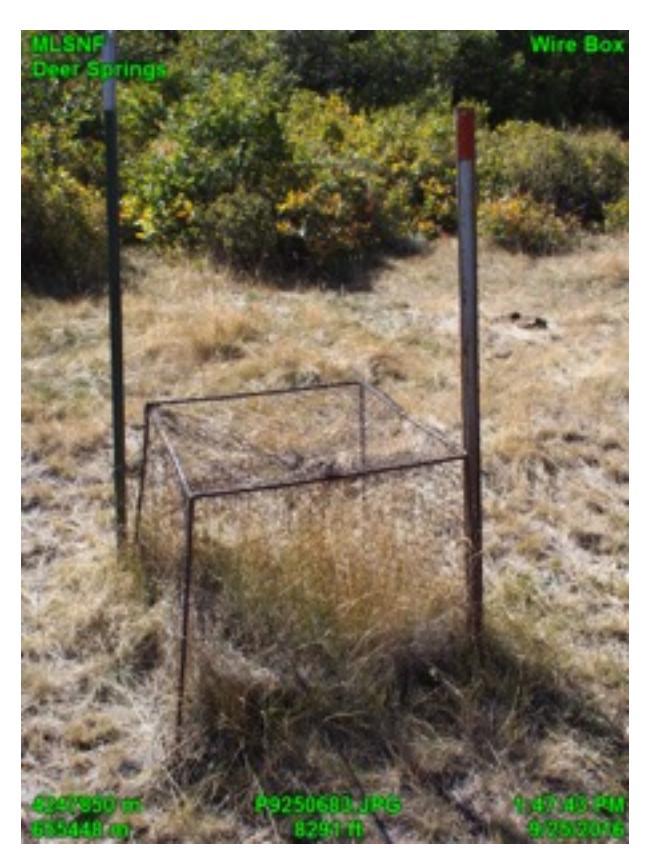
Fig. 9: A caged enclosure in the meadow.

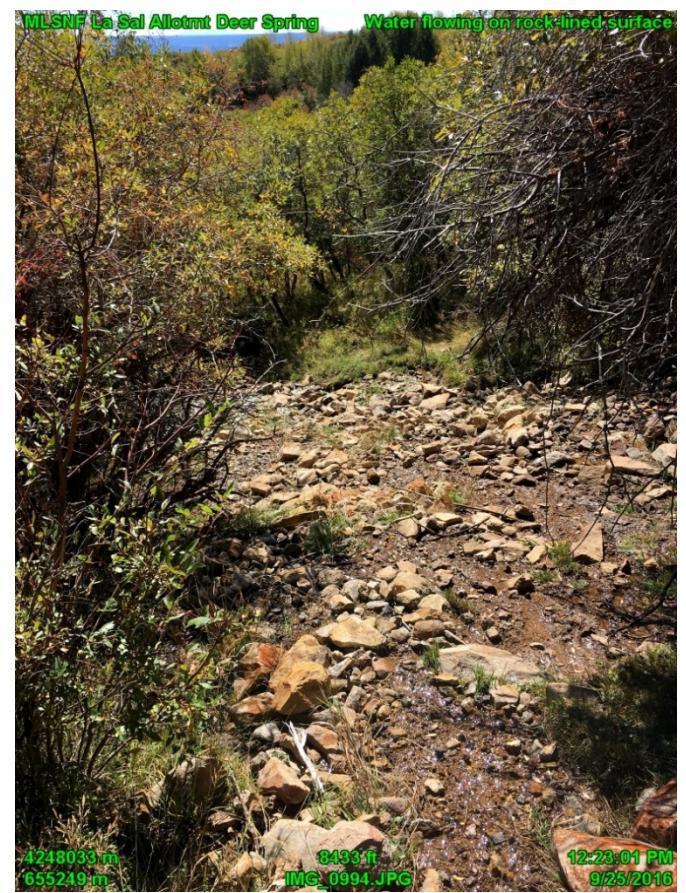
Fig.16. Armored creek bottom

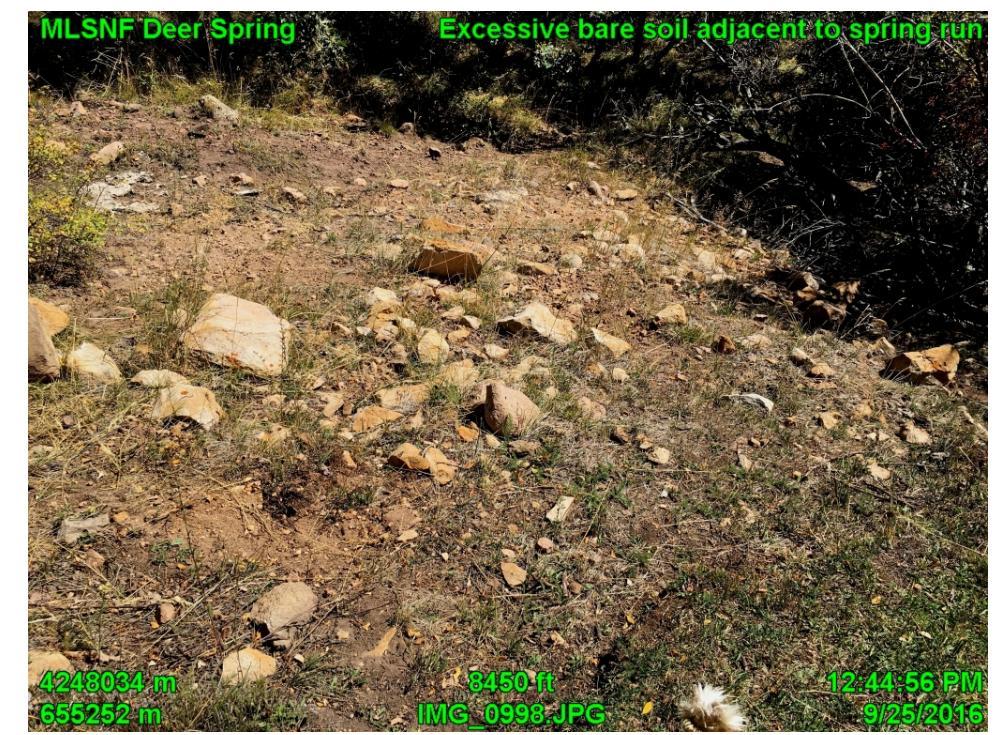
Fig. 17 Excessive bare soil adjacent to spring run

Grasses, forbs, and shrubs in the drier areas of the complex, and particularly the meadow have been grazed so heavily that in some areas, exposed dirt and rocks are all that is left (Fig. 17). This leaves critical land near streams and riparian areas prone to erosion, which can mean decreased water quality for the complex and inhospitable land to vegetation growth, as well as habitat loss. The only area that looked healthy and showed no signs of grazing was the enclosed main source.

Based on the evidence of degradation present at the Deer Springs complex, it is recommended that the US Forest Service take steps to ensure that the presence of livestock in the area does not continue to negatively impact the complex. Since the majority of impact is in the open meadow, the riparian areas are not in need of immediate protection. It is recommended, then, that the grazing pressure be reduced. To further improve the health of the springs complex, nonnative species could be removed from fragile environments such as the enclosed spring source.
