Gentry Mountain Spring 158 Condition Assessment

Location: Gentry Pasture, Gentry Allotment (Wasatch Plateau), Manti-La Sal National Forest

Date: September 28, 2016 **Begin/End Time:** 11:11 AM, 12:00 PM

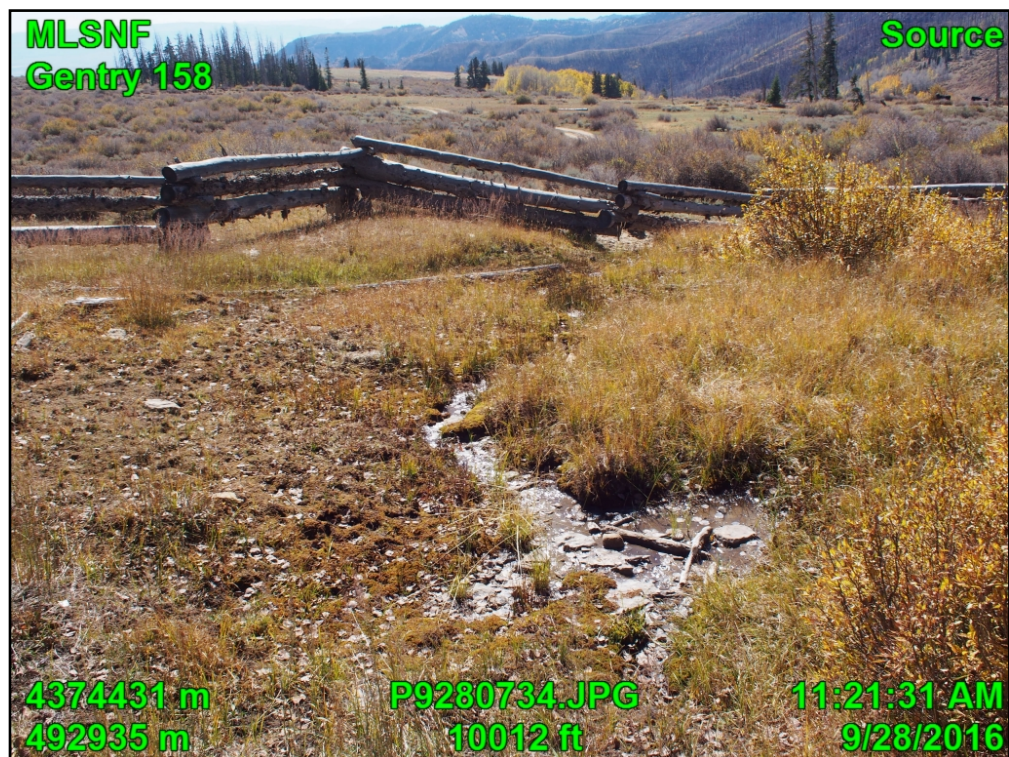
Fig. 1: The Spring Source.

The spring source (Fig. 1) has no water infrastructure associated with it, but is within an enclosure approximately sixty feet in diameter, made of three stacked logs. Downhill, southwest, and across the road from the spring source is a developed cattle pond (Fig. 2). Approximately half of the pond’s perimeter is a constructed berm holding in water. Along this berm is a small fenced-in section that is most likely a fragile part of the bank enclosed to protect it from the cattle.

1. Ensure that livestock in the area do not continue to negatively impact the spring and surrounding riparian area.
2. Maintain the fence around the spring source to protect the intact riparian area.
3. Fence the stream flowing out of the spring to protect the riparian area, and concentrate use on the already heavily impacted cattle pond. This would help mitigate their negative impacts.

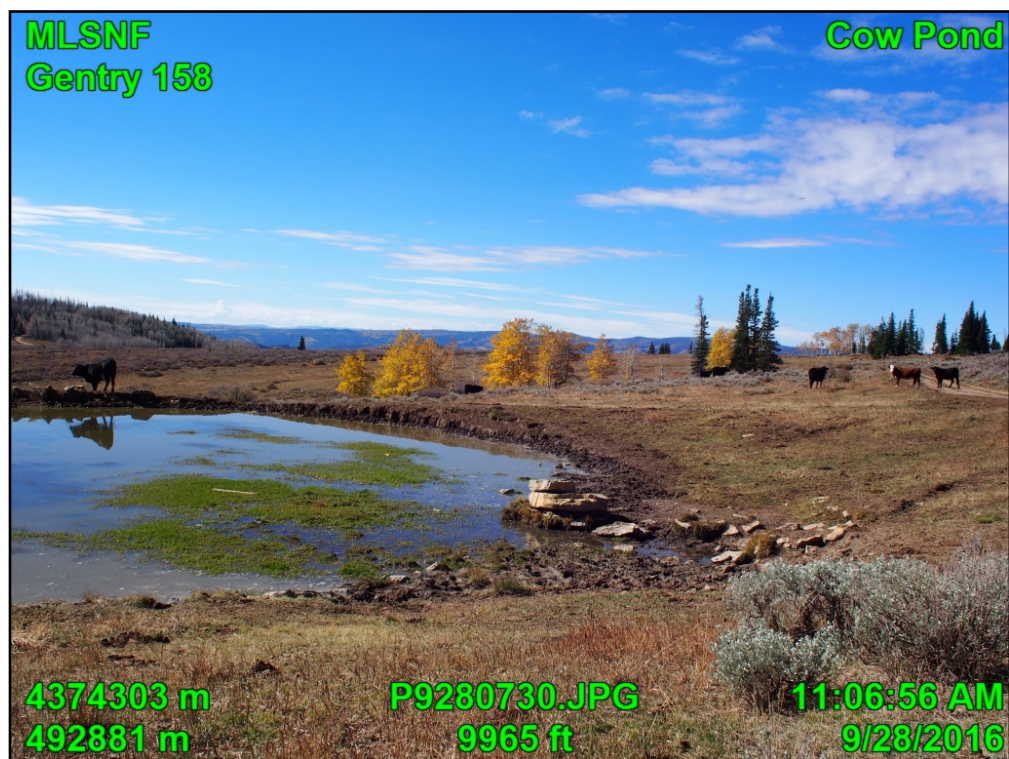
Fig. 2: A cow pond.

The pond located southwest of the source is also heavily disturbed. The area surrounding the pond is extraordinarily trampled and covered by bare ground. Deeply in-cut livestock trails also surround the pond.

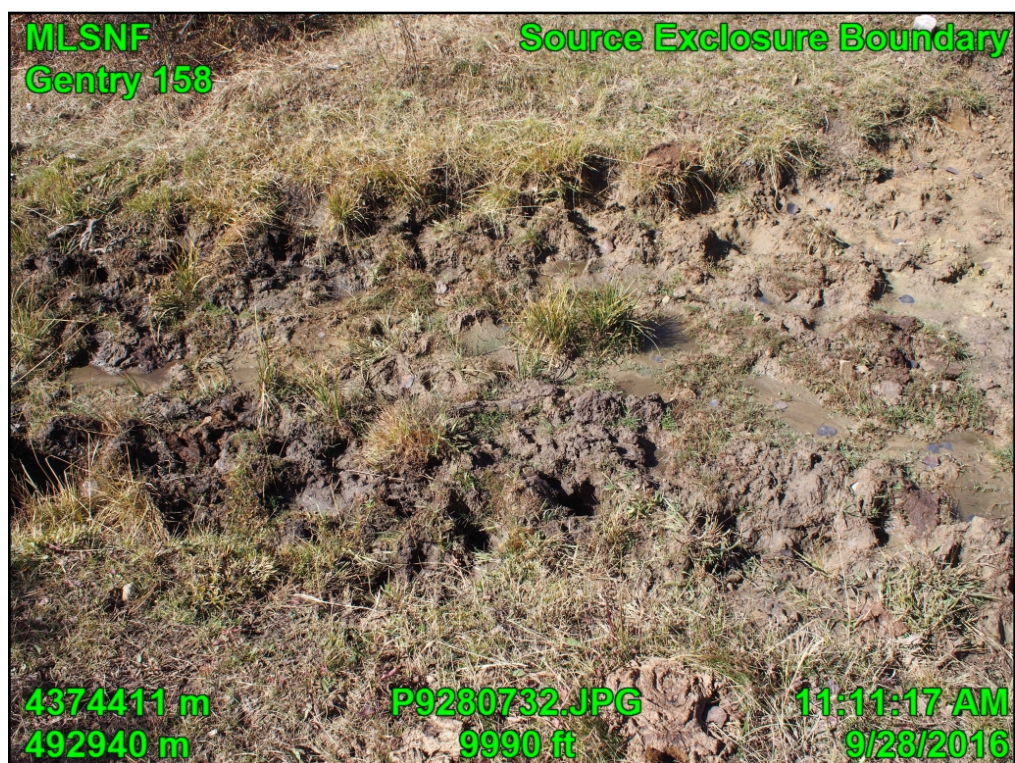
Fig. 3: Trampling outside exclosure.

due to cattle presence and left over from before the spring source was fenced. Outside the enclosure, disturbance is more extreme. The vegetation surrounding the enclosure has been flattened and heavily grazed back. The streambed flowing from the source is muddied and trampled (Fig. 3), and hummocking is present throughout the area. The bank of the streambed has been sheared, most likely by cows' hooves, and manure is littered in and around the streambed.

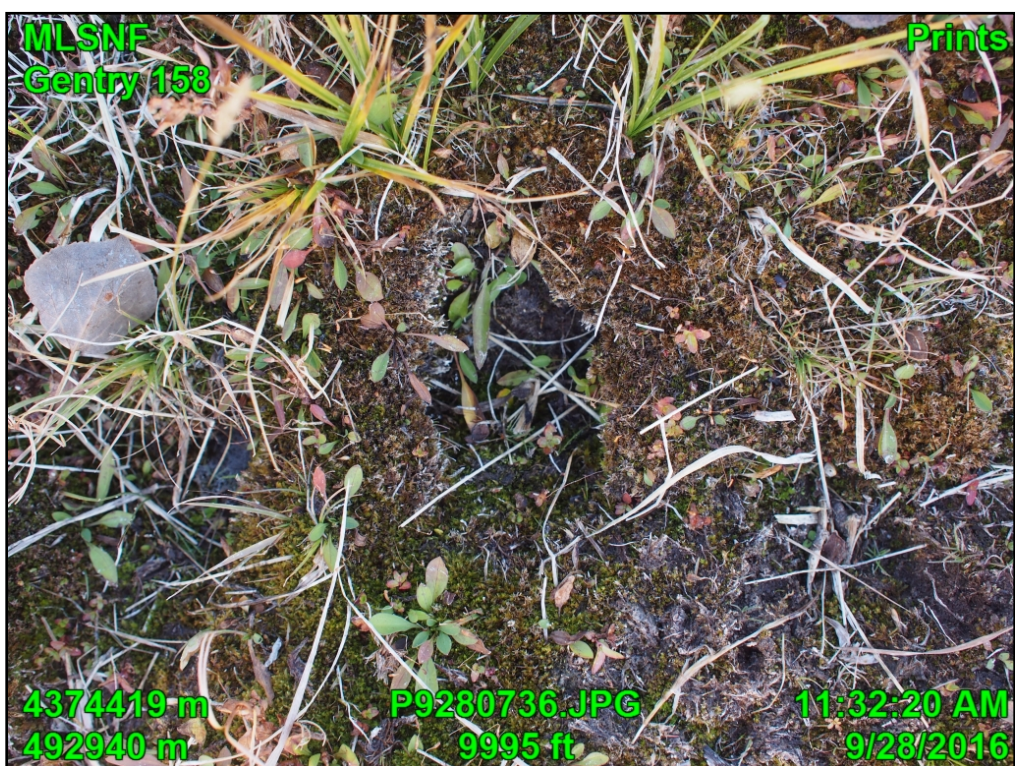
Fig. 4: Unidentified prints near source.

Within the source enclosure, there are few signs of wildlife presence. Hoofprints, most likely belonging to mule deer (*Odocoileus hemionus*), are present in the soft, wet soils surrounding the source itself (see Fig. 4). Also within the enclosure is a small area of flattened grass (see Fig. 5), perhaps deer bedding down or moving under the fence. Small hills of bare earth are also present near the source, possibly indicating the presence of vole or mole species. Elk are likely present outside of the enclosure, as evidenced by the presence of scat around the microhabitat.

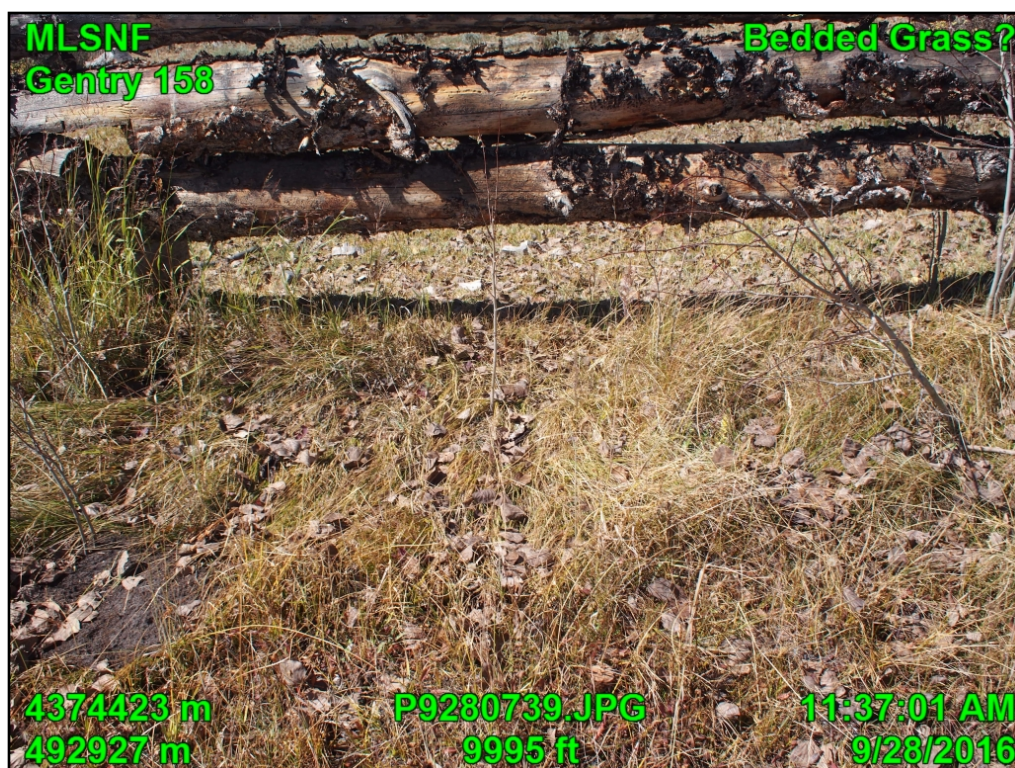
Fig. 5: Flattened grass within enclosure, that has not been grazed.

The contrast between the two microhabitats at Spring 158 is stark, marking the impact of cattle grazing on the landscape. Microhabitat A is an enclosed area surrounding the source of the spring, which bars cattle access. At the source, there is very little standing water, but what water is present at the surface meanders slowly downhill. Rushes, sedges, and grasses are most common in this area, accompanied by a few shrubs and some signs of fungi along the marshy banks of the source. A few small animal tracks (likely deer) were identified in this marsh area, but the banks were not significantly disturbed. Another light impact within the enclosure was scattered signs of browsing on young aspen. One patch of grass inside the enclosure near the fence border is flattened, a sign that an animal (potentially deer) has either bedded down here or crawled under the enclosure fence from

the outside (the gap between the ground and the bottom of the fence here is approximately 1.5 feet, enough for a deer to come through).
