Gentry Mountain Spring 181 Condition Assessment

Location: Gentry Pasture, Gentry Allotment (Wasatch Plateau), Manti-La Sal National Forest Date: September 28, 2016 Begin/End Time: 12:50 PM, 1:28 PM Observers: Kenzie Spooner, Sarah Dunn, Signe Lindquist, Fields Ford, Collin Smith

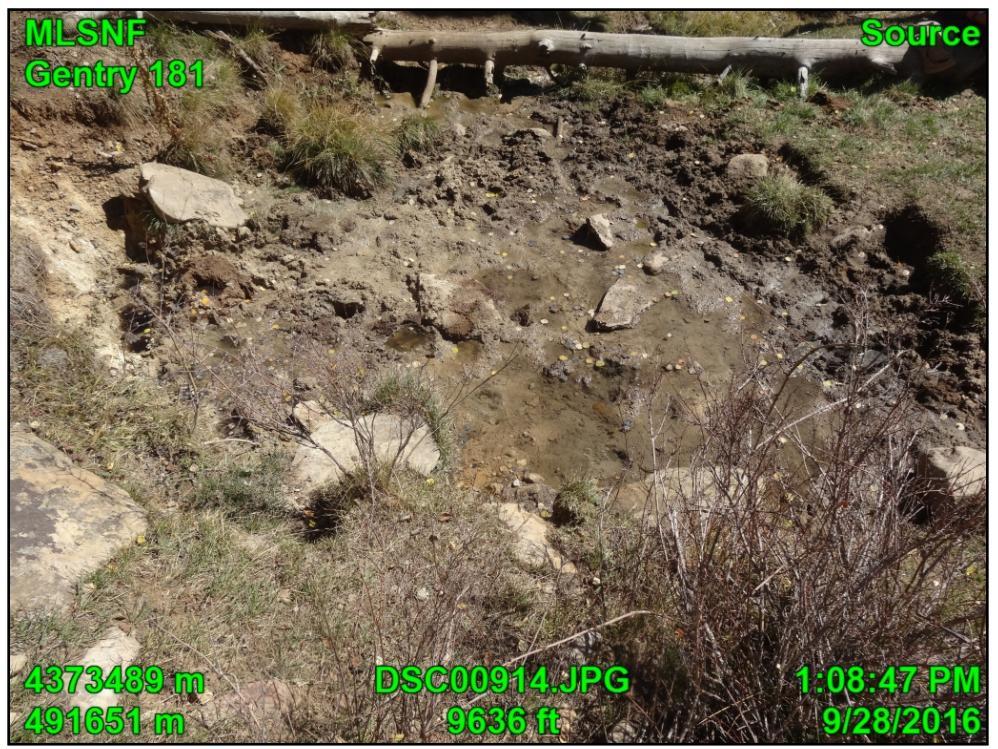
Fig. 1: The spring source.

At spring 181, there is a strong water presence, starting at the source (see Fig. 1), water flows quickly and consistently downhill. Although a large volume of water does not flow from the stream, it is evident that there is consistently a perennial flow. There are small pockets of standing water, caused by cattle who trample the riparian area.

Because the source of spring 181 is not fenced, the source and surrounding vegetation have been heavily grazed and trampled. The grass, aspen (*Populus tremuloides*), and nearby shrubs are impacted by ungulate browsing. Aside from browsing, the spring was severely affected by ungulate presence. The cattle who graze in the area contribute to the shearing of the source and stream banks. Hummocks that are present in the source pool are the result of trampling by cattle, and manure litters the area surrounding the source and stream flow.

It is highly recommended that spring 181 be enclosed by a fence. The degradation of the microhabitat is nothing less than extreme, as evidenced by the aforementioned bank sheering, hummocking, trampling, and heavy browsing. Creating an exclosure for the spring would prevent further erosion due to livestock presence as well as improve the water quality at the source and ensure that the source is not buried by perpetuated trampling.

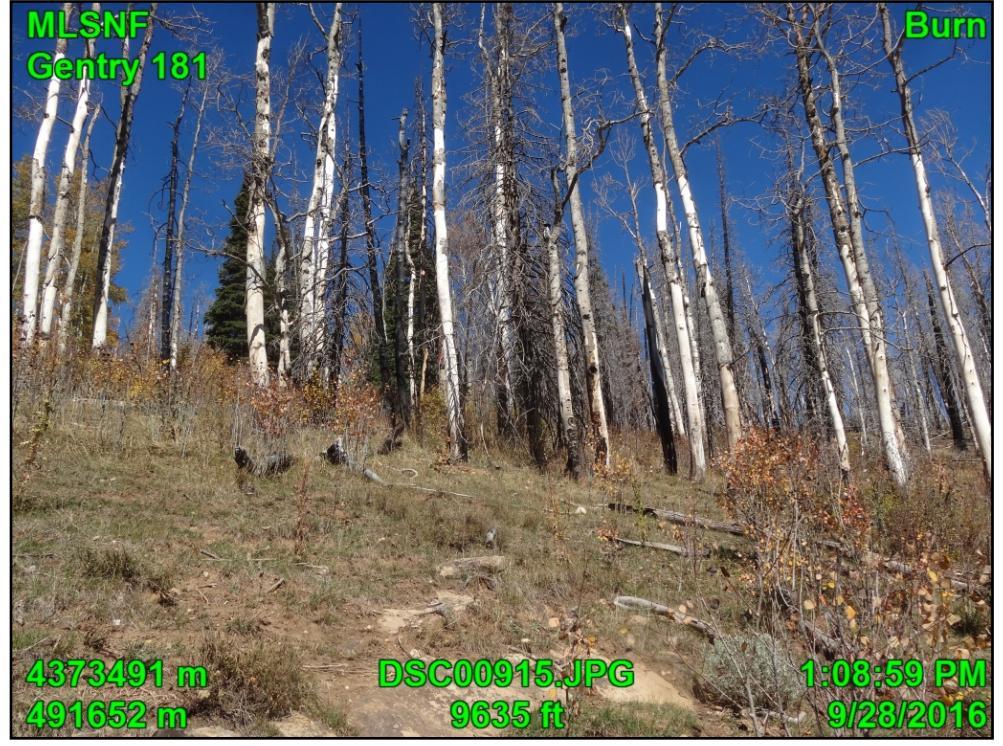
Fig. 2: Aspen impacted by wildfire on the South slope.

Aside from wild ungulate impact (most likely deer), the area surrounding the source specifically to the south is impacted by wildfire (Fig. 2). Upslope there is evidence of aspen recruitment and the ground is littered with fallen snags.

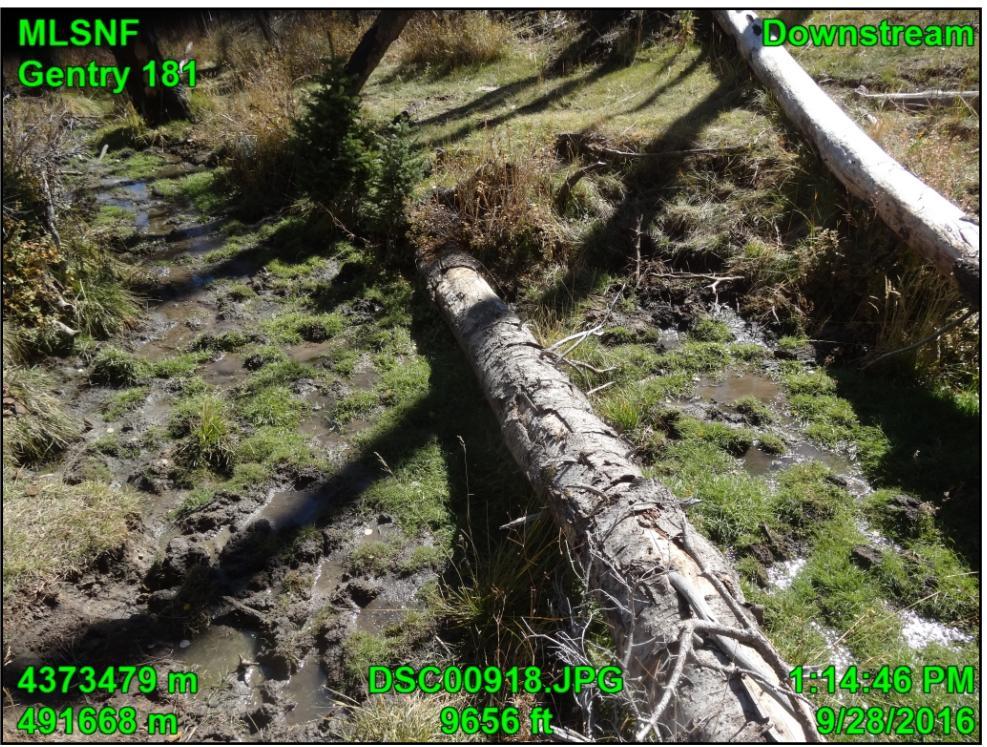
Fig. 3: Downstream habitat.

Ideally, the downstream riparian areas would also be protected. The muddy, trampled conditions currently affecting two large areas of the stream could be prevented if cattle were kept from accessing the water at those points and instead were provided a single location to get water. Alternatively,

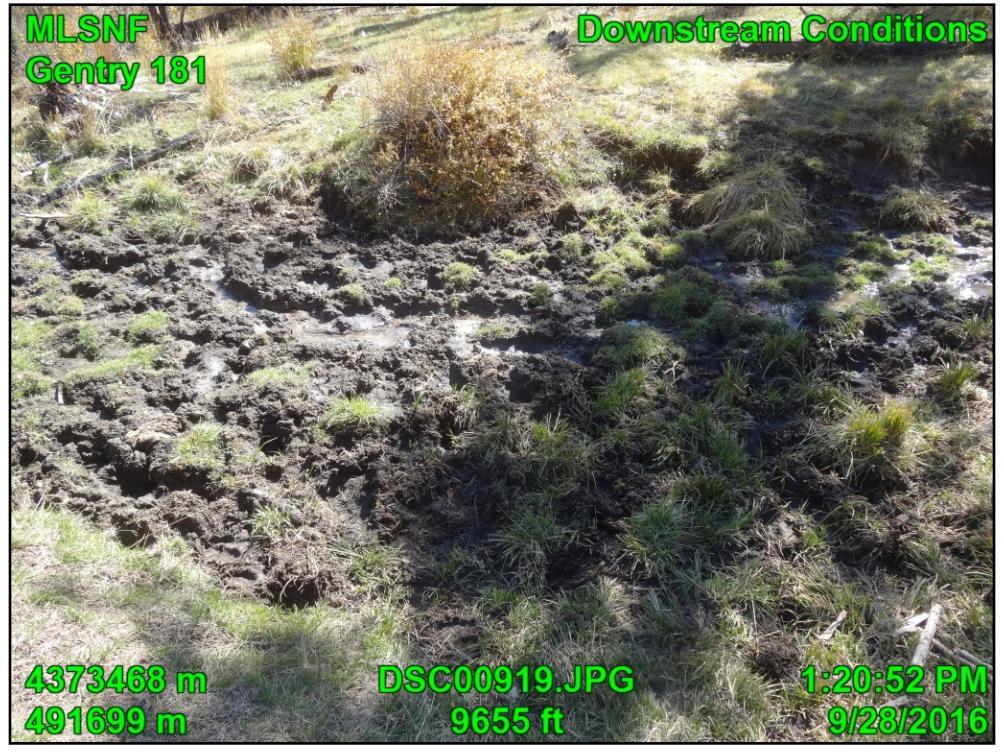
Fig. 4: Hummocking and trampling downstream of spring.

The general health of spring 181 is undeniably poor. The impacts of livestock specifically, cattle—presence in the area are extreme. The trampling of the spring source causes the earth to become bare and overturned. This trampling also leads to the hummocking evident at the source and downstream. Livestock presence also has an effect farther down the flow; between one and two hundred feet downstream, where trampling has created two muddy areas filled with standing water. The vegetation surrounding the source is heavily grazed, including aspen sprouts. The banks of both the source area and the stream flow have been sheared by hooves, promoting erosion and sedimentation of the riparian area and water.
