North Point Spring Condition Assessment

Location: Trail Mountain Allotment, North Trail East Pasture, Manti-La Sal National Forest
Date: September 28, 2016 Begin/End Time: 12:30 pm to 1:30pm
Surveyors: Griffin Cronk, Elizabeth Greenfield, Sophie Poukish, and Hannah Trettenero

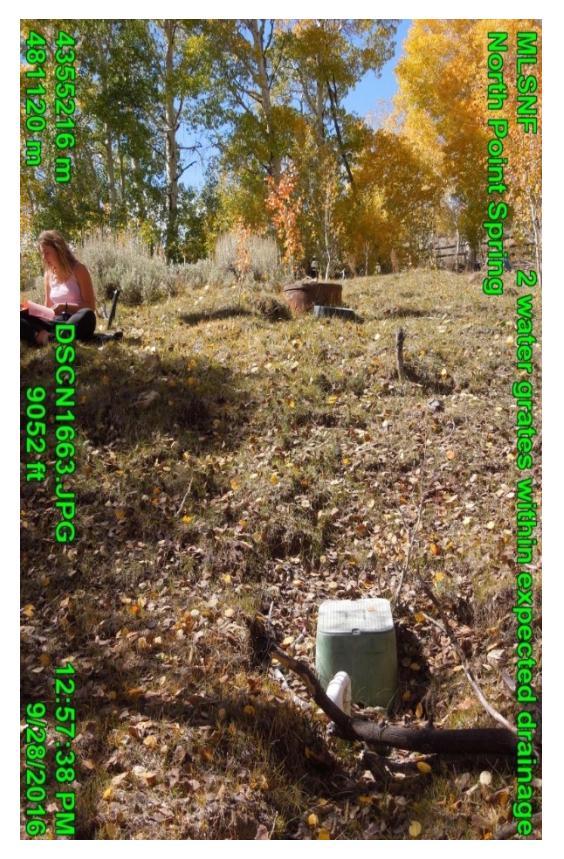
Fig. 2. Microhabitat 1 with two water grates

Water Infrastructure. Water infrastructure included white piping starting at the source and connecting to two water grates within the exclosure (Fig. 2). A metal cylinder was found above the first grate. A black tube was found coming out of the ground below the second grates and connected to the large trough outside the fence. Black tubing was also found on the ground next to the trough, though not attached to the trough.

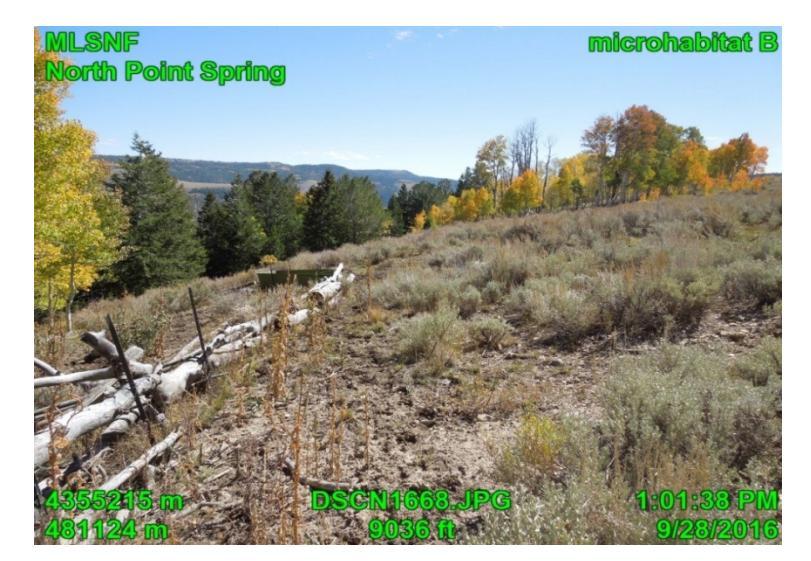
Fig. 3. Microhabitat 2

Outside the exclosure, the landscape is in even worse shape, due to a heavily trampled cattle path and many cow patties. This, however, is expected near a watering trough.

The trough looks dilapidated and ineffective due to unattached tubing, possibly done after cattle had left.

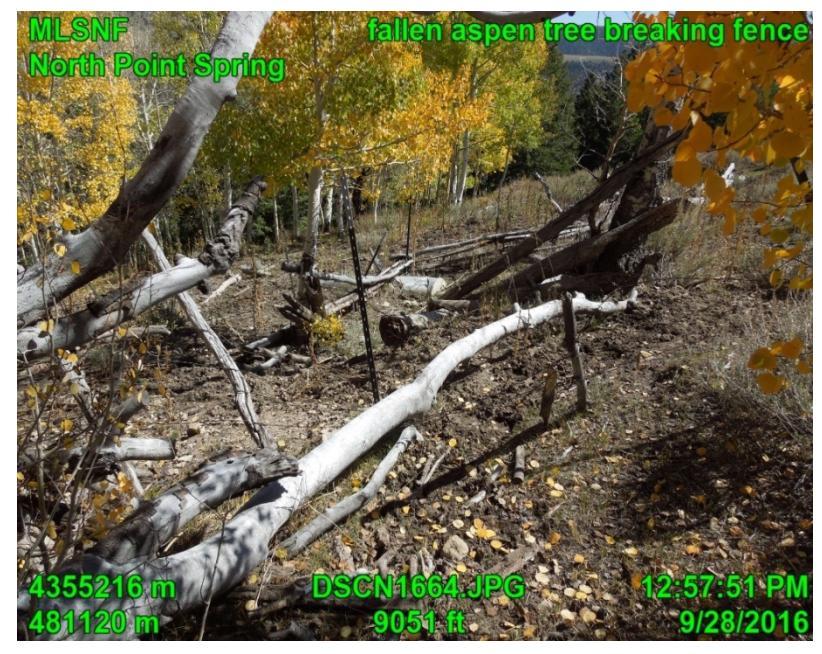
Fig. 4. A fallen aspen has broken the wire fence

The North Point Spring is in a disappointing state. The spring seems to have been previously maintained, as there are signs of two separate fence attempts (one with wood and one with barbed wire). The fence needs to be repaired, as two fallen aspen have collapsed the fencing in two locations (Figs. 4, 5). This has led to a browsed interior, as well as many observed cow patties and cattle hoof prints.

The fence needs to be repaired, due to aspen having broken the fencing in two places

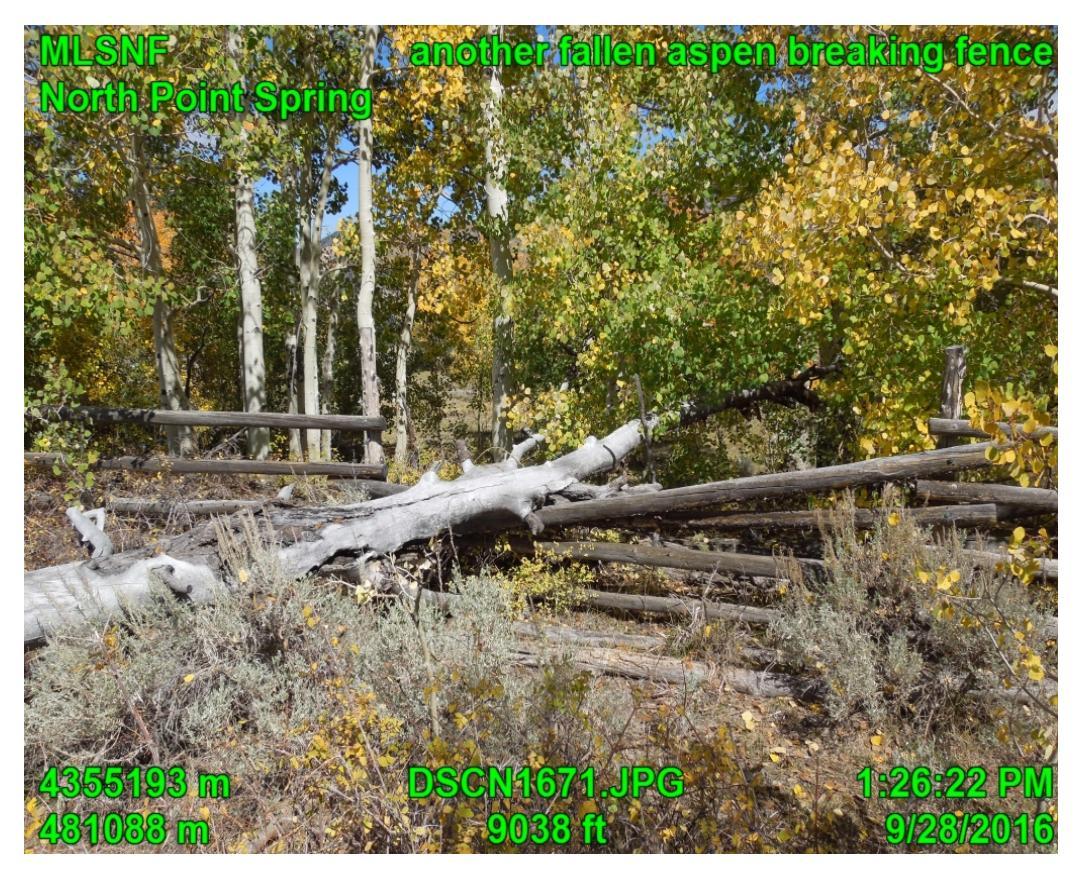
Fig. 5. A second aspen has broken the log fence
