Pack Creek Spring Condition Assessment

Location: Pack Creek Spring, Dorry Allotment, Dorry Canyon Pasture, Manti-La Sal National

Date: September 25, 2016 Begin/End Time: 1:15pm to 2:20pm

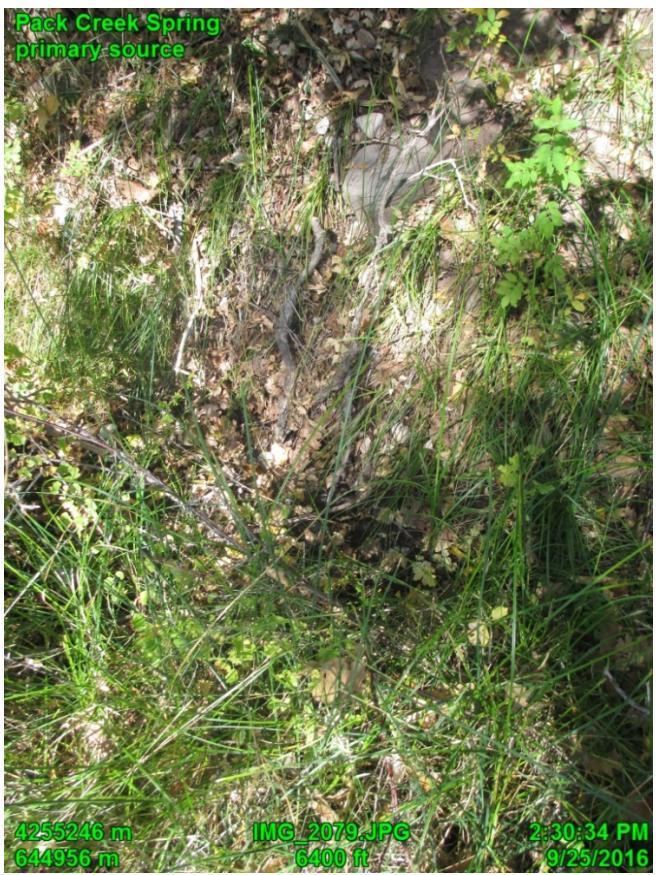
Fig. 1: Primary spring source flowing into stream

The spring complex consists of a primary source (Fig. 1), secondary source (Fig. 2), and outlet into a creek (Fig. 3). Both the primary and secondary sources consist of moderately flowing perennial surface water. Together they flow downslope, feeding a small flowing stream that empties into an outlet in a larger creek (Fig. 4). No water infrastructure was observed. The riparian area of the Pack Creek Spring was considered to be one microhabitat as the vegetation and water presence were relatively consistent throughout the smaller spring stream and its sources.

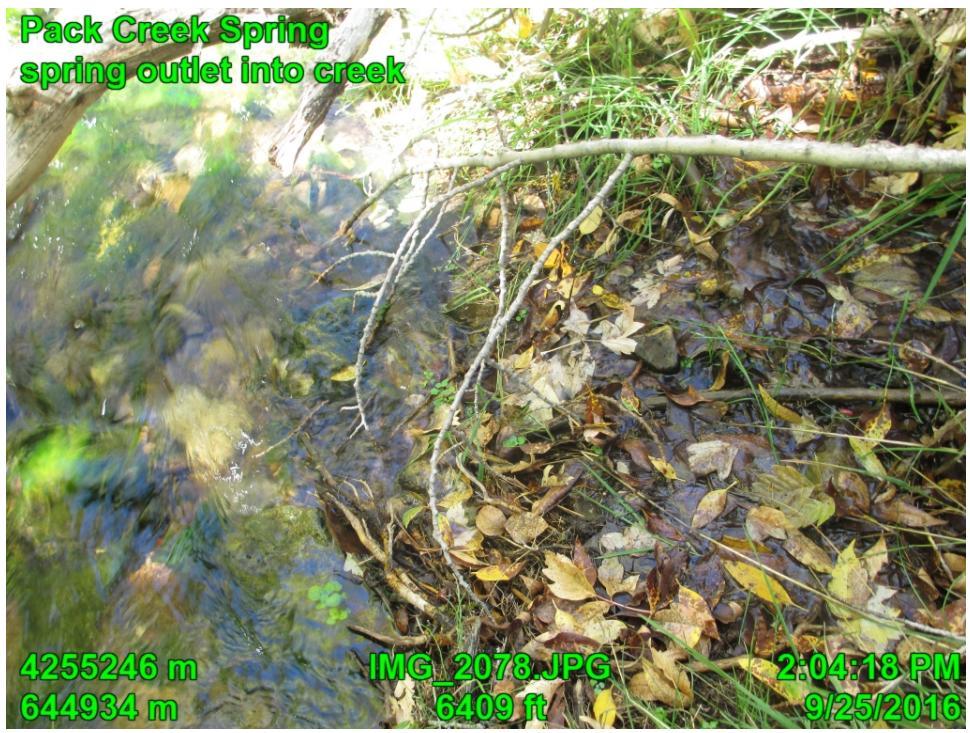
Fig. 3: Spring stream outlet into larger Pack Creek

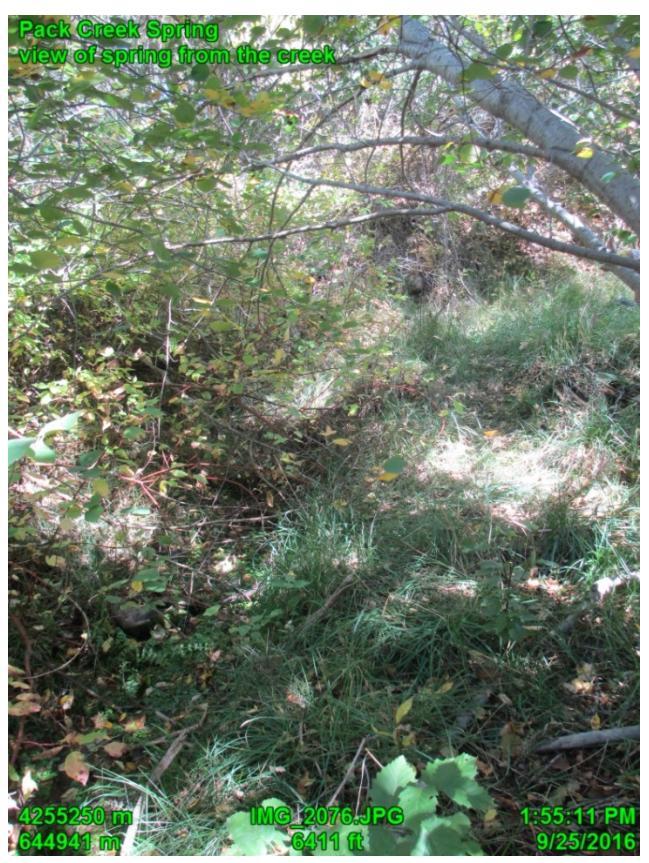
Fig. 4: Overall view of spring stream that flows into larger Pack Creek

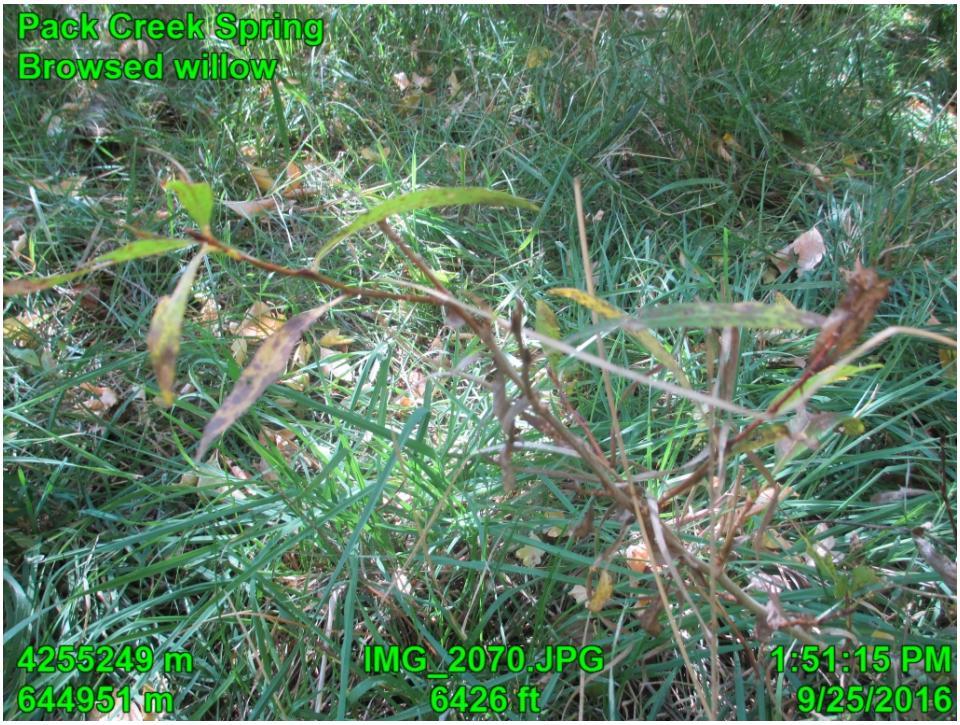
Fig. 5 Browsed willow and trampled grass near creek

Both the primary and secondary spring sources show evidence of moderate browsing/grazing that resulted in some degradation to the spring site. In particular, Wood's rose and the willows that had not yet reached recruitment height were heavily browsed and stripped of leaves. Several willows above recruitment height were browsed below the six-foot mark (Figs.5,6). Evidence of moderate trampling was observed throughout the riparian area and spring outlet. In terms of human usage, trash (plastic bottles, broken glass, razor blades, and a diaper) was observed in the vegetation of the riparian zone and surrounding wooded areas. It is possible that there is more trash at this spring because it adjacent to a day-use picnic area.

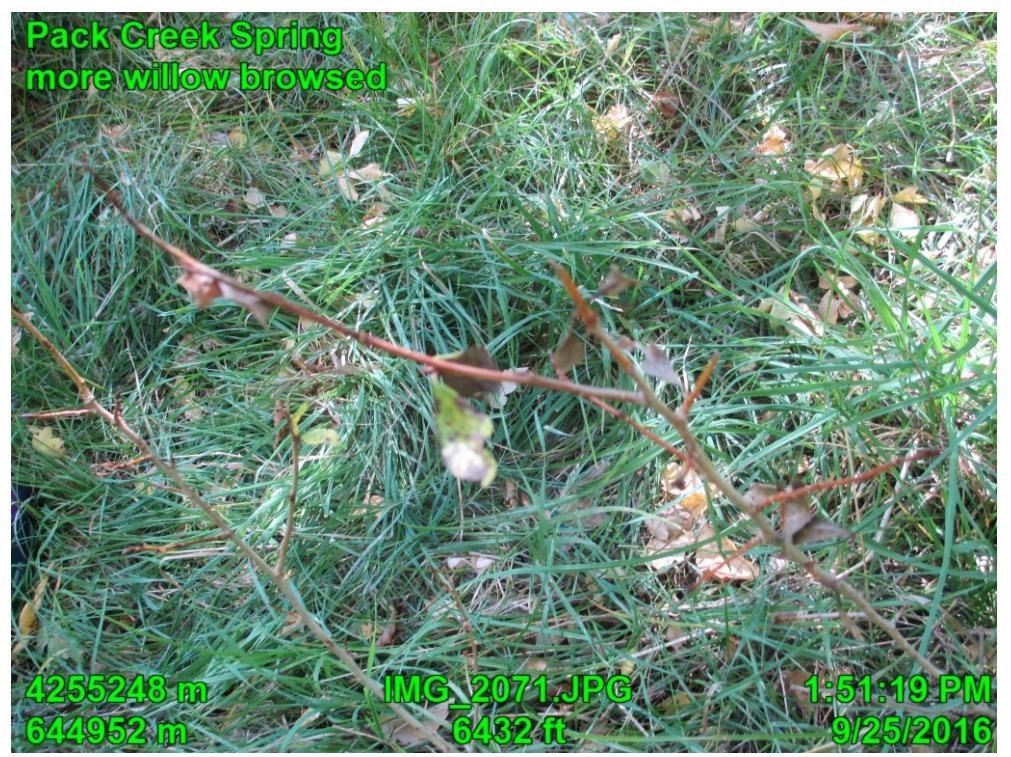
Fig. 6: Browsed willow and trampled grass near stream

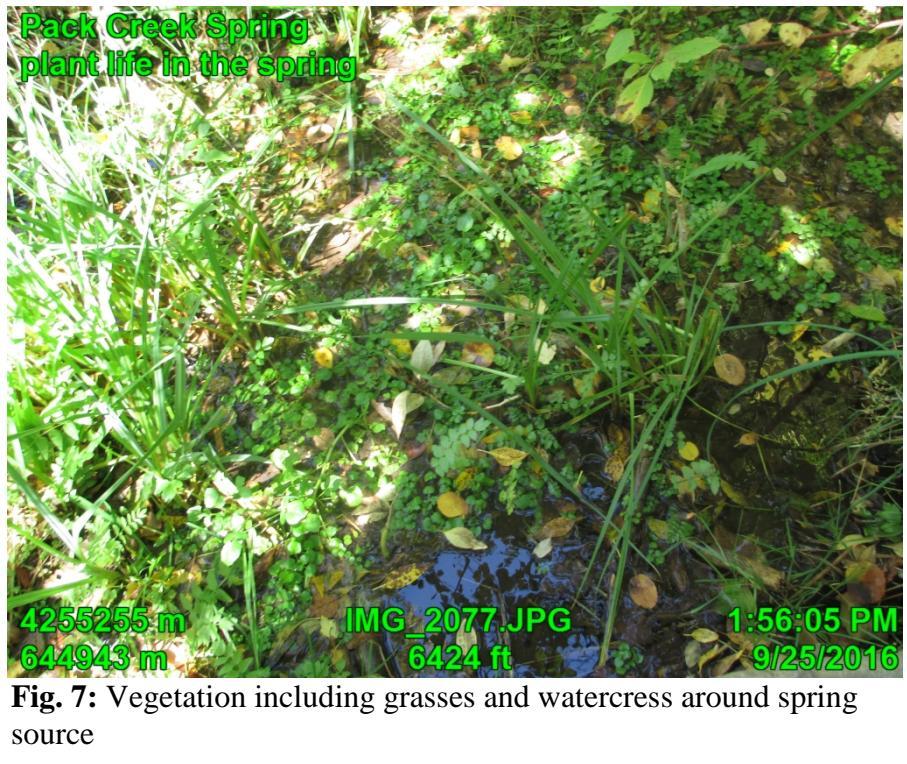
The most abundant vegetation around the source of the spring is grasses and rushes (Fig. 7). Mosses were scattered streamside as well as the exotic watercress (*Nasturtium officinale*). Also common around the source are willow, Woods' rose (*Rosa woodsii*), poison ivy (*Toxicodendron radicans*) and a midsize red osier dogwood (*Cornus sericea*). Mature trees populate the area near and surrounding the spring including cottonwood (*Populus fremontii*) water birch (*Betusa occidentalis*) and western serviceberry (*Amelanchier alnifolia*). These tall trees provide shade to the lush understory and stream that makes up Pack Creek Spring.
