Lackey Basin Spring Condition Assessment

Location: Buck Hollow Pasture, La Sal Allotment, Manti-La Sal National Forest

Date: September 25, 2016 **Time:** 1:54 pm to 4:22 pm

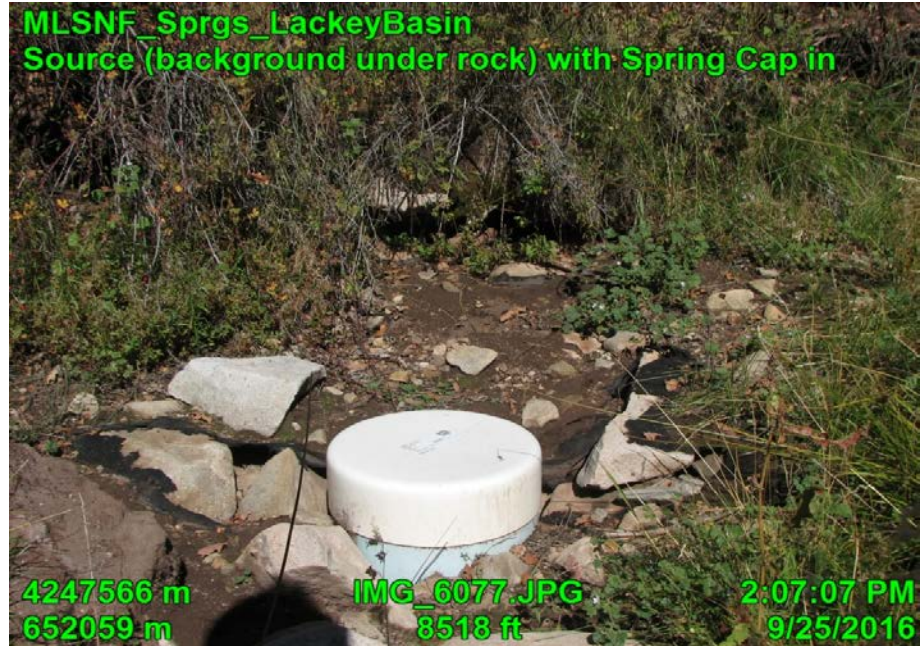
Fig. 1: Source beneath rock (top center), w/ capped spring containment in foreground

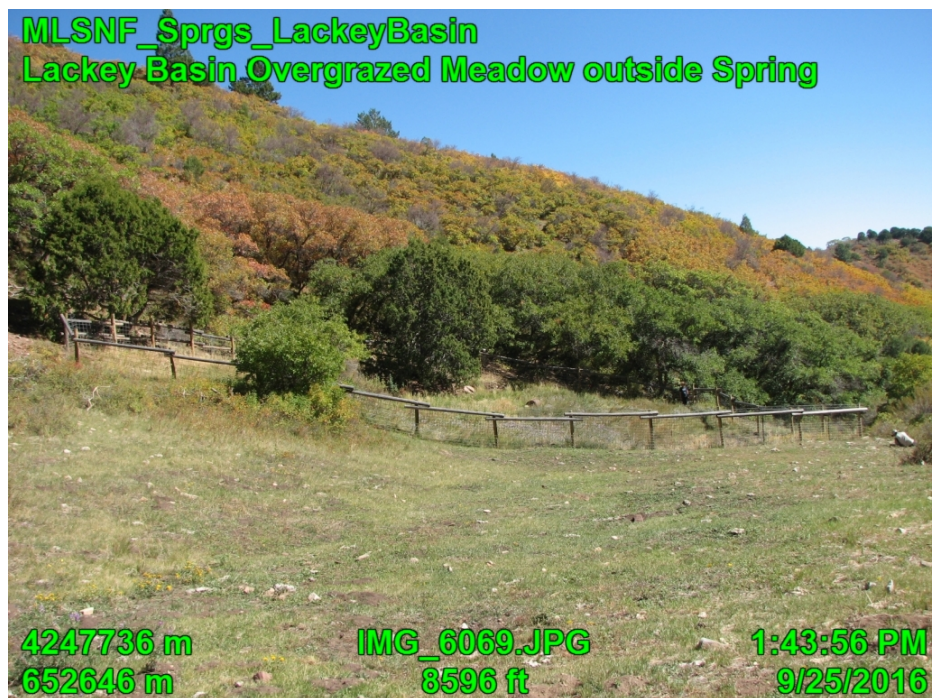
Fig. 2: Overview of spring enclosure, overgrazed meadow in foreground

Although the spring enclosure, a sturdy hog-wire fence, appeared to be effective at keeping cattle away from the source of the spring, this spring was also so heavily diverted that very little flow from the spring was able to reach the surface to provide spring habitat. However, the spring's additional moisture zone extends 150 feet northwest upslope of the enclosure, and this meadow, if exclosed from cattle, could offer a diversity of grasses and forbs, important habitat for pollinators. As it is now, this meadow is cropped to the ground.

We recommend extending the fence, which is sturdy and effective, to include the grassy meadow directly northwest of the enclosure. If not grazed, this isolated meadow otherwise would provide important habitat for wildlife, especially pollinators.

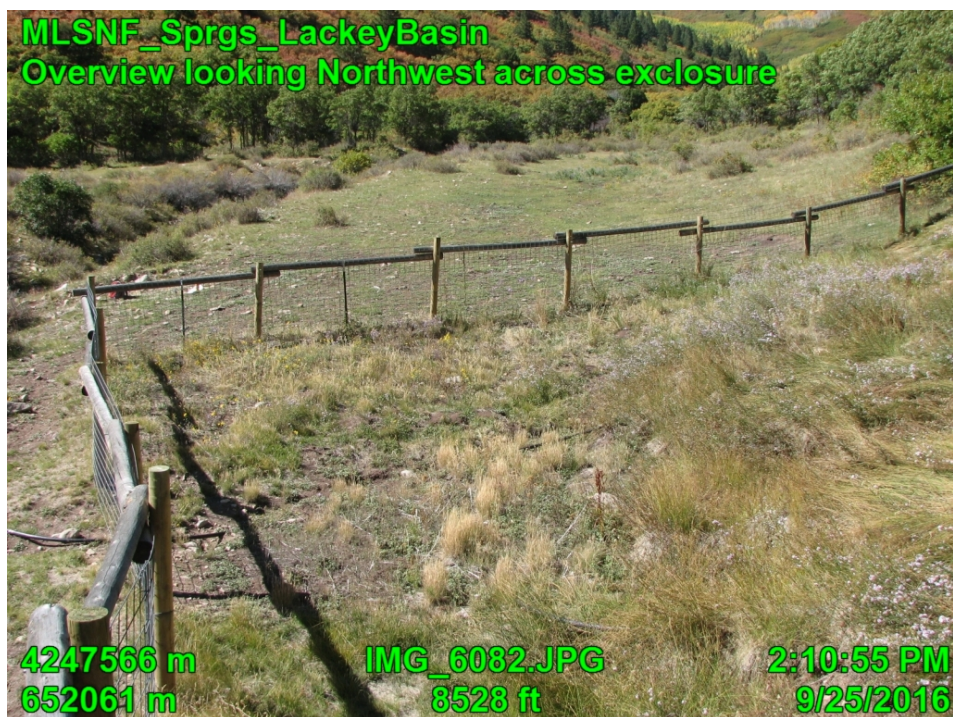
Fig. 3: Overview of enclosure, from SE corner, looking NW toward grazed meadow outside enclosure (spring source right of captured scene)

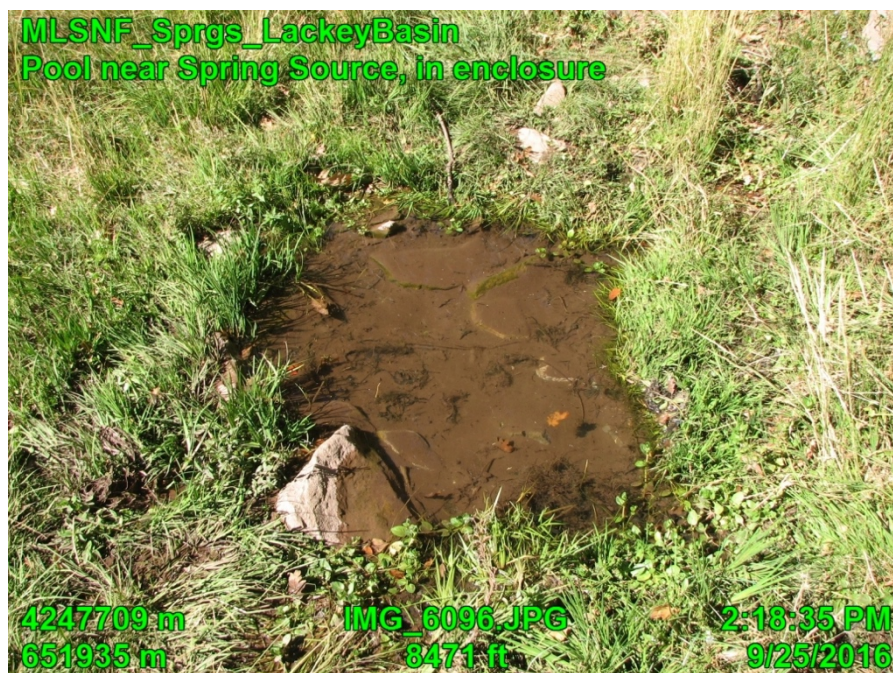
Fig. 4: Isolated pool within enclosure, near spring source, slightly lower than original source (possible second source?)

No noticeable water flow was observed at the spring, but the small pool within the enclosure, the damp ground beneath a low rock ledge at the source, and the cistern lower down the valley all appeared to be perennial water sources. Water was flowing from the fully diverted spring through a pipe a quarter mile down the valley to a large, overflowing cistern.

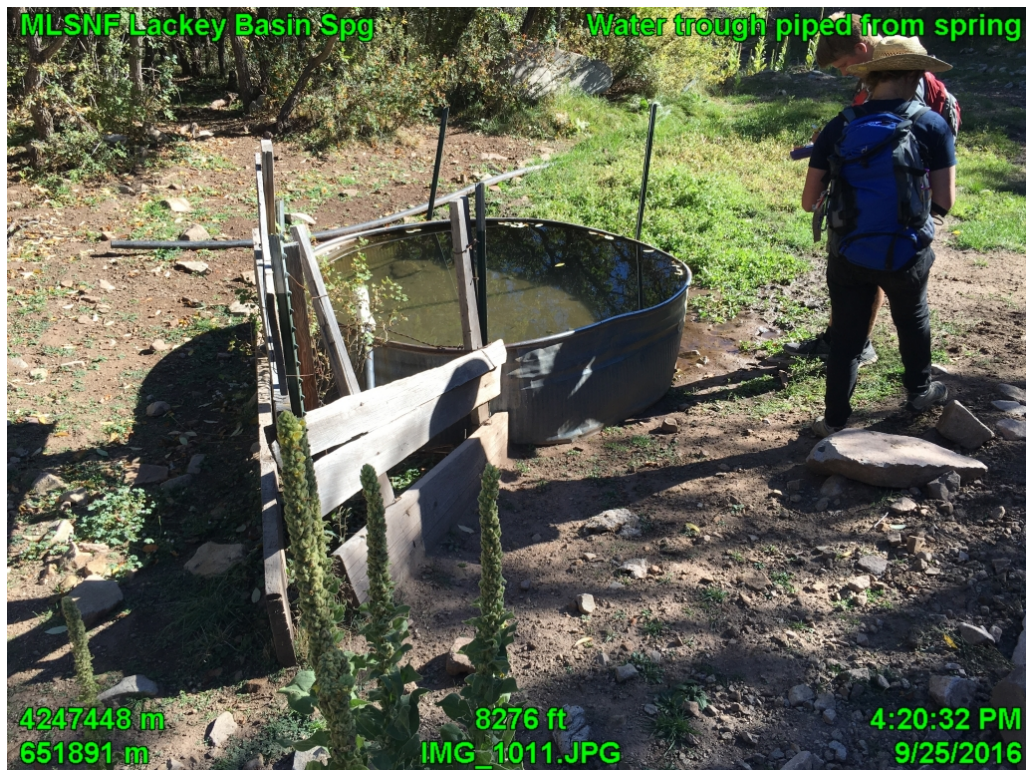
Fig. 5: Overflowing cistern, down valley from spring

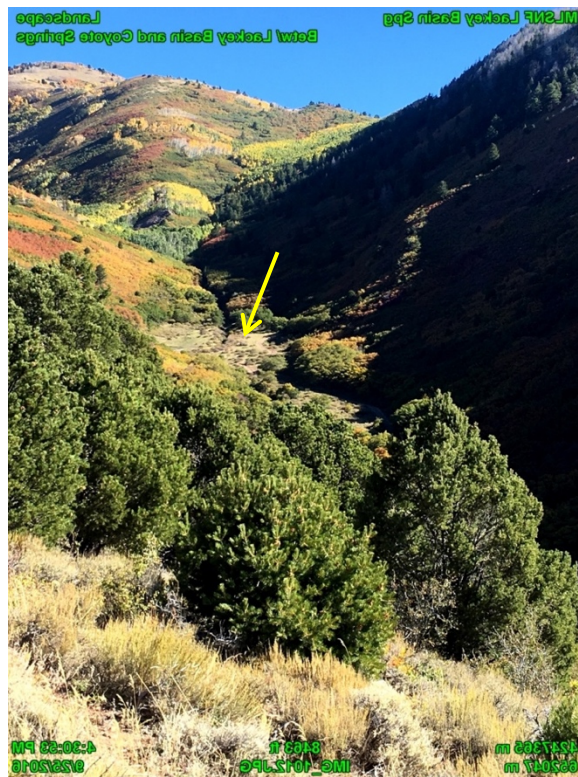
Fig. 6: Overview of valley, showing small grassy meadow (yellow arrow) surrounded by thick oak and juniper
