# **Lower Pinhook Spring Condition Assessment**

**Location:** Castle Valley Allotment, Manti-La Sal National Forest

**Date:** September 23, 2016    **Begin/End Time:** 10:30am to 12:30pm

Whitman College Semester in the West (20 students)

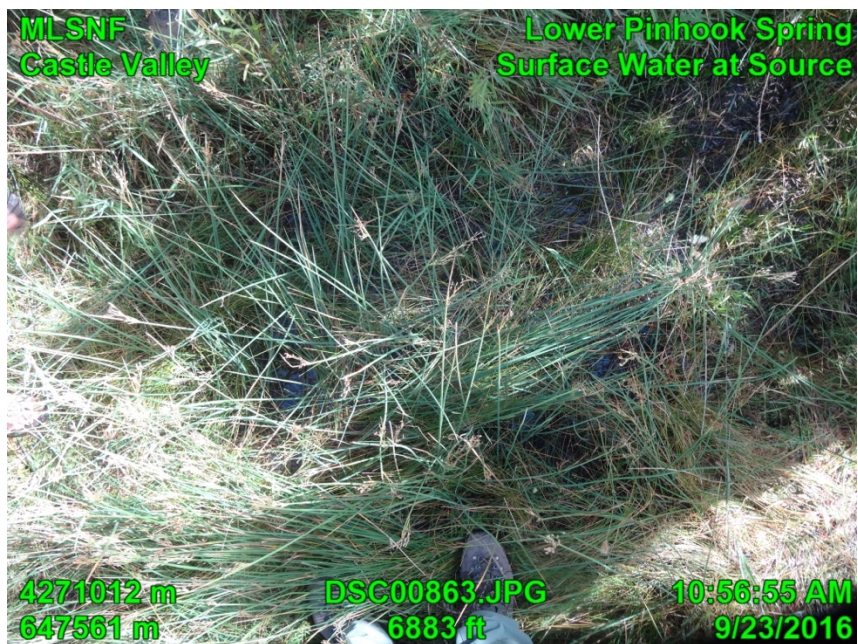
*Fig . 1 Spring source*

Within the enclosure, surface water was present at four locations: a, source pool (Fig. 1), lower pool (Fig. 2), intermittent pool (Fig. 3), and creek (Fig. 4). The source pool and lower pool contained non-flowing surface water and were approximately the same surface area. There was no surface water present in the intermittent pool, but it showed signs of intermittent water presence. The creek flowed through dense vegetation from near the cistern (see map) downslope to the edge of the enclosure.

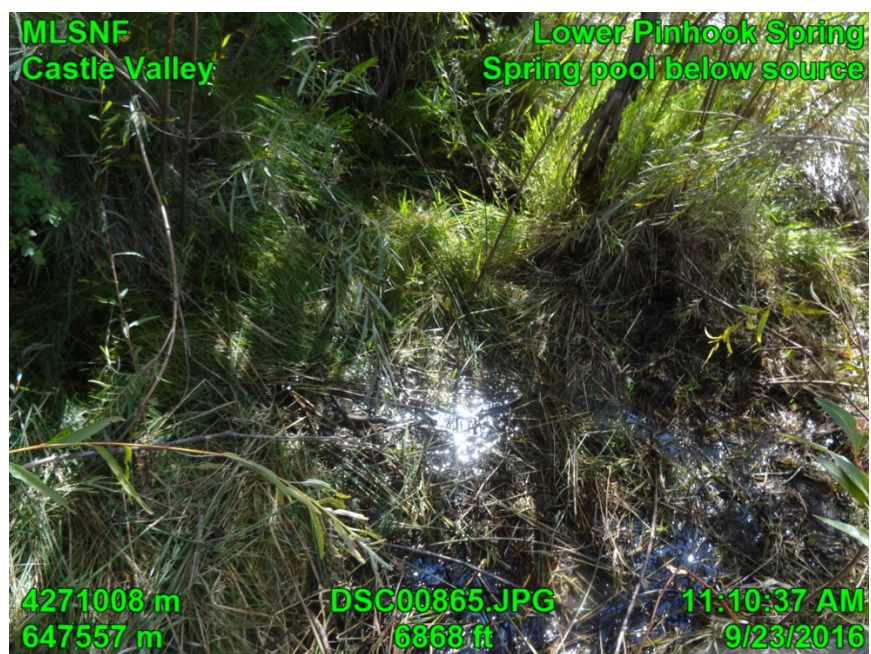
*Fig. 2: Lower pool*

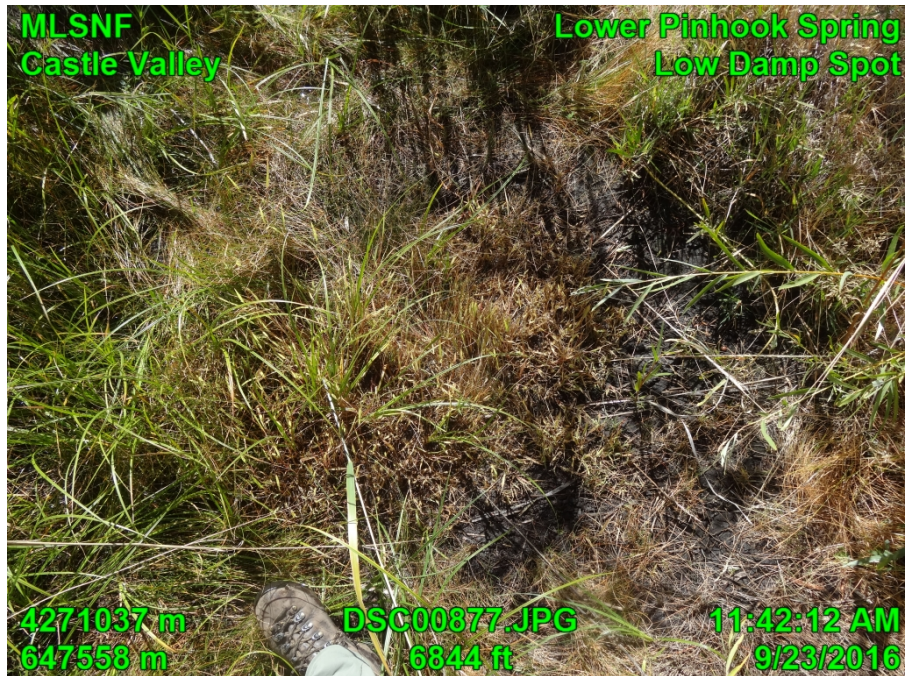
*Fig. 3: Intermittent pool*

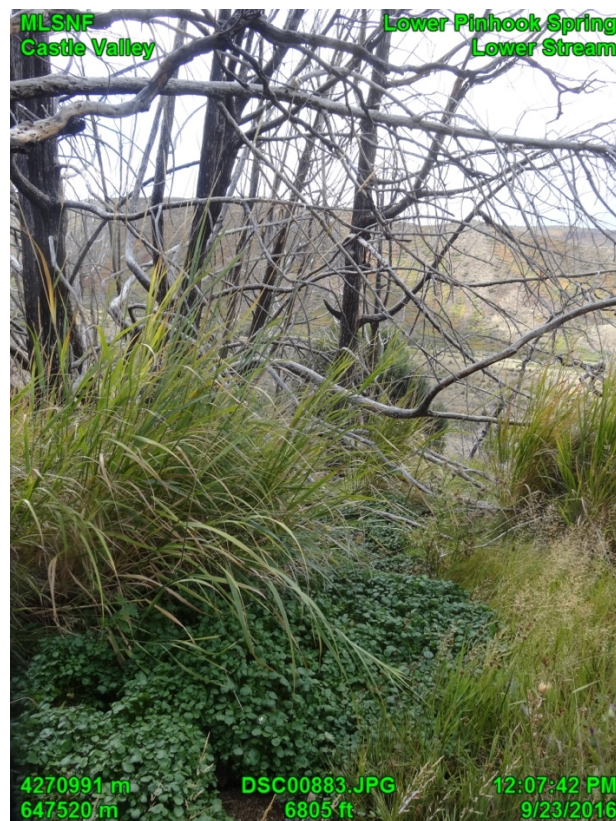
*Fig. 4: Stream with burned trees in overstory, Great Basin wildrye below and exotic watercress as groundcover near and on water*

northern bedstraw, *Galium boreale*), shrubs (including Woods' rose, *Rosa woodsii*), Mountain willow (*Salix monticola*), and horsetail (*Equisetum* sp.). The enclosure was also home to small populations of non-native species including watercress (*Nasturtium officinale*, Fig. 4), Burdock (*Arctium minus*) and an exotic thistle.

Based on the assessment performed, the stream appears to be in relatively good health, within the enclosure, with the exception of the presence of non-native species (e.g., watercress). There was some evidence of human travel both inside and outside the fenced enclosure. The area surrounding the livestock trough displayed a markedly higher rate of degradation than that of the area within the enclosure. The damage observed included trampling, soil compaction, grazing/browsing, and non-native plants-- a stark contrast with the dense Coyote willows and Gambel oaks of the riparian area. Within the enclosure, there is no channeling or surface erosion, and these factors, combined with the presence of Great Basin wildrye and Coyote willow, indicate a healthy stream ecosystem. The small amount of ungulate browsing within the fence did not seem to impact the spring. The ratio of nonnative to native species, too, is not large enough to warrant concern about the overall health of the spring ecosystem.

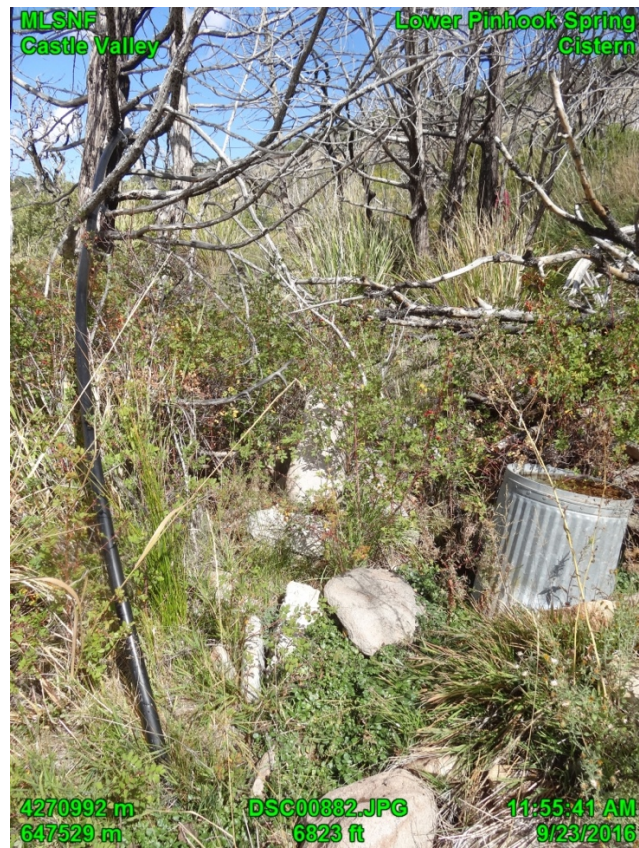
*Fig. 5: Cistern with pipe*

Within the enclosure, adjacent to the stream, there was a single cistern connected to a plastic pipe (Fig. 5). Outside the enclosure there was a livestock trough fed by a steady flow of water from a pipe (Fig. 6).

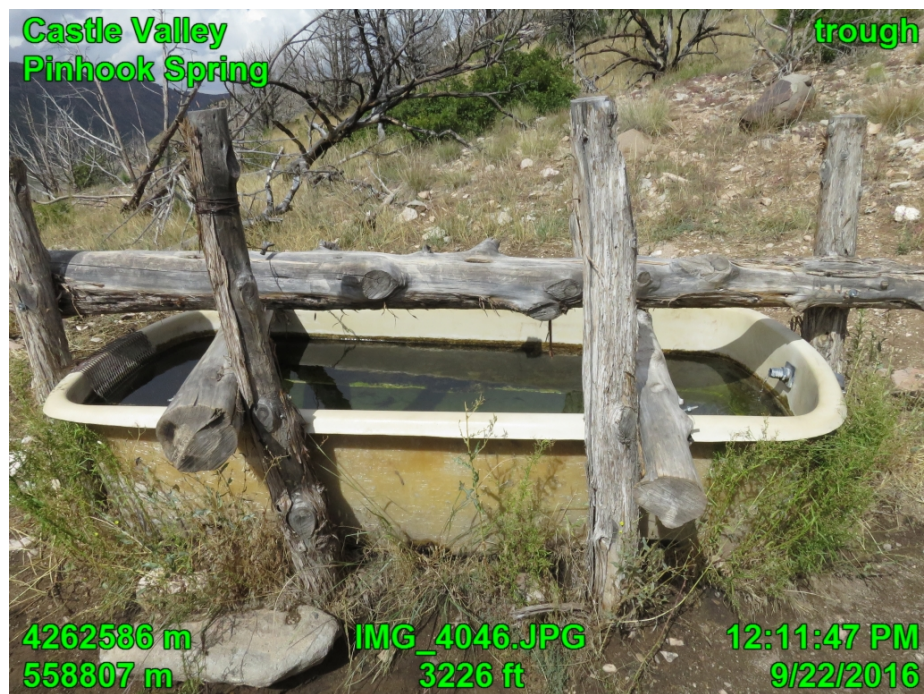
*Fig. 6 Trough outside exclosure; critter ramp on left*

The livestock trough outside the enclosure experienced the largest disturbance of the overall spring area, with trampling, browsing of vegetation and compression of soils around the structure. Non-native prickly lettuce (*Lactuca serriola*) is common outside the enclosure.

In order to maintain a healthy spring, continue maintenance of the fence. When the surrounding pasture is not being grazed, move the water from the trough back into the spring system.

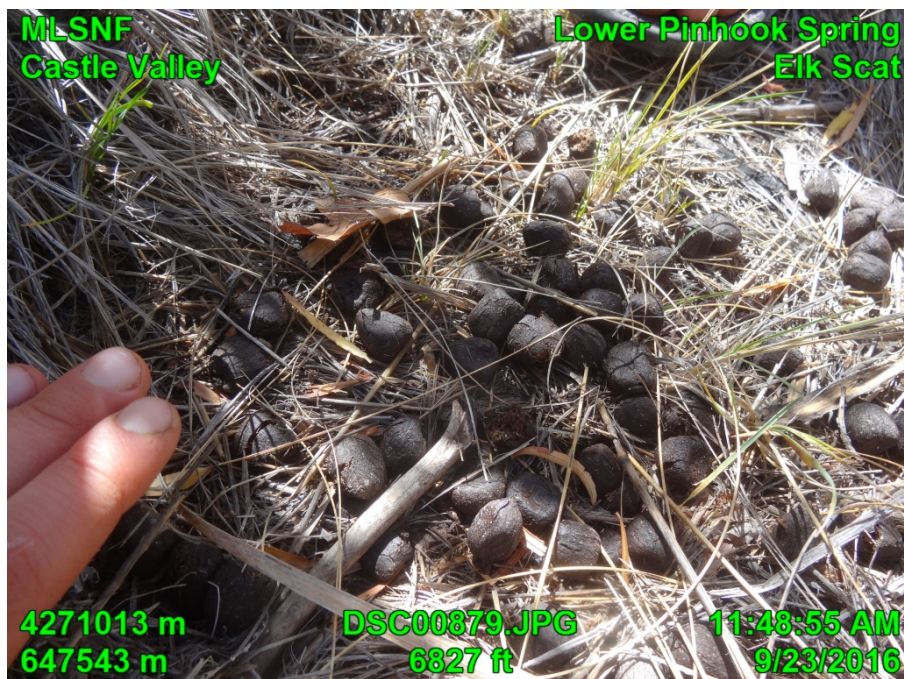
*Fig. 7 Elk scat*

Within the enclosure, there was evidence of several species of wildlife. The more prevalent species, identified by their scat, were American Elk (*Cervus canadensis*, Fig. 7) and Mule Deer (*Odocoileus hemionus*, Fig. 8) and Black Bear (*Ursus americanus*, Fig. 9). Various birds were identified by their calls, including the Black-billed Magpie (*Pica hudsonia*) and Common Raven (*Corvus corax*). An injured Vole (*Microtus* sp.) was also found.

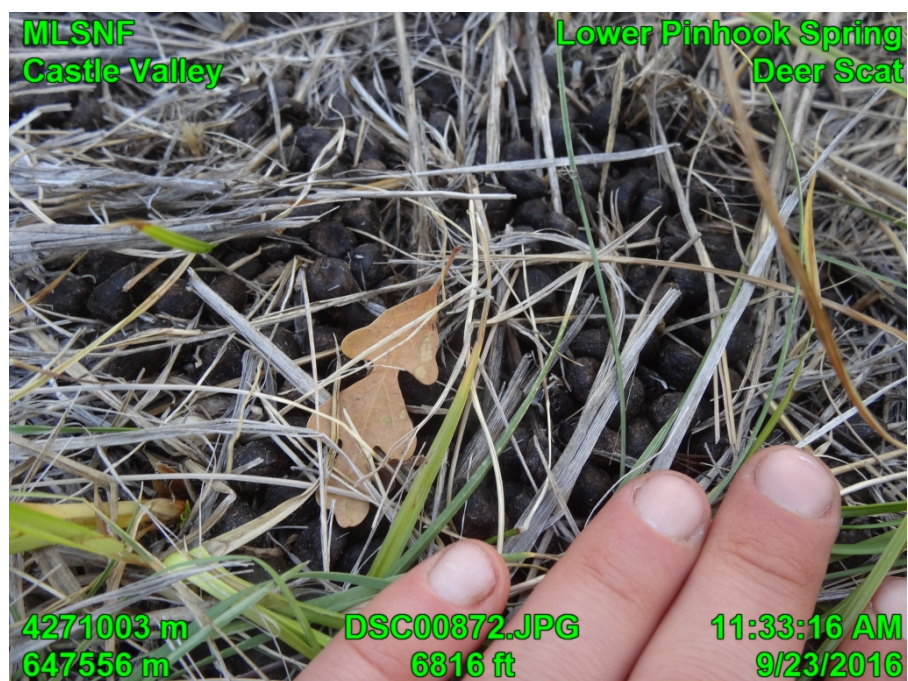
*Fig. 8 Mule deer scat*

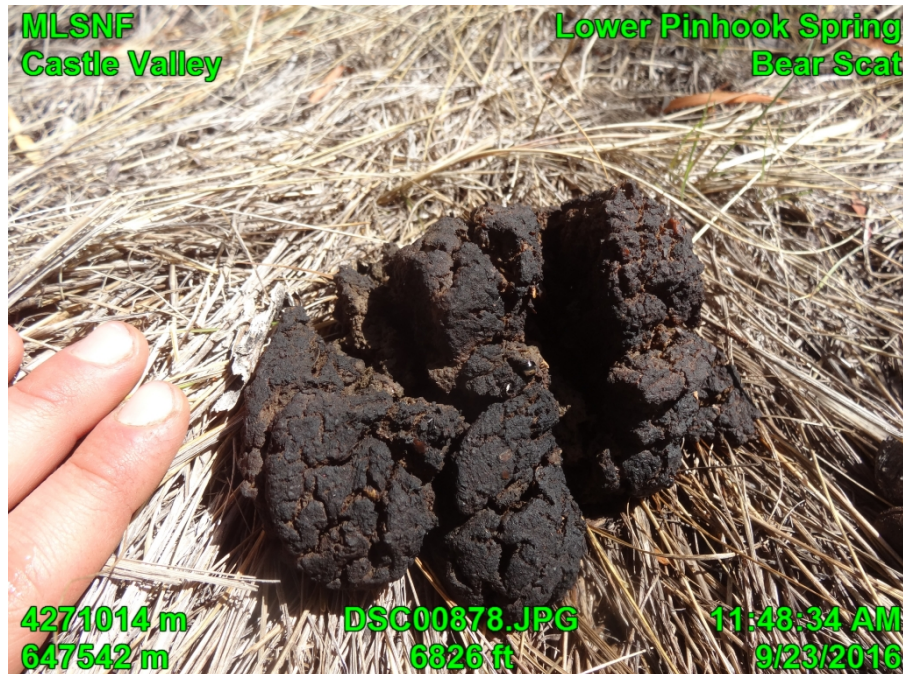
Fig. 9: Black Bear scat
