# Mason Draw Spring Condition Assessment

**Location:** Mason Draw Allotment, Manti-La Sal National Forest

**Date:** September 25, 2016    **Begin/End Time:** 12:30pm to 2:00pm

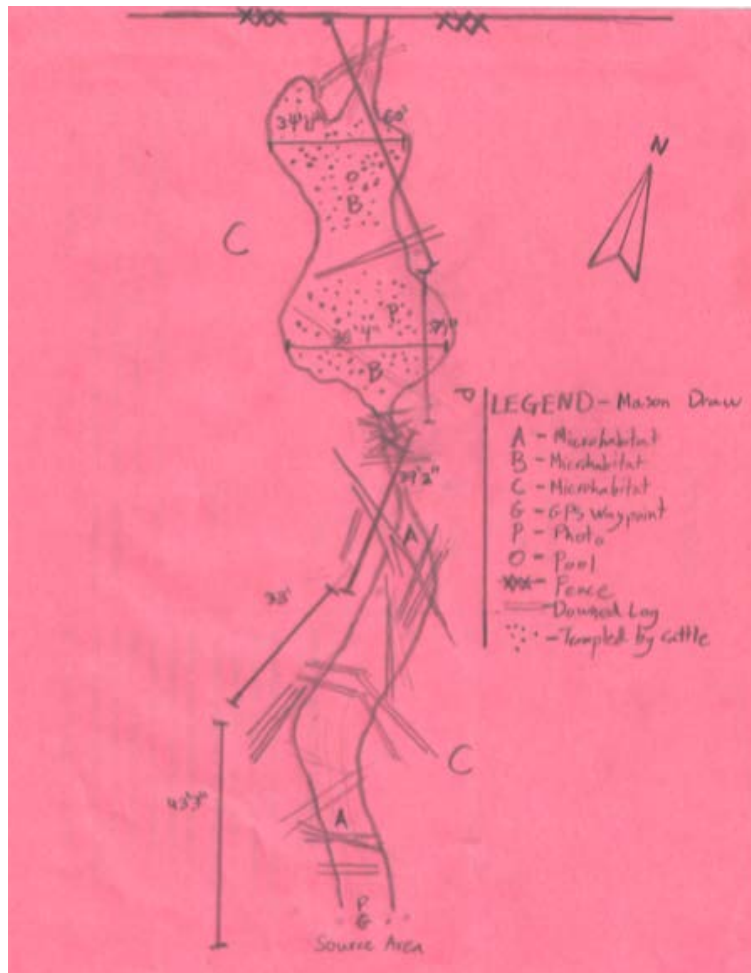
Mason Draw Spring is located close to the Loop Road on Mason Draw Allotment in the Manti-La Sal National Forest at E 0647896, N 4267291 with an elevation of 8,385 feet. The upper area of the spring is covered with downed logs, very dense shrubs, and other vegetation. No surface water was seen in the surrounding area of the spring, implying the source is intermittent. The lower part of the spring has been affected by grazing and browsing cattle, evident by the abundant bare ground, grazed vegetation, cow manure, and hoof prints dominating an approximate 30 square foot area. The spring is approximately 30 yards outside of a nearby fenced campground (Fig. 1).

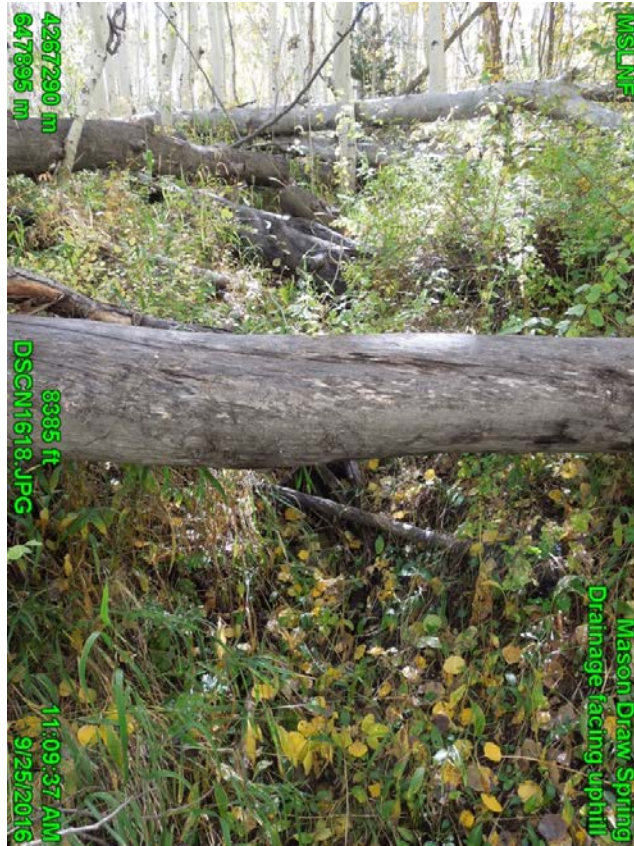
Fig. 2. Approximate site of source

Mason Draw Spring has a non-vegetated lower spring area. The source of the spring could not be identified, as no water or moist soils were found at the coordinates supplied for the source. Thus, a site was located as the most likely source, as it was very vegetated, within the proper drainage, and closest to the set of coordinates. This upper drainage was covered by downed wood and shrubs but was somewhat eroded and had less vegetation within the actual drainage. The outside area (surrounding the drainage) was healthy with many aspens and decomposing downed trees.

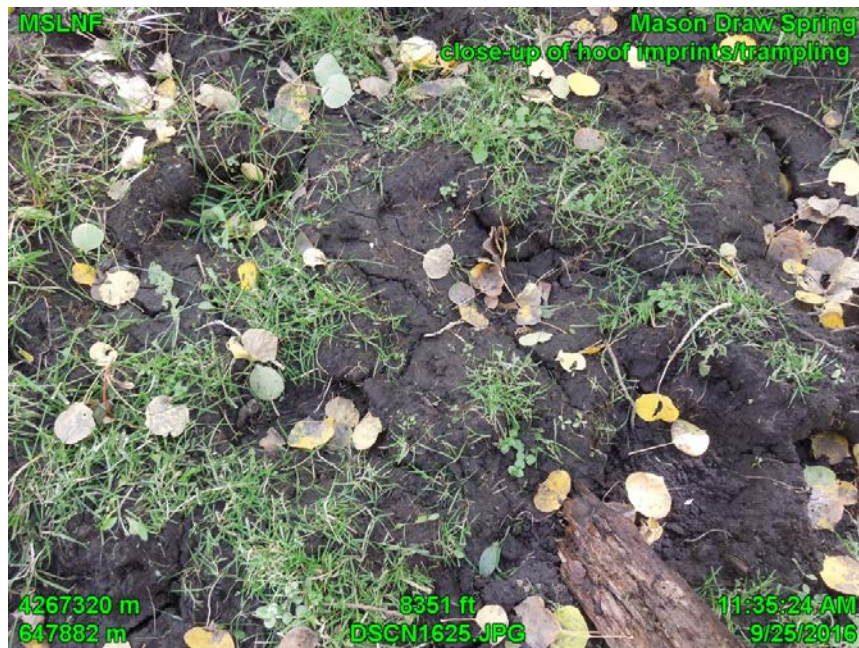
Fig. 3. Lower trampled microhabitat (appx. 30 square feet)

Microhabitat C was largely barren but had some browsed juvenile aspen, western wheatgrass (*Pascopyrum smithii*), non-native, invasive creeping bentgrass (*Agrostis stolonifera*), uncommon, native Great Basin wildrye (*Leymus cinereus*), and Scouler's willow (*Salix scouleriana*), . The microhabitat also included scattered, non-native stinging nettle (*Urtica dioica*).

The lower drainage was a stark contrast to the upper drainage. It was extremely bare and muddy with hoof prints covering the area. We determined that both the upper and lower drainage microhabitats had a flow rate of 1 due to it being dry intermittent. Cow manure was found covering the ground, introducing bacteria to any natural spring that would pass through. The vegetation, mostly aspen, was browsed by ungulates.

.The lower drainage area at Mason Draw Spring should be fenced .This would prevent cattle from interfering with the spring system and stop any further erosion and loss of vegetation.

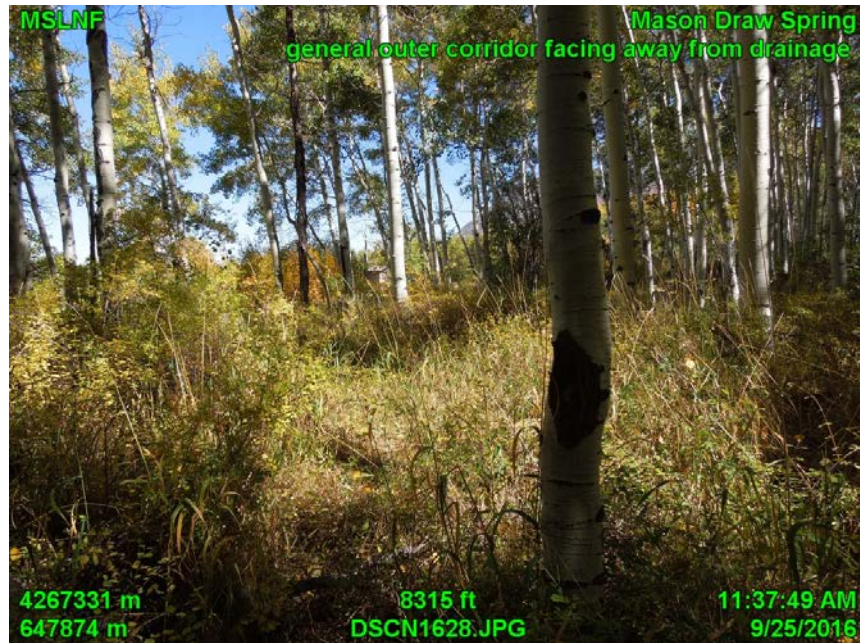
Fig. 4. Outer microhabitat

Microhabitat B dominantly held aspen, more dead and downed trees, as well as native Great Basin wildrye (*Leymus cinereus*).

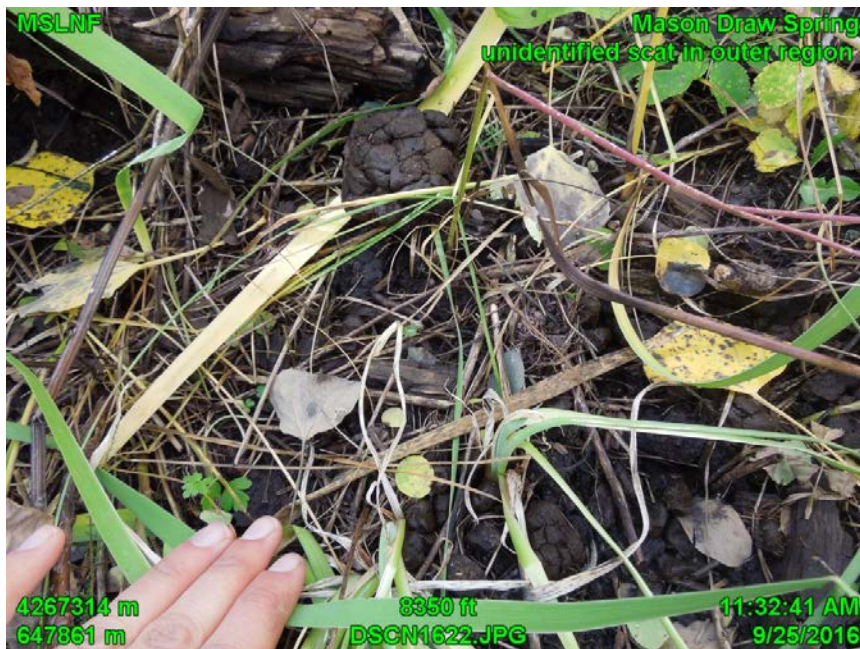
Fig. 5. Elk scat

**Wildlife evidence.** Deer and elk (Fig. 4) scat were found outside the drainage in the outer microhabitat. Cow manure and cattle hooves were observed within the lower drainage microhabitat (Fig. 2).
