Spring 243 Condition Assessment

Location: North Trail East Pasture, Trail Mountain Allotment, Manti-La Sal National Forest

Date: September 28, 2016 **Begin/End Time:** 1:17pm to 2:30pm

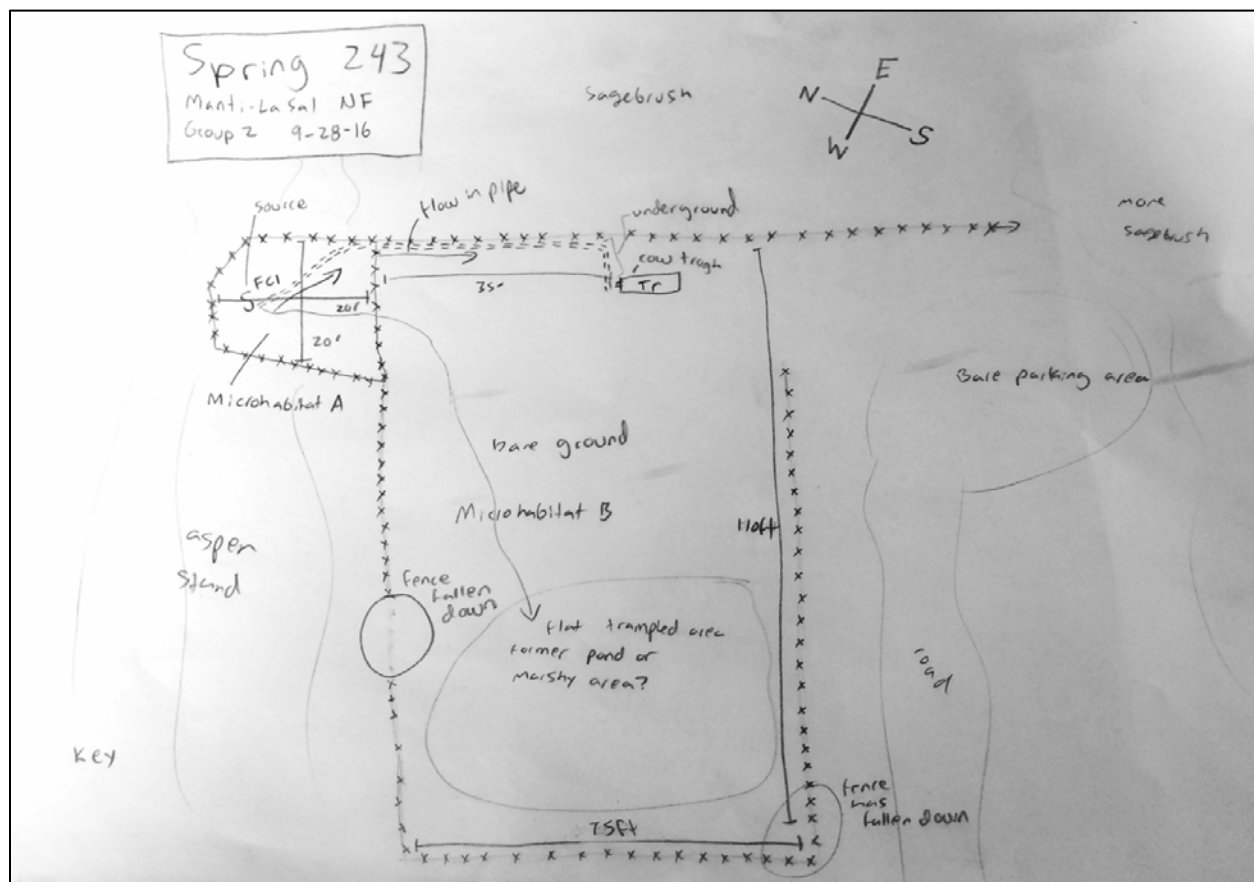
Fig. 1 Sketched map of spring 243

The purpose of this report is to assess the condition of Spring 243 in the North Trail East pasture of the Trail Mountain allotment in Manti-La Sal National Forest. The spring is located on the Wasatch Plateau in a valley that leads into Upper Joe's Valley from the east (NAD 83 UTM coordinates: Zone 12S, 480907m E, 4361419m N), at an elevation of approximately 9156'.. Water emerges from a small outcrop of sandstone at the base of a hill cloaked in aspen and is immediately diverted into a plastic pipe that leads to a livestock trough about 50 feet downslope. The spring outlet and the 20 by 20 foot (~400 ft²) area directly around it are surrounded by a barbed-wire fence that separates it from another fenced area that has several openings, which contains the trough (Fig. 1).
