Citizen Road and Trail Condition Survey and Monitoring Project 2011 Accomplishment Report

Olympic Forest Coalition in collaboration with Olympic National Forest and Great Old Broads for Wilderness Polly Dyer/Cascadia Broadband

Prepared by Shelley Spalding January 2012

Citizen Road and Trail Condition Survey and Monitoring Project 2011 Accomplishment Report January 2012

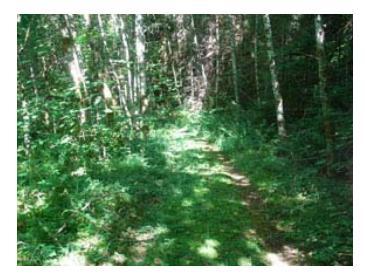
Most of the road was in good condition for conversion to trail with mostly native plants and little sign of dispersed camping. After the first quarter mile the road became a shady trail with lovely wildflowers. It had been used by both hikers and horseriders.

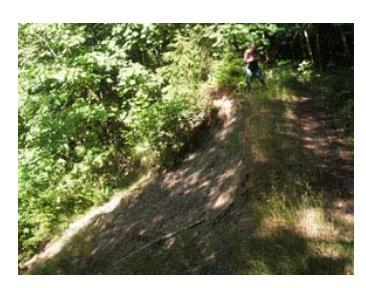
There were two areas on the road with large landslides. The first was within a quarter mile of the beginning of the road and the slide took out at least half of the road bed.

At the end of the road there was a large washout as the stream crossed the road.

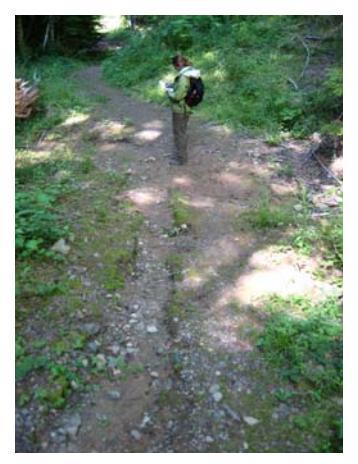
A seasonal creek runs down the trail before draining off the trail and cutting downslope into the ravine beyond the trees.

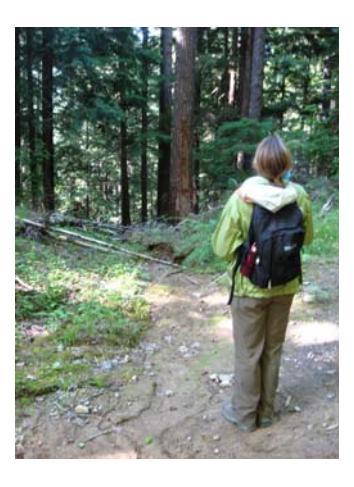
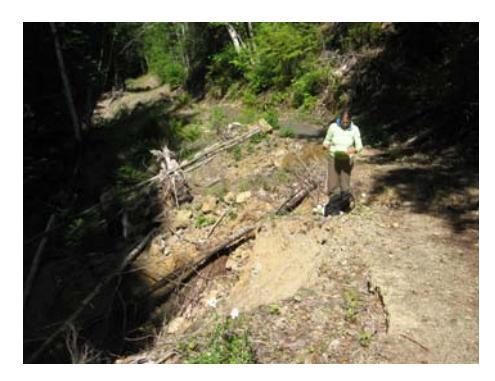
Water from an upslope spring is cutting across the trail and causing extensive erosion, highlighting how unstable fill slopes can be even when converted to a trail.

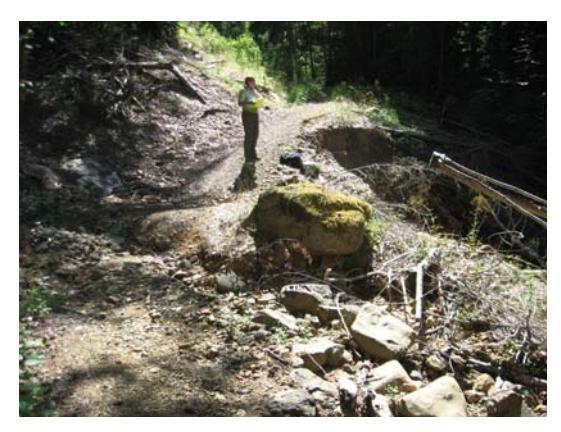
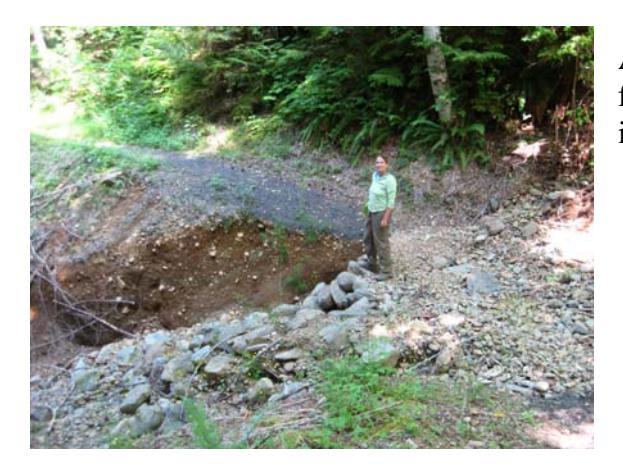
At this last site before the trail enters the forest, there is an upslope rock slide which is down-cutting the margin of the trail.

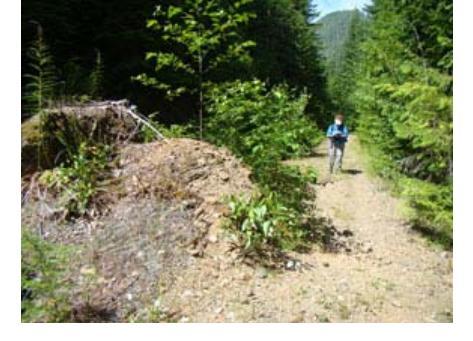
Berm at beginning of road

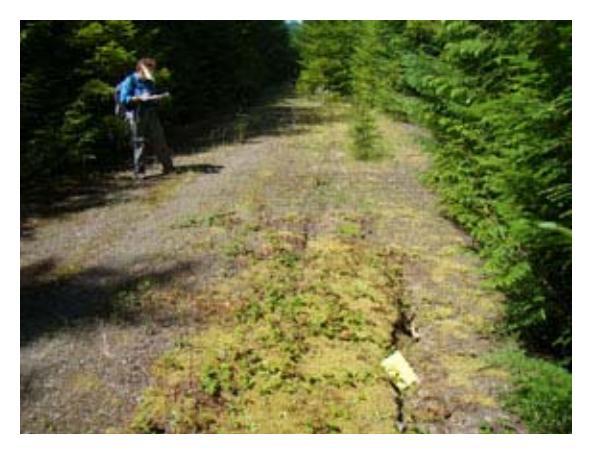
4X6 notebook in tension crack along side road

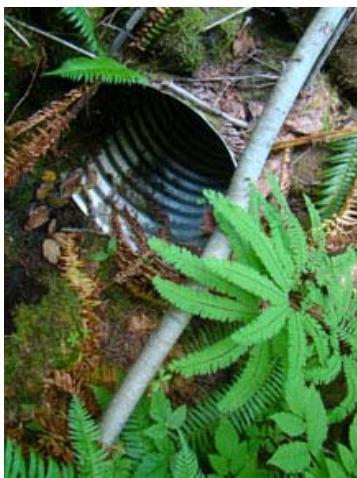
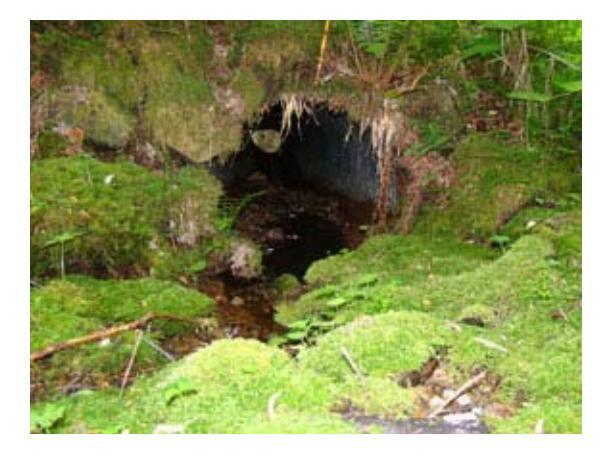
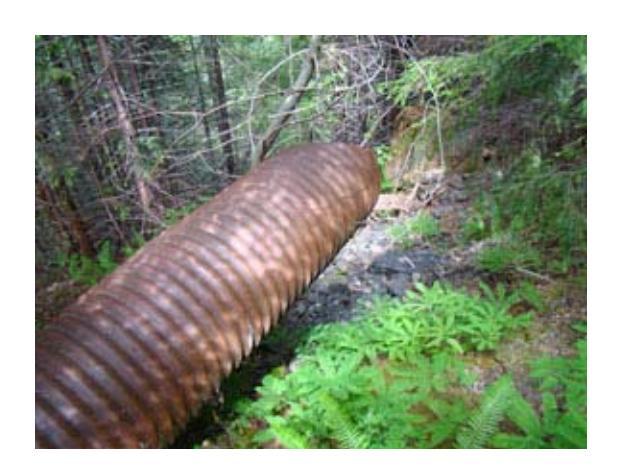
The surveyors noted a dozen culverts in various states of functionality – from fully functioning to fully not-functioning.

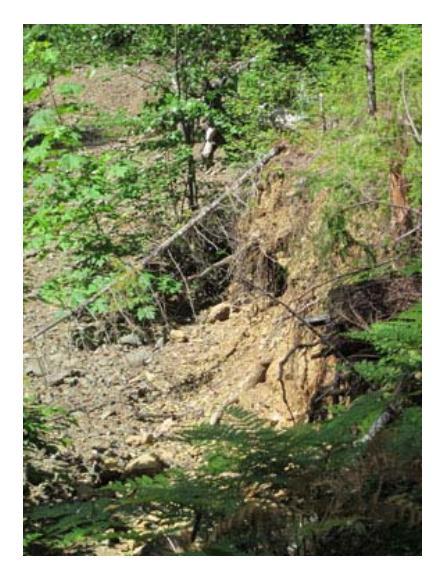
Looking down at culvert inlet. Stream is mostly subsurface. Direction: 150°

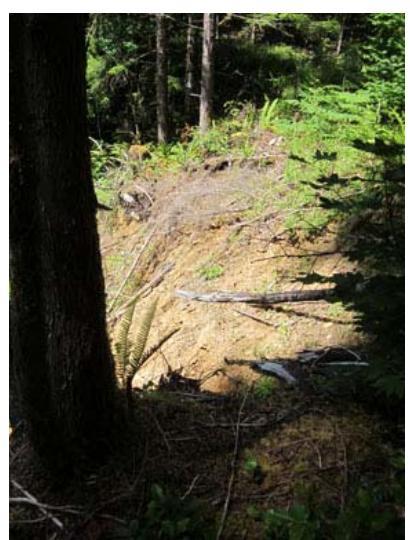
Steep cut on north side of stream showing lots of erosion. Direction: 250°

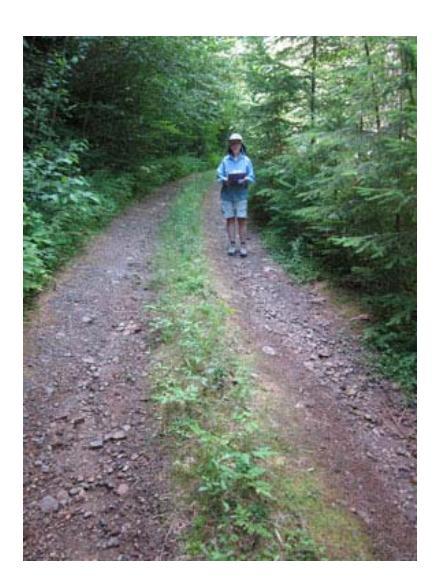
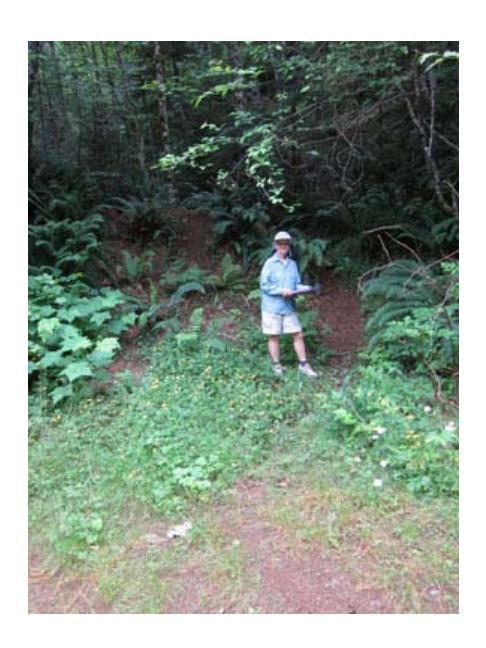
FSR 2351510

As the road becomes steeper, gullies are forming from erosion in the roadbed. At end of the road there were signs of dispersed camping, including a fire ring and trash.

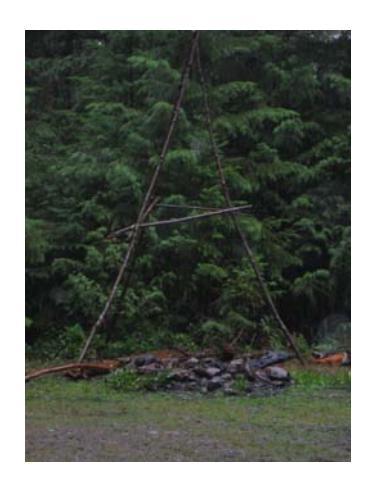
Photo #: 1 Direction: 300° UTM Coordinates: N 47° 26.100' W 123° 23.400' Notes: Dispersed camping area

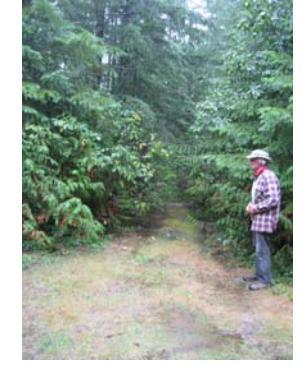
Photo #: __2___ Direction: 300° UTM Coordinates: N 47° 26.100' W 123° 23.400' Notes: road as it leaves the open dispersed camping area.

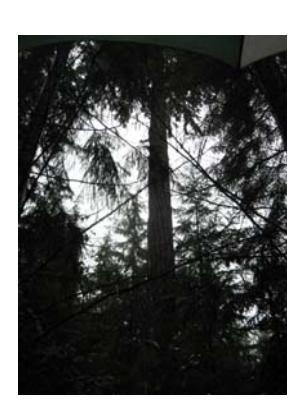
Photo #: 5 Direction: 20° UTM Coordinates: N 47° 26.098' W 123° 23.334' Notes: Very large, late successional douglas fir approximately 35' from road bed

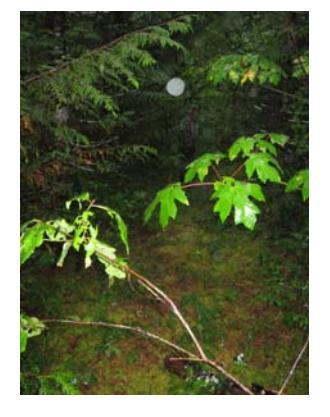
Photo #: 6 Direction: 255° UTM Coordinates: Same as Photo # 5 Notes: Looking downhill as road continues

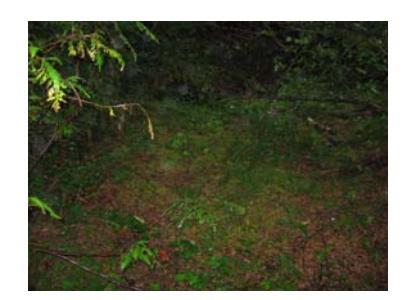
Photo #: 7 Direction: 210° UTM Coordinates: N 47° 26.096' W 123°23.280'

Notes: Looking downhill towards end of identifiable road bed

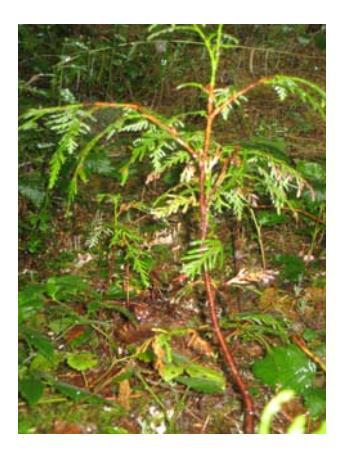
Photo #: 8 Direction: 250° UTM Coordinates: Same as Photo # 4 Notes: Small cedars growing in the roadbed

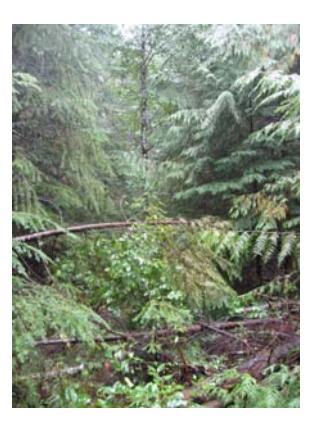
Photo #: 9 Direction: 120° UTM Coordinates: N 47° 26.554' W 123° 25.566' Notes: Descend road down hillside from edge of 2361000

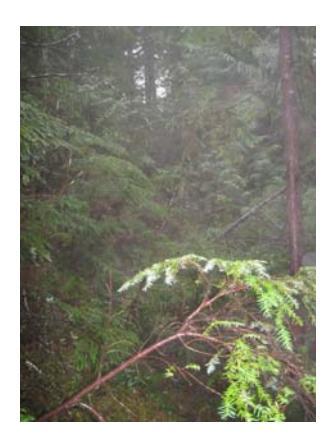
Photo #: 10 Direction: 120° UTM Coordinates: N 47° 26.543' W 123° 25.588' Notes: Road merges with surrounding vegetation and roadbed disappears after a short distance.

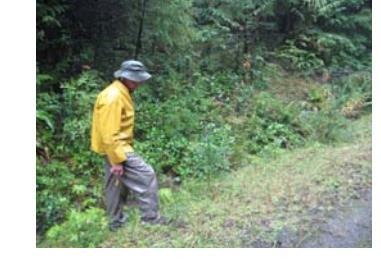
Photo #: _11 Direction: 115° UTM Coordinates: N 47° 26.548 W 123° 25.563' Notes: Possible berm at beginning of the road

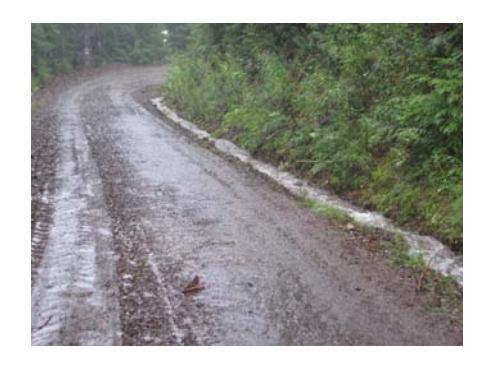
Photo # 15 Direction: 322° UTM Coordinates: N 47° 24.200' W 123° 26.026 Notes: Ditch with clean water runoff

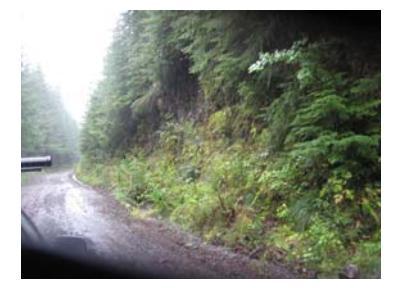
Photo #16 Direction: 305° UTM Coordinates: N 47° 24.392 W 123° 25.789 Notes: Very steep slope adjacent to the road – both uphill (photo) and downhill

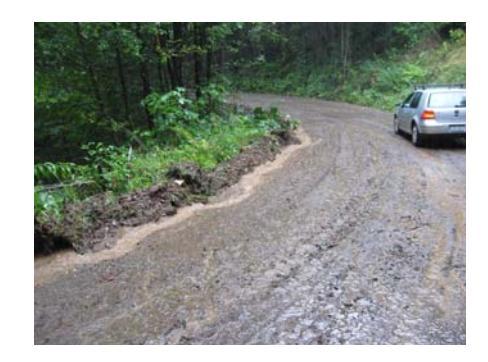
Photo #17 Direction: 355° UTM Coordinates: N 47° 24.519 W 123° 25.507' Notes: Ditch along road with sediment laden run-off

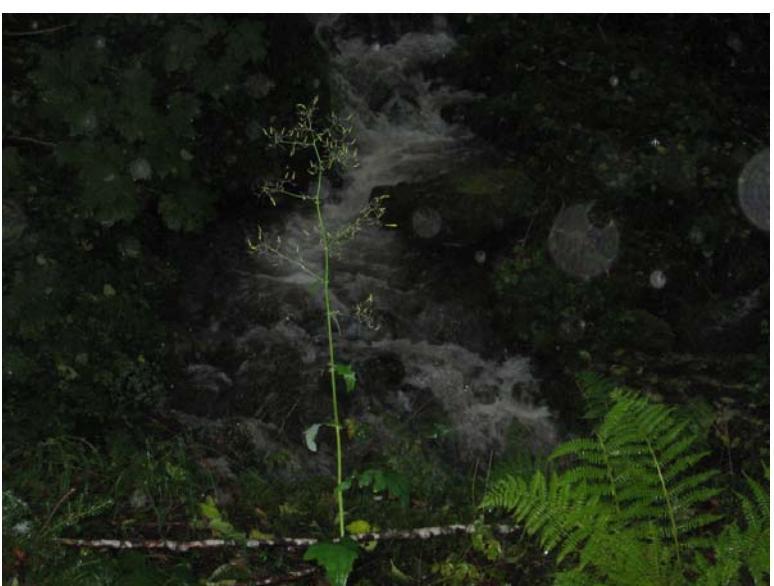
Photo #18 Direction 200° UTM Coordinates: Same as Photo # 17 Notes: Although it was raining very heavily, this creek was flowing very clear. Creek crosses under the road.
