# Hillside (Beaver Creek) Spring Condition Assessment

Location: Chicken Creek Allotment, Manti-La Sal National Forest Observers: Emma Rollins, Hunter Dunn, Nina Finley, Abby Popenoe Date: September 25, 2016 Begin/End Time: 1:20pm to 2:30pm

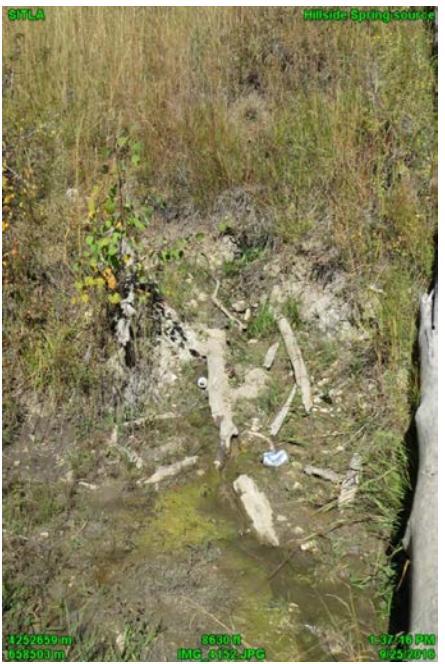
Fig. 1. Source of the Hillside Spring. Notice trampled, muddy ground with mat of green algae on water surface.

Cattle are moderately disturbing the Hilltop Spring. Cows have trampled the area surrounding the source and the pool, as evidenced by bare ground, mud, and hummocking (Figs. 1,3,10). Cow patties can be seen and smelled at the site. The dilapidated infrastructure does not minimize the impacts of cattle. The motorized-vehicle trail has enabled humans to impact this site as well, and three aluminum cans were found by the source and pool. Additionally, the forest surrounding the spring has been affected by fire and tree die-off, and trees have been logged here (Fig. 6). Despite the disturbances, Hillside Spring provides habitat and a water source for an abundance of wildlife.

We recommend fencing the spring source and pool. These two perennial water sources are important for aquatic species, evidenced by the presence of northern leopard frogs and many pond snails and insects. A fence would eliminate impacts of cattle and reduce the impacts of humans littering around the spring from the adjacent motorized-vehicle road.

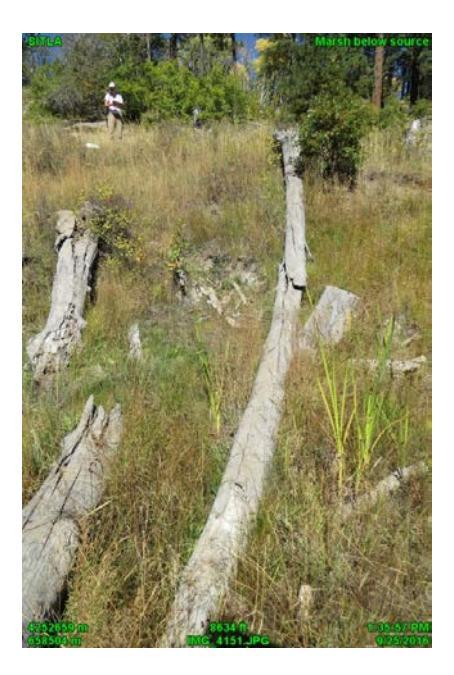
Fig. 2. Wet, marshy area at spring source. Notice source in middle of photo, common dead wood, and person in background for scale. The person is standing on the motorizedvehicle road directly above the spring.

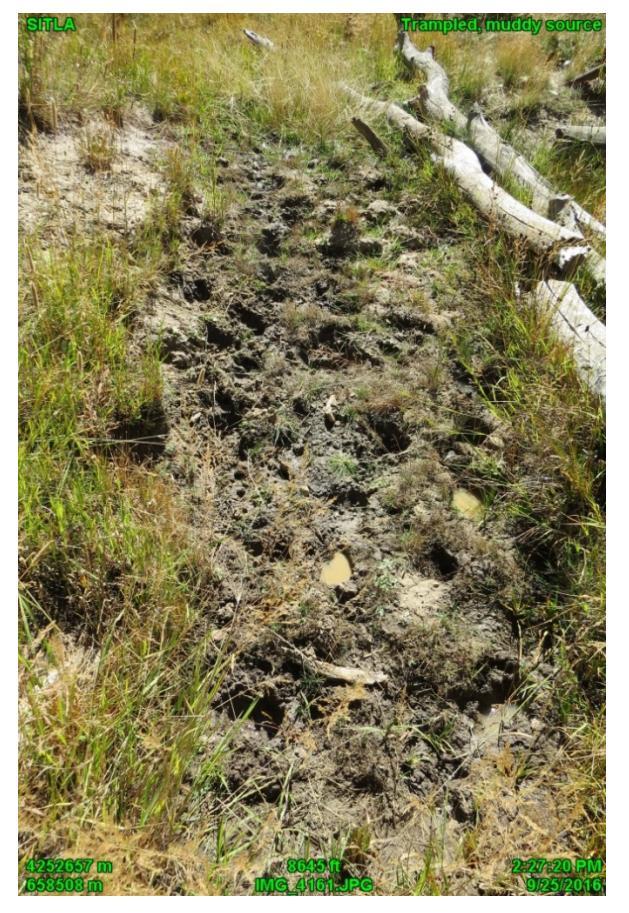
Fig. 3. The ground was muddy, trampled, and partially hummocked in front of the source.

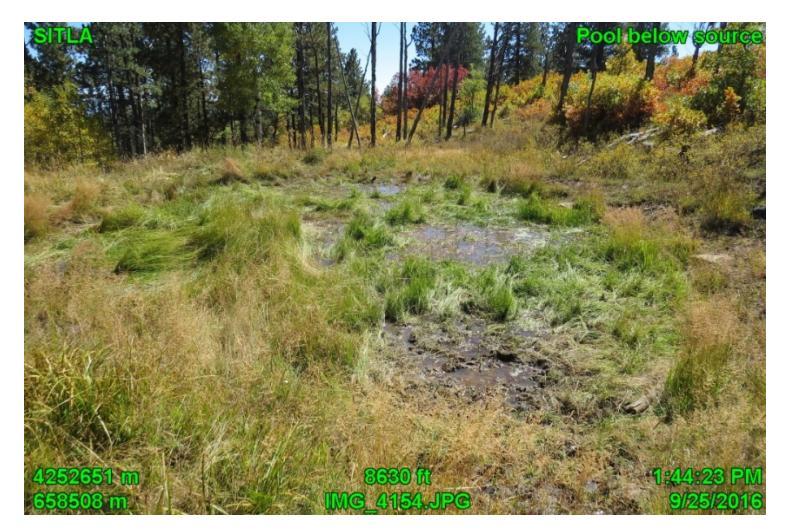
Fig. 4. Large pool of water and grazed grasses, rushes, and sedges below the source.

*Browsing evidence* Stubby and broken grasses and rushes provide evidence of grazing/browsing here.

In the larger pool below the source, rushes and sedges are quite common, growing along the rim of the water as well as in deeper areas. Thurber's fescue (*Festuca thurberi*) was present. The water was fairly open with the exception of the areas covered in rushes or a pondweed. Downed wood and rock were scattered throughout the pool and a ring of bare ground, 2-3 feet wide, encompassed the water. The four species of grasses were still the most common vegetation in this area. Among the grasses there was a large presence of Rocky Mountain iris (*Iris missouriensis*) along with other forbs scattered throughout, such as plantain, an unidentified thistle and hoary aster (*Machaeranthera canescens*). Round-leaf snowberry (*Symphoricarpos rotundifolius*) was the most common shrub in the area and a few Gambel oak (*Quercus gambellii*) and Ponderosa pine (*Pinus ponderosa*) were present on the edges of the microhabitat. Just outside the pool microhabitat, aspen (*Populus tremuloides*) stands and an abundance of Ponderosa pine are present.

*Water Presence* Standing water was present at the source of the spring, with a very slight but constant flow of clear water coming out of the ground. The source was rated a 4 on the flow consistency scale, as we believe that it is present perennially. Below the source is a pool of standing water, approximately 40 by 70 feet and marshy. We believe that flow to this pool is also present year round.

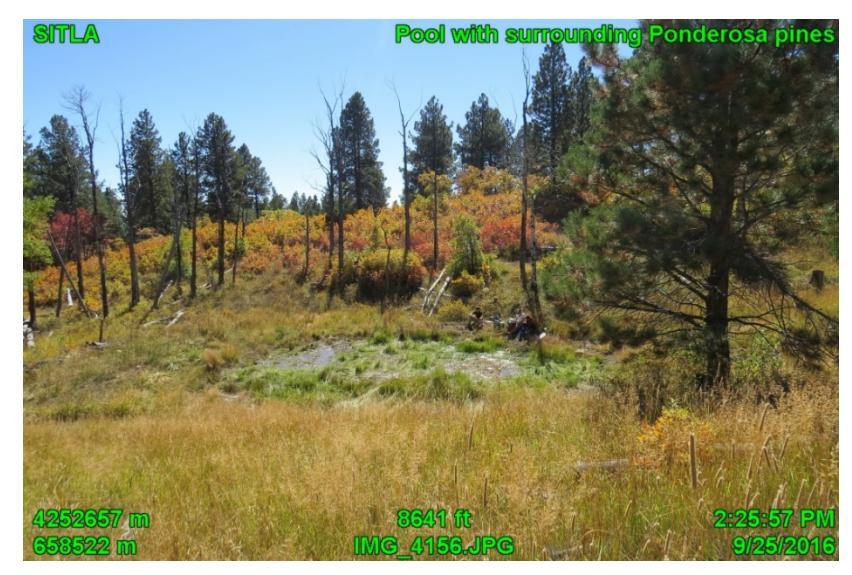
Fig. 5. Overview of pool, burned snags, and Ponderosa pines.

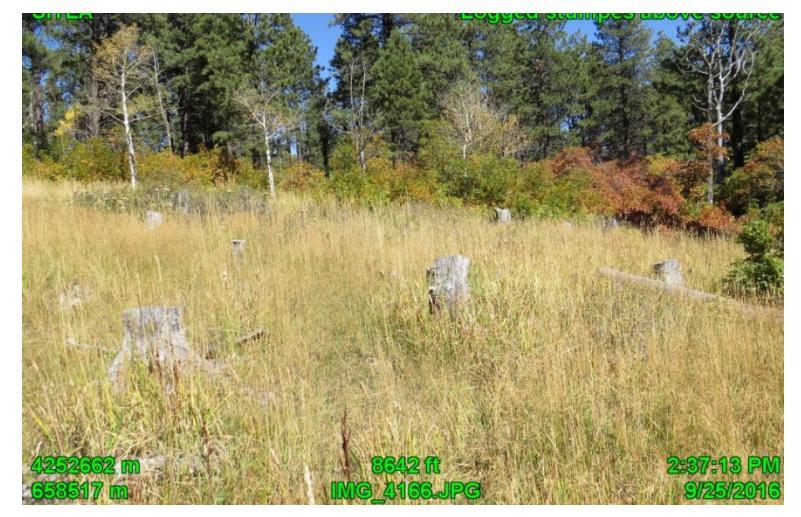
Fig. 6. Dry meadow of logged stumps above the source.

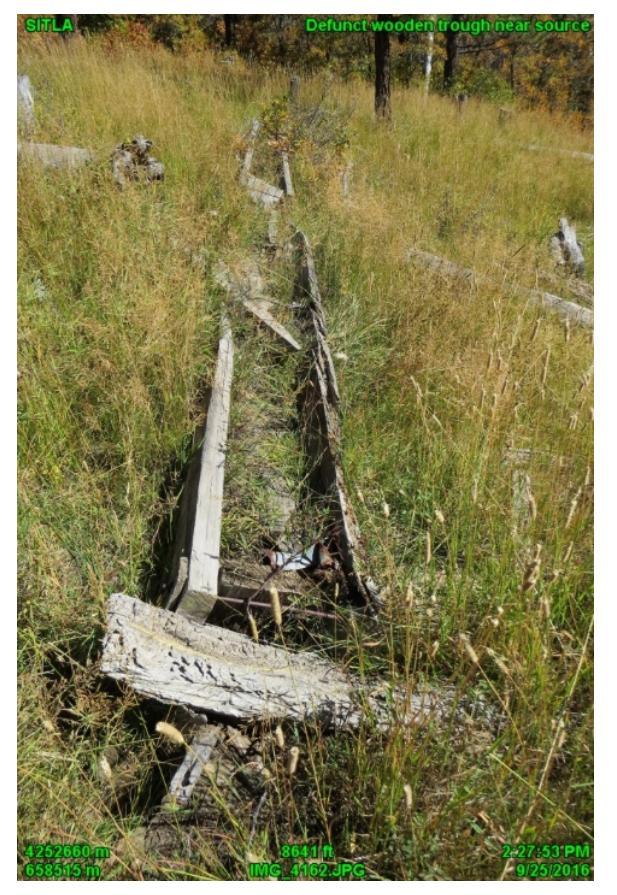
Fig. 7. Defunct, broken wooden trough above source.

*Water Infrastructure* The entire water infrastructure at this site is extremely old and defunct (Figs. 7,8). Remnants of a metal pipe stick out of the ground immediately downhill of the source, but it is rusted and full of holes. To the side of the spring are wooden boards that once formed a cow trough, but today the structure is not capable of holding water. There is no fencing around this spring.

Finally, if required for cattle, we recommend installation of a cattle trough outside the fence and a pipe from the spring to the trough. A significant portion of the water should be left for the riparian area, and the pipe should be closed when the allotment is not being actively grazed.

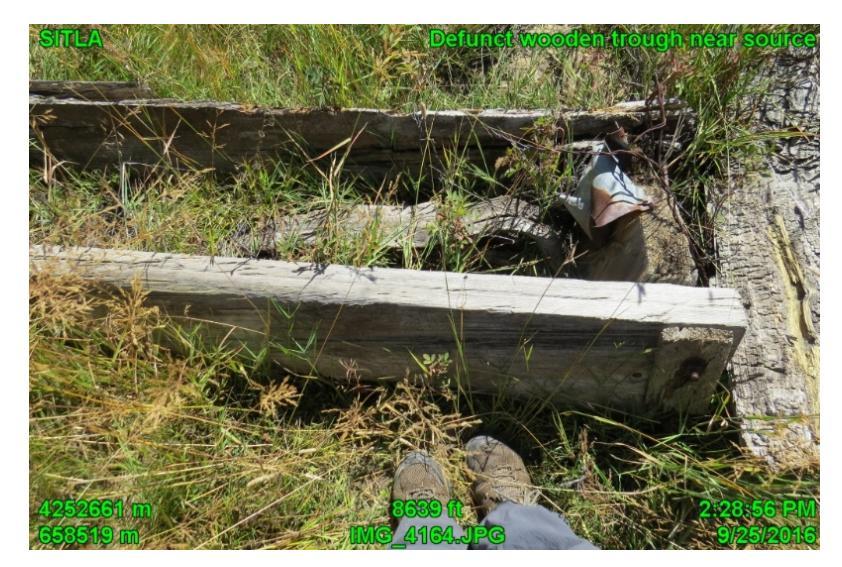
Fig. 8. Close-up of defunct, broken wooden trough above source

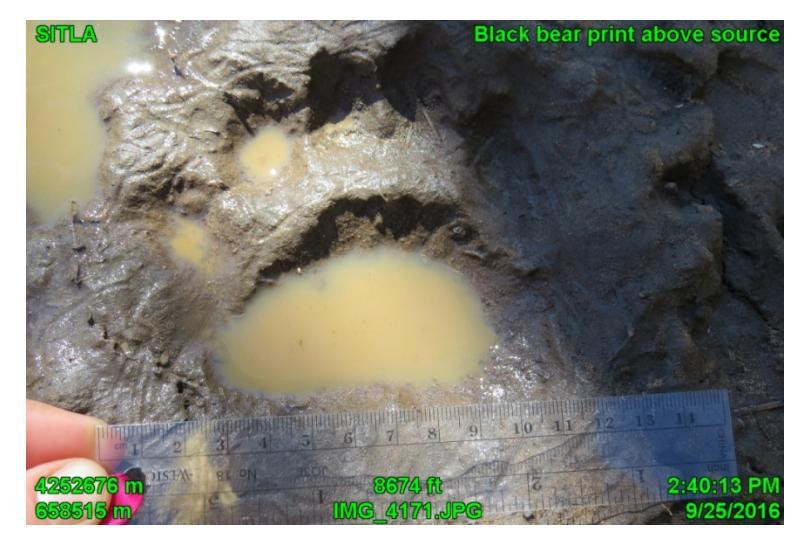
Fig. 9. One of several black bear prints found in the motorized-vehicle road directly above the spring source. The print measured 8 inches across ( ruler for scale.)

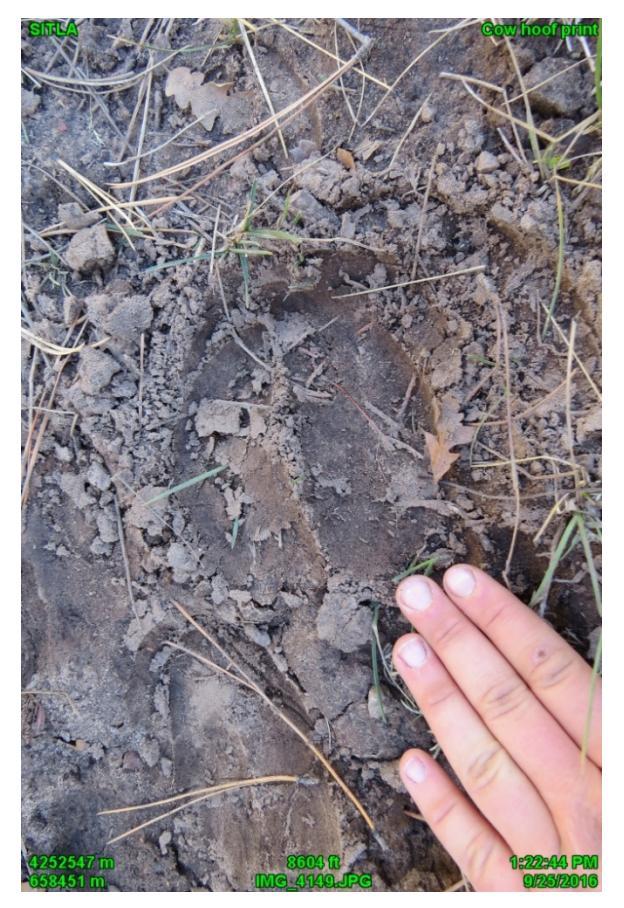
Fig. 10. Cow print found in the vicinity of the spring.
